# Lake Waukewan | Watershed Survey Results

**TO:** Angela Labreque, Town of Meredith  
**FROM:** Evan Ma & Maggie Kosalek, FB Environmental Associates (FBE)  
**SUBJECT:** Lake Waukewan Watershed Survey Results  
**DATE:** January 14, 2026  
**CC:** Laura Diemer, FB Environmental Associates

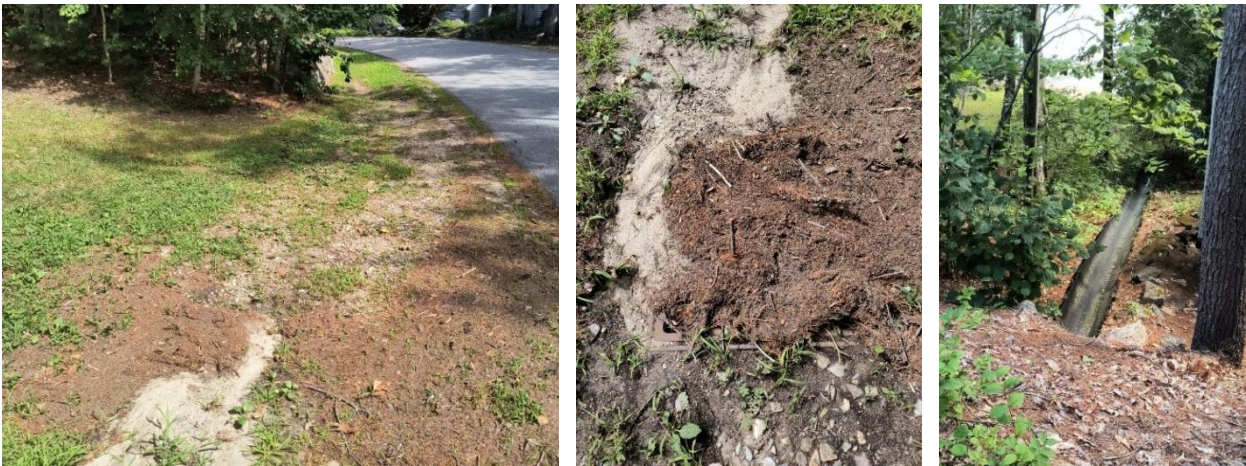
### Site 1-01: Water Street #1 (Meredith)

**Observations:** A catch basin on Water Street is completely blocked by debris with clear signs of sediment transport from the road shoulder into the catch basin. The catch basin leads to a culvert that crosses Water Street to a half-culvert that delivers sediment-laden runoff directly to the lake.

*Visible sediment transport (left) to clogged catch basin (middle) that leads to half-culvert across the street (right) and delivers runoff directly to lake.*

**Recommendations:** Clean out the catch basin and re-vegetate the road shoulder, diverting runoff to the wooded area on the upstream side of the road where possible. Remove the half-culvert that leads to the lake and vegetate the area to allow for runoff infiltration. Add a plunge pool and level spreader to the downstream side of the culvert if needed. Consider installing a sediment bag in the catch basin if there is excessive sediment or restrictions due to private property.

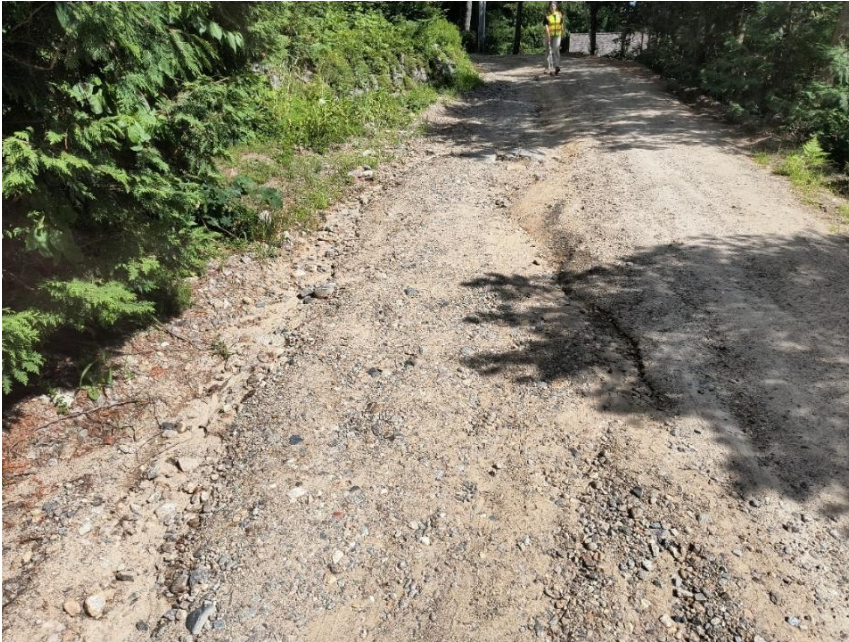
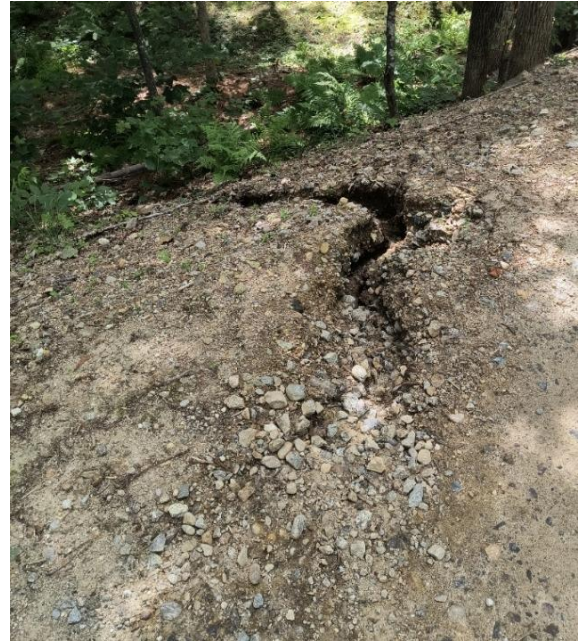
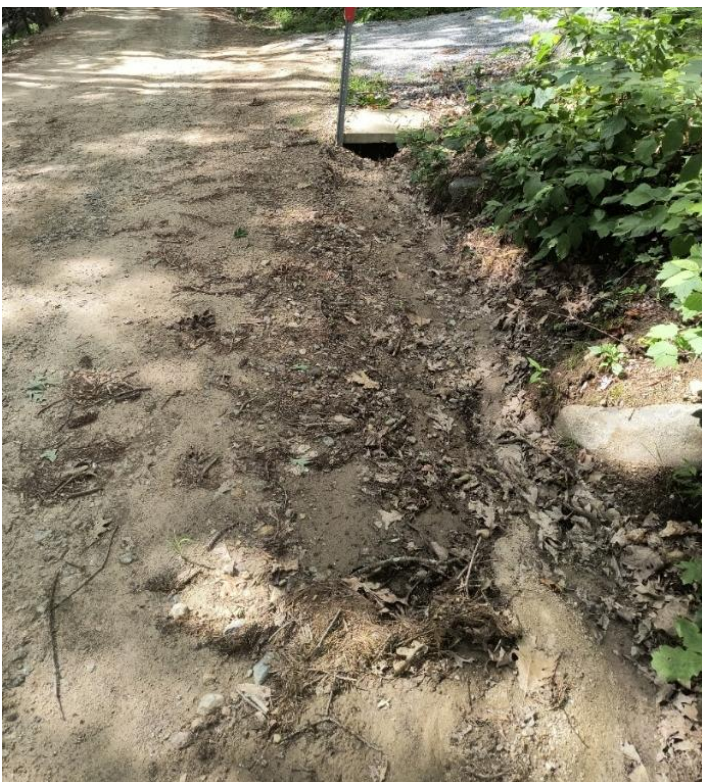
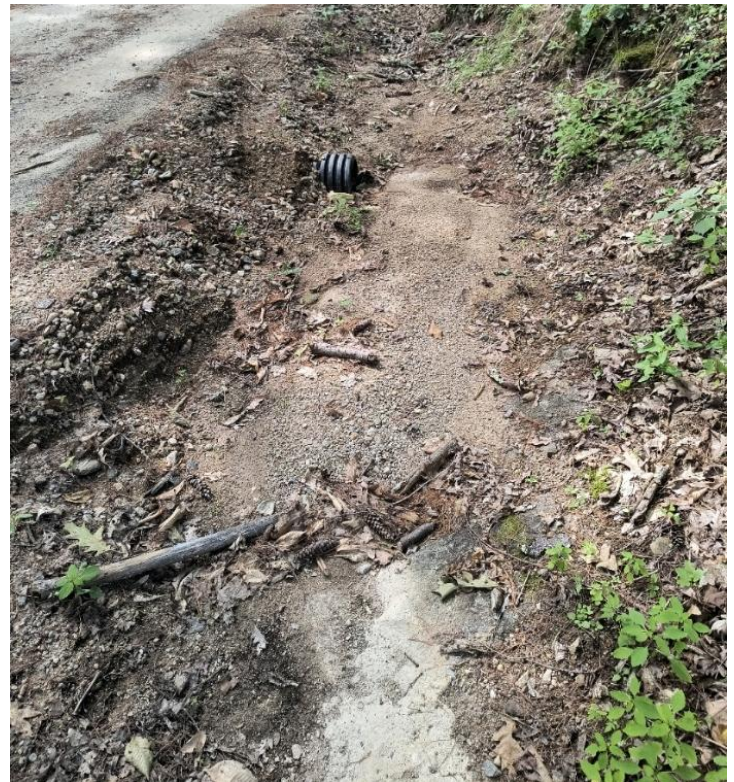
*Severe road surface erosion (top left and top right) leading to clogged culverts (bottom left and bottom right) and ample sediment transport to lake across road.*

**Recommendations:** Clean out sediment from the culvert. Recrown the road to prevent gullies from forming along the road surface. Armor the road ditch with vegetation (grass) or rip rap, especially near the culvert inlet.

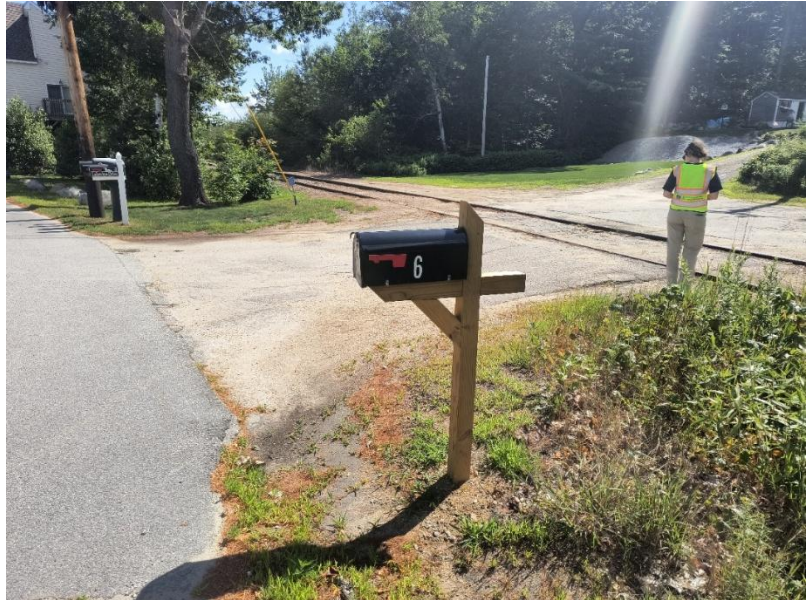
*Slight sediment transport to ditch (left) and sediment build-up on road surface (right).*

**Recommendations:** Include this site in regular street sweeping.

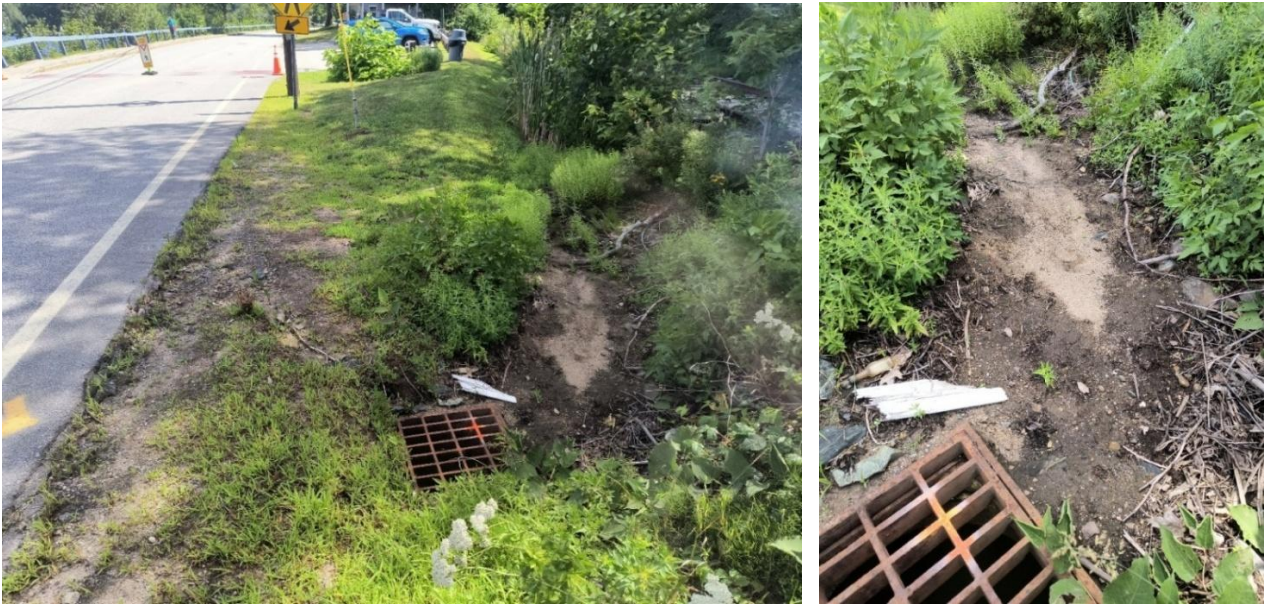
**Observations:** A small gully was observed leading from the road to a catch basin on Waukegan Street that outfalls to the lake. Eroded sand is deposited in the gully, and there is minimal vegetation around the catch basin.

*Bare soil area and gully on side of road (left). Sediment build-up around catch basin (right).*

**Recommendations:** Revegetate the road shoulder and around the catch basin. Stabilize the gully near the catch basin. Alternatively, a portion of the grassy area could be dug out into a wider vegetated ditch that can slow and infiltrate stormwater to prevent erosion at the site.

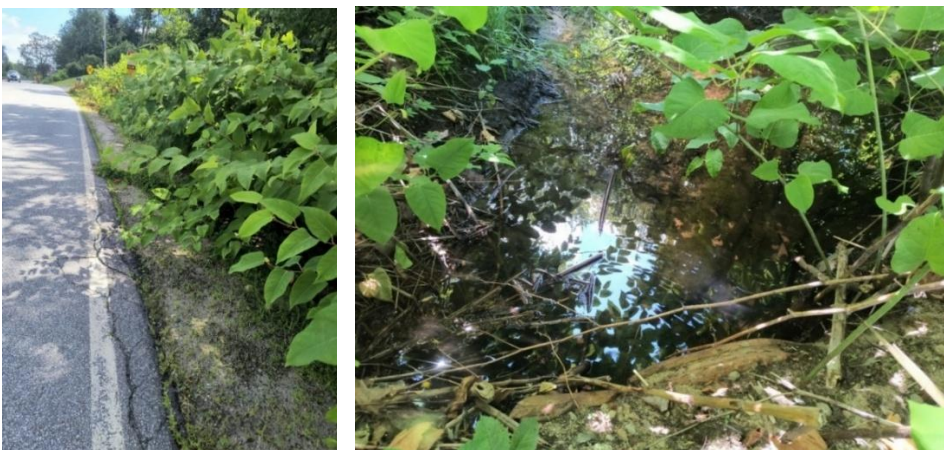
**Observations:** Although there is ample vegetation here (invasive knotweed), the road shoulder at the culvert inlet is bare. The culvert inlet is rusted, and the surrounding bank is still being undercut.

*Bare road shoulder (left) that leads directly to rusted culvert and stream (right).*

**Recommendations:** Reseed the shoulder with grass. Install turnouts to divert stormwater away from the culvert. Replace the rusted-out culvert. Remove knotweed if feasible and replace it with native plants (though this is a lower priority).

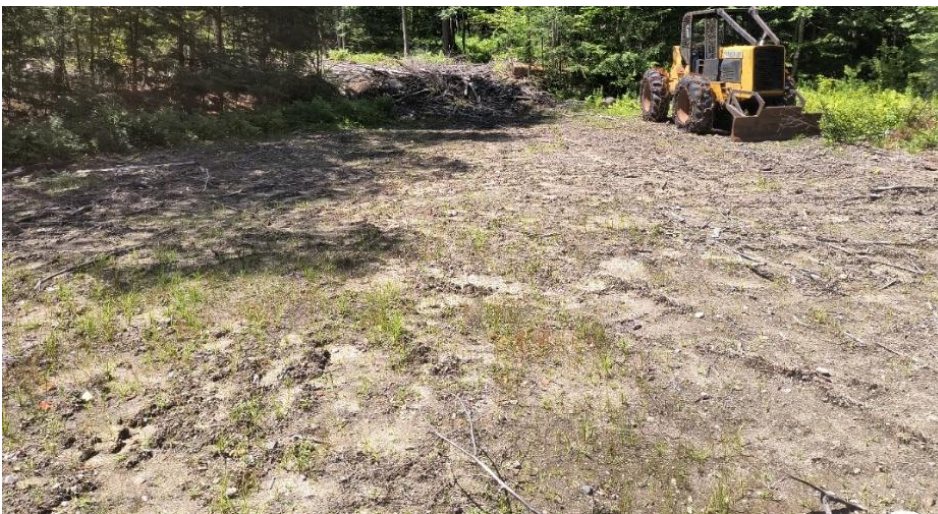
**Observations:** A Wall Street resident provided an anecdote about how increased development on the upstream side of the road (between Wall Street and Winona Road) has caused a large increase in runoff volume over the past years. Before, the runoff would infiltrate on the upstream side of the road, causing the area between Wall Street and the lake to be a marsh. With the increased impervious surface, culverts have been added under the road, thus channelizing stormwater flow instead of dispersing runoff and allowing it to infiltrate. The resident also noted sediment entering the lake from the watershed near their home has caused a beach to form on their property. They also noted biological changes to the lake, such as the absence of freshwater mussels that were previously found in the lake. Site observations appeared consistent with this description.

*New construction on the upstream side of road (left). A culvert under the road to drain water from the upstream side (right; there are several of these along the road).*

**Recommendations:** Add level spreaders at the culvert outlets to disperse flow throughout the forest. Add check dams near the banks of the stream as needed to slow and disperse flow. Investigate options on the uphill side of Wall Street to slow and infiltrate runoff before it reaches Wall Street. Stabilize bare soil areas with vegetation.

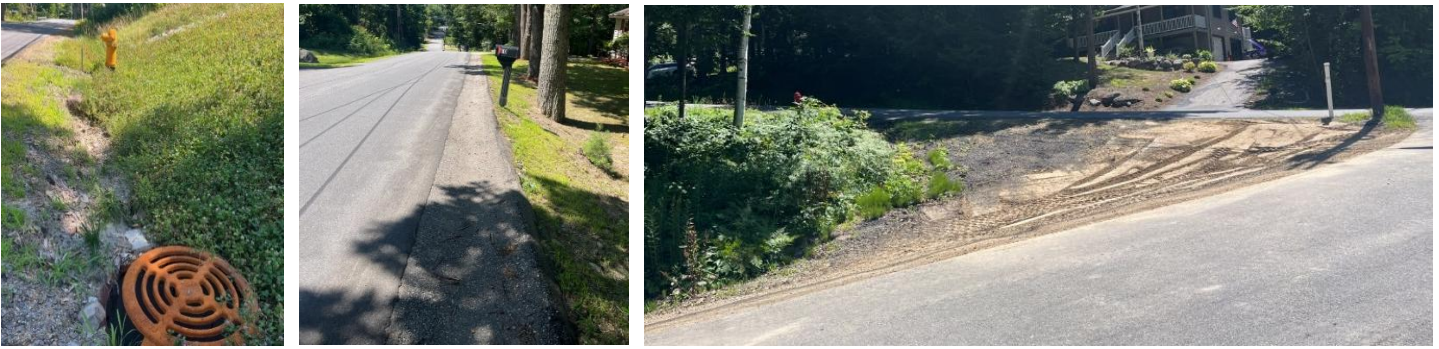
*Catch basin to underground drainage system (left). Paved swale (middle). Loose dirt on corner for DPW material staging (right).*

**Recommendations:** Install engineered BMPs near the traffic circle to treat as much runoff as possible at the top of the road before it travels downhill. Maintain the closed stormwater system. Revegetate the bare soil area.

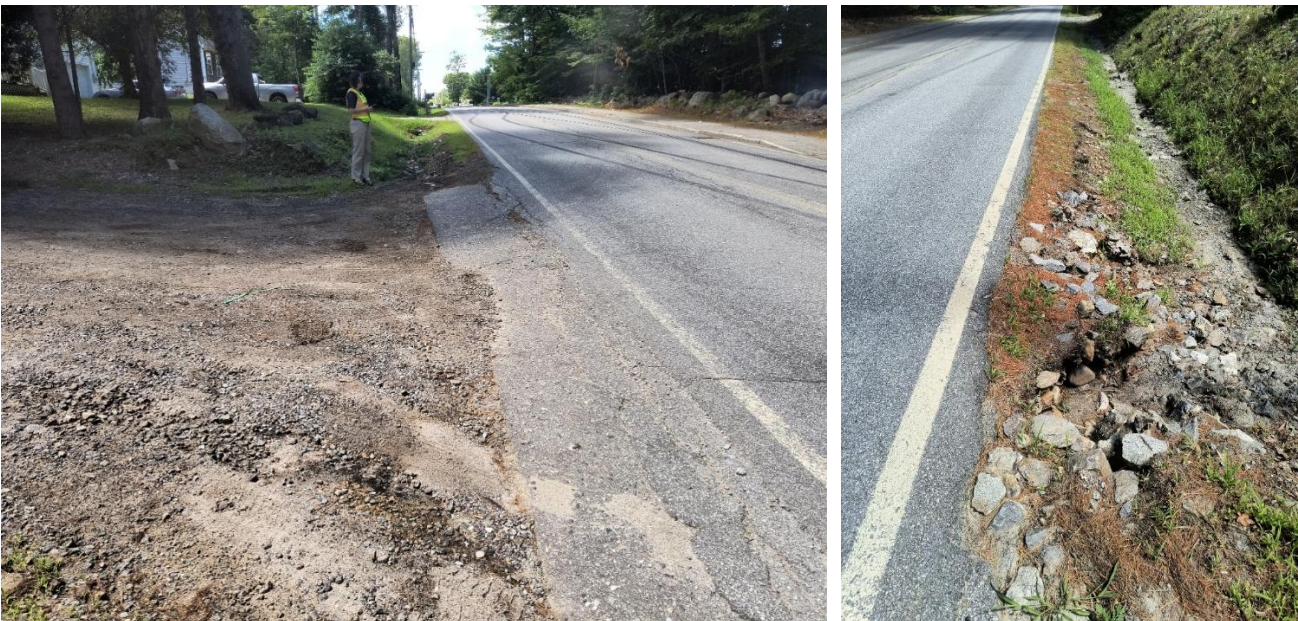
*A commercial driveway is eroding and transporting sediment (left) to the downstream ditch, causing erosion and sediment build-up (right).*

**Recommendations:** Vegetate the ditch and install check dams and vegetation mats or rip rap to stabilize the ditch. Refrain from scraping the ditch as this practice loosens soil, making it more susceptible to erosion. Consider working with the landowner to pave their driveway and use sediment control practices near sediment piles

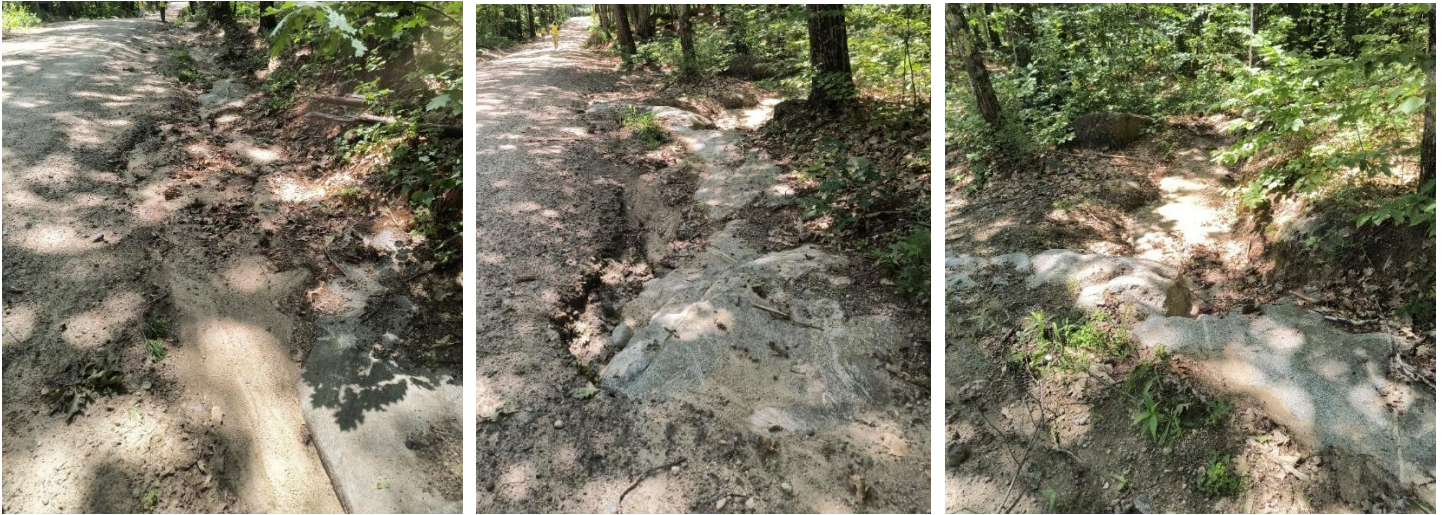
*Erosion and sediment build-up in ditches (left and middle) leading to turnouts into woods (right).*

**Recommendations:** Stabilize the road shoulder and ditch with vegetation. Install and maintain check dams along the ditch. Ensure turnout areas remain adequately vegetated and remove sediment as needed.

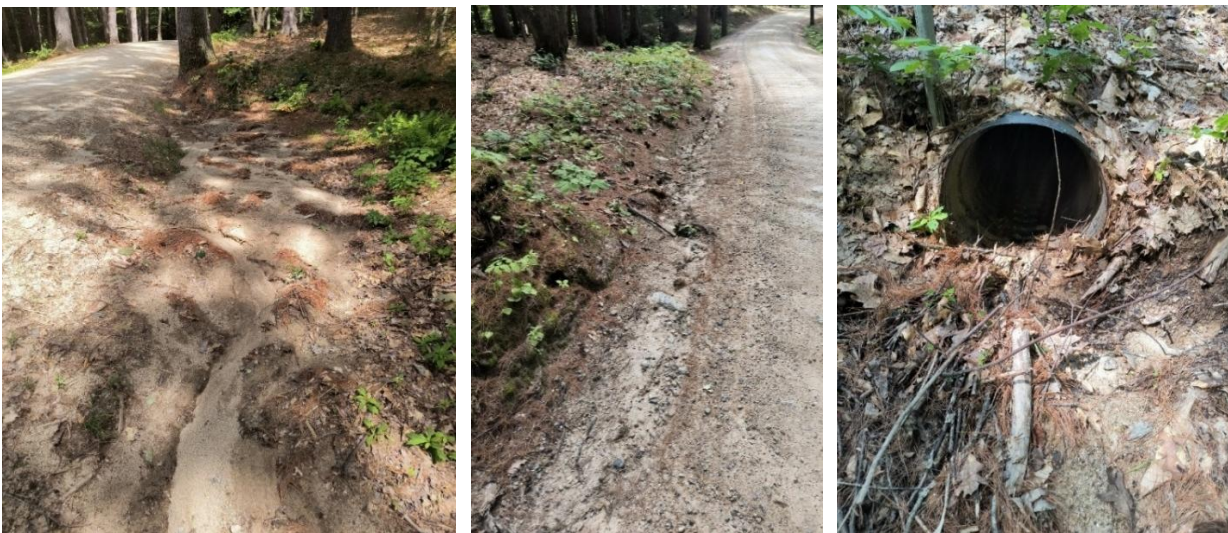
**Observations:** No changes were observed at the site since 2014. There is moderate road surface and ditch erosion on Bonney Shore Road. Stormwater transports eroded sediment through a nearby culvert which ultimately connects to a nearby stream.

*Road shoulder/ditch erosion and sediment transport (left and middle) leading to culvert that is partially filled with sediment (right).*

**Recommendations:** Vegetate and/or armor the ditches. Line the turnouts with rip rap and remove sediment periodically. Install plunge pools at the end of turnouts to capture and filter out sediment.

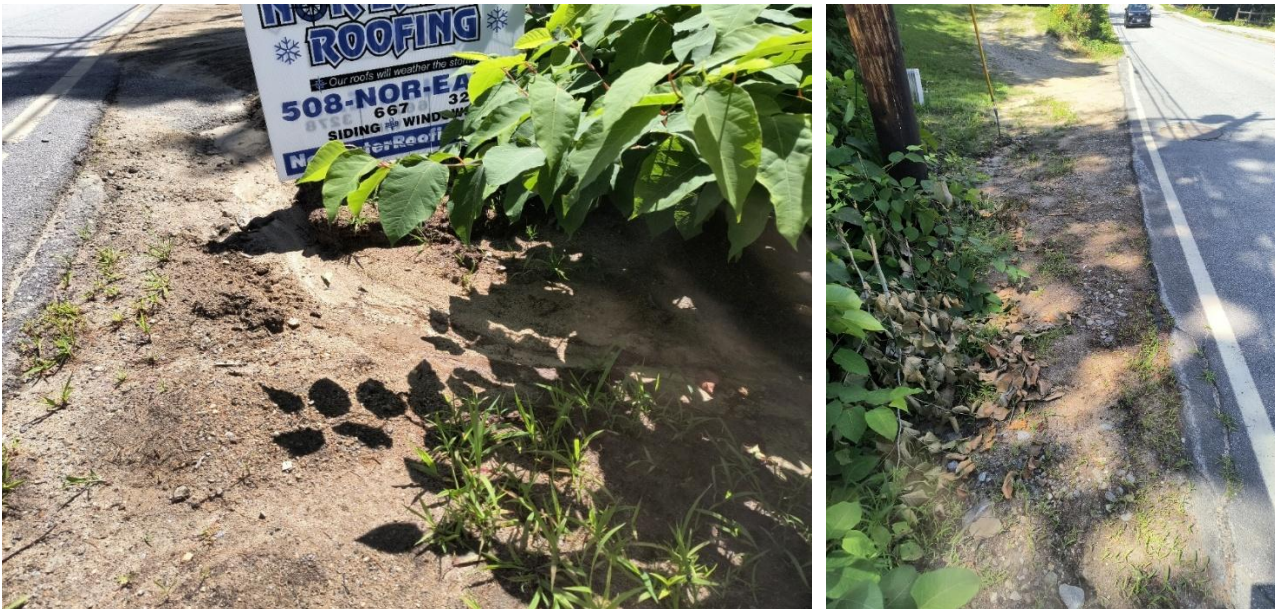
*Road shoulder/ditch erosion and sediment transport (left and right).*

**Recommendations:** Armor the road shoulder with crushed stone. Engage with homeowners on paving driveways or sediment control practices.

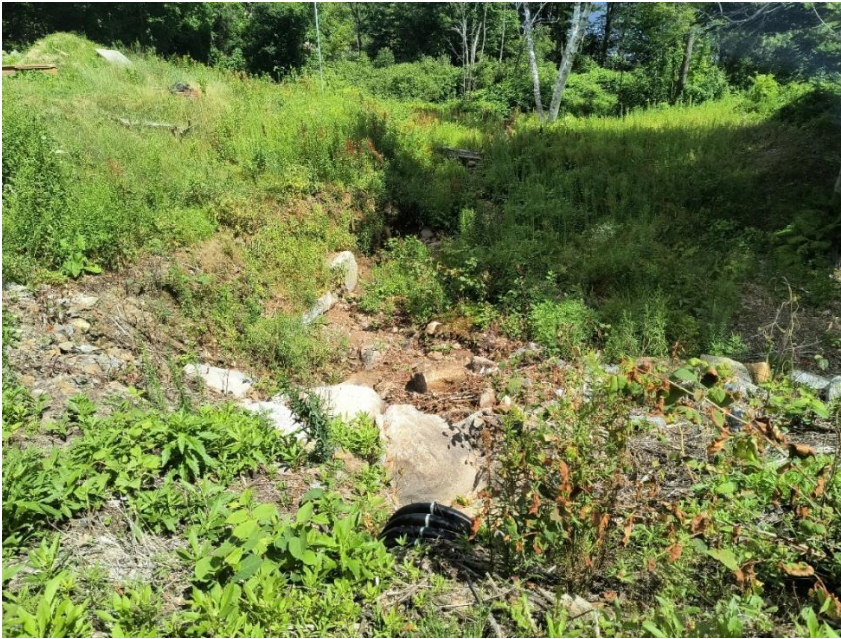
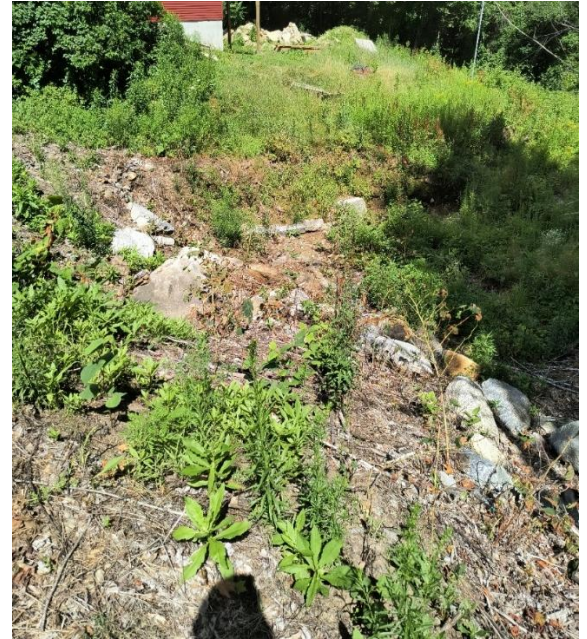
*Road shoulder/ditch erosion and sediment transport (left and right).*

**Recommendations:** Armor road shoulder with crushed stone. Engage with homeowners to encourage paving driveways that are currently contributing to pollutant loading at the site.

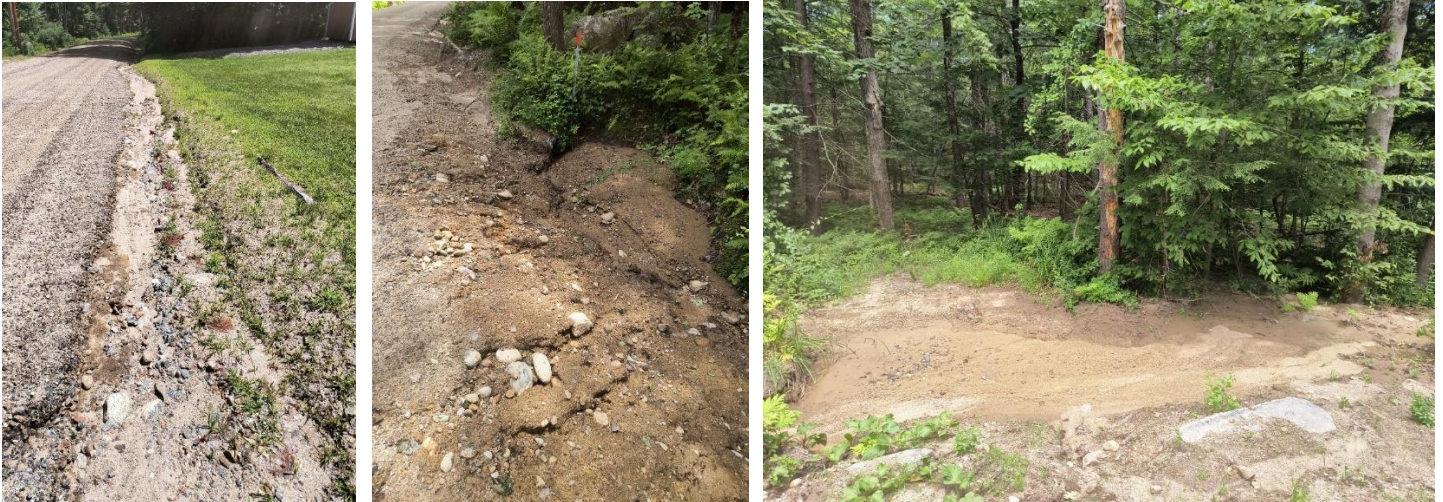
*Gullies and erosion along road shoulder (left and middle) that lead to sediment deposits (right).*

**Recommendations:** Install U-shaped road ditches that are lined with rip rap to prevent further erosion and improve stormwater management. Install check dams and turnouts along the ditch to divert stormwater into the forest. A level spreader may be used to disperse the channelized stormwater at the end of each turnout. Remove the accumulated sediment and revegetate the area, if possible.

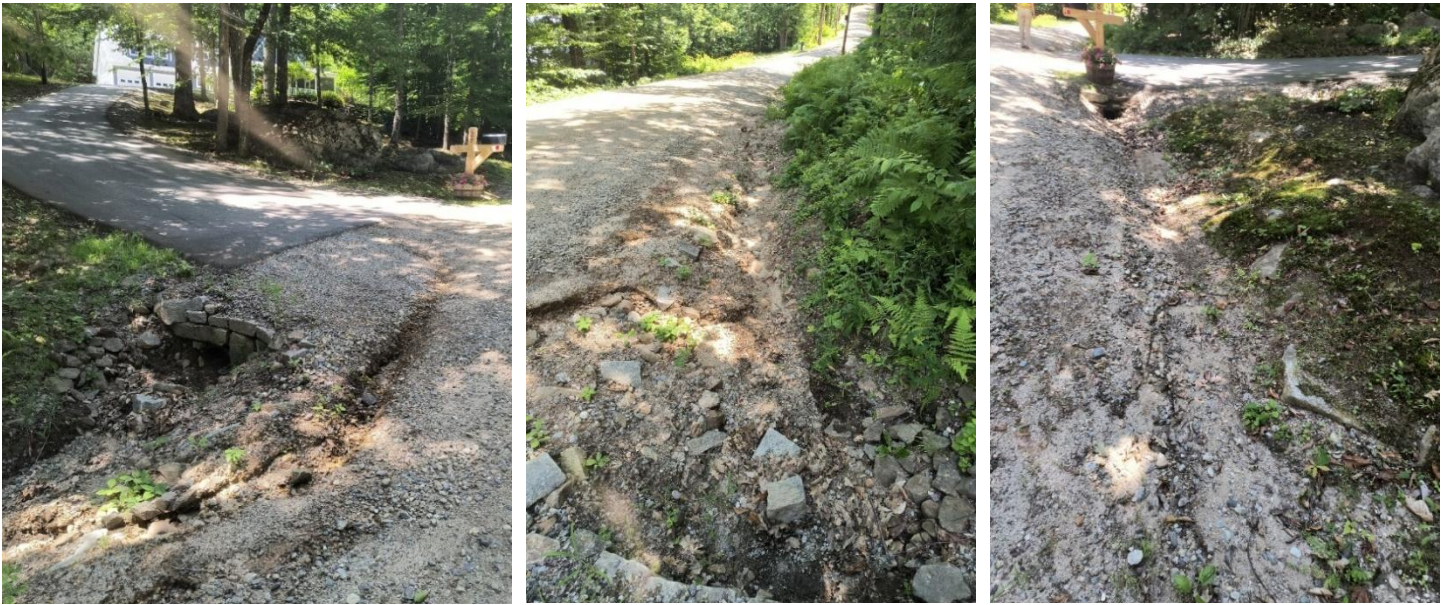
*Gullies along bottom of driveway (left) lead to ditch erosion and sediment transport (middle and right).*

**Recommendations:** Engage with the homeowner to direct stormwater from the driveway into the wooded area or to the ditch using a rubber razor or broad-based dip. Stabilize the ditch with rip rap. Install check dams in steeply sloped portions of the ditch.

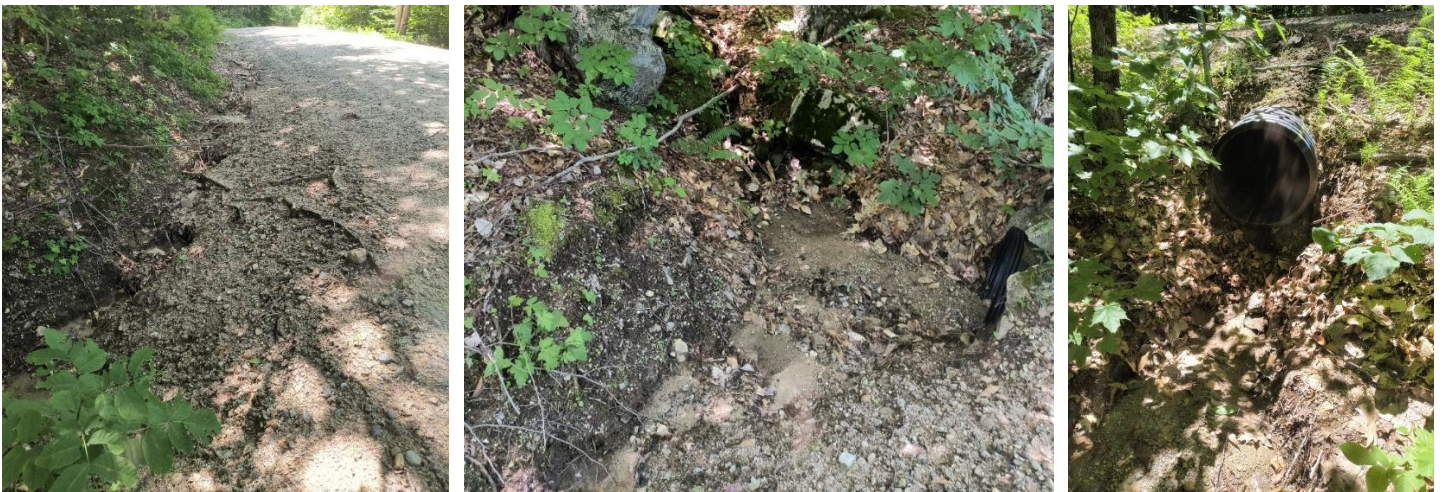
*Sediment transport to culvert inlet (left) with lack of buffer and sediment accumulation (middle). Culvert outlet is perched and sediment deposit is visible (right).*

**Recommendations:** Stabilize the road shoulders, culvert inlet, and culvert outlet with vegetation and/or rip rap. Install a level spreader at the outlet to disperse and reduce the velocity of the culvert outflow.

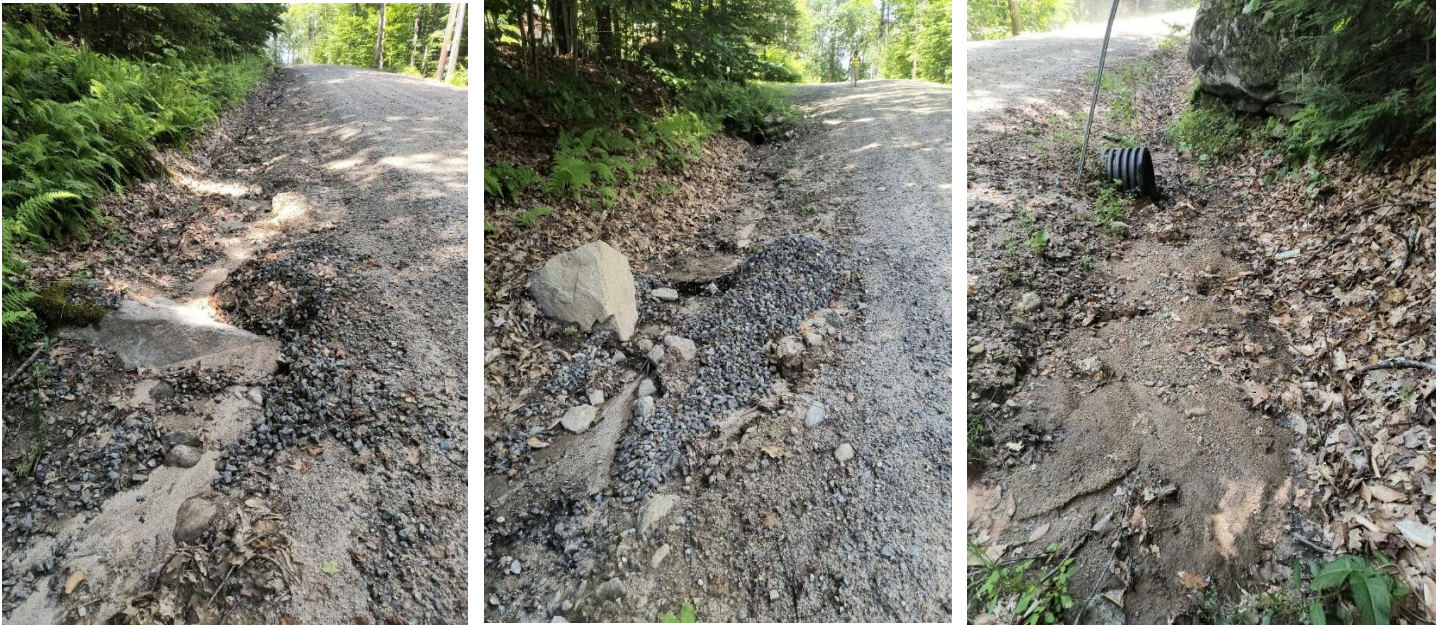
**Observations:** The check dams installed at the site have been washed out, causing a gully to form in the road ditch. Several additional rills on the road surface lead into the gully which has caused a buildup of sediment at the culvert inlet. The culvert outlet drains to a wetland in a vegetated channel. The outlet is not visible, so evidence of erosion or sediment deposition could not be determined.

*Washed out check dams caused gullies to form in ditch (left and middle) leading to sediment buildup at the culvert inlet (right).*

**Recommendations:** Improve the check dams and ensure maintenance after storm events. Reshape the road ditch into a U-shape and armor it with rip rap. Consider installing a larger check dam near the culvert inlet or using a plunge pool to capture stormwater before it enters the culvert. In cases where a check dam may not be suitable, consider using a silt sock.

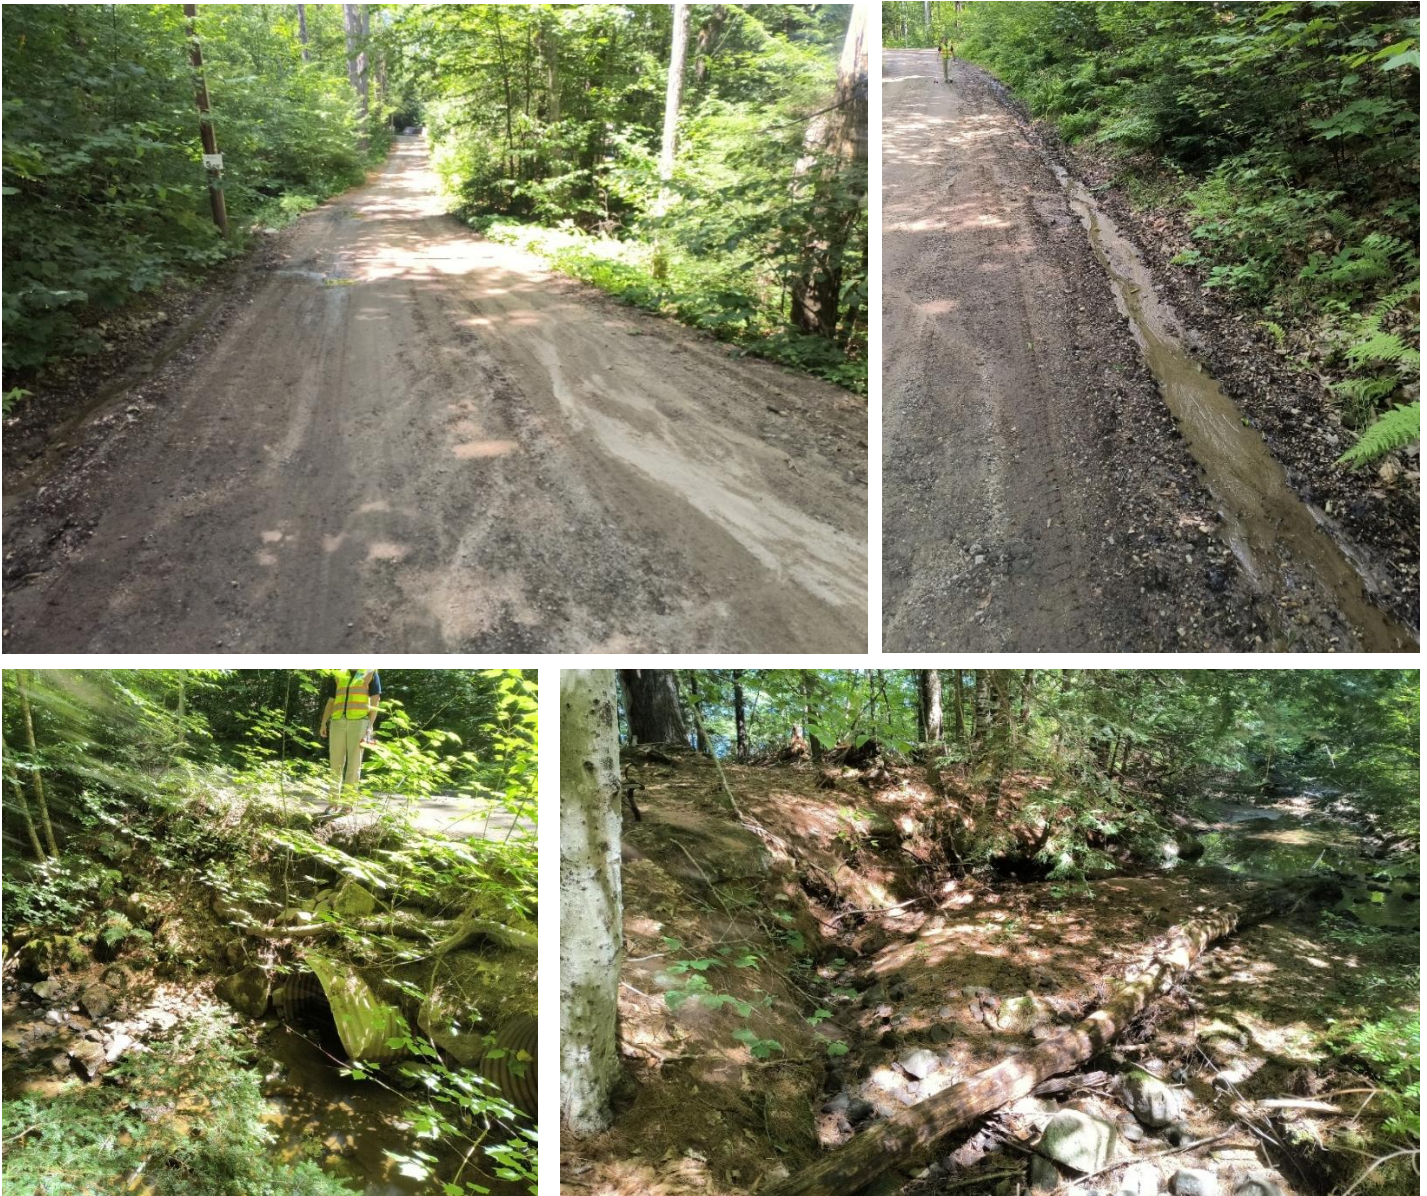
*Gullies on road surface and shoulder (top left and top right) lead to outlet of a double culvert (bottom left) and a stream that leads directly to the lake (bottom right).*

**Recommendations:** Recrown the road or consider super-elevating it to direct all stormwater runoff to one side. Stabilize the ditches with vegetation or rip rap; check dams may be installed, if necessary, to reduce the velocity of water to the stream. Replace the culverts if they are at risk of collapse and regularly clear debris to prevent blockages. Stabilize the culvert inlet and outlets with rip rap and vegetate the road shoulder. Perform restoration on the eroding stream bank downstream.

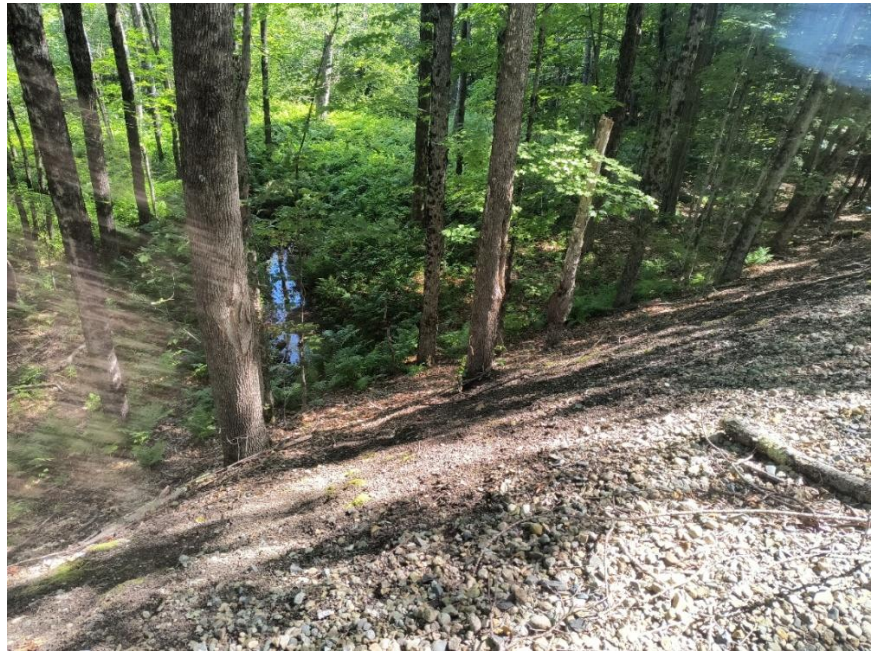
**Observations:** In the original 2014 watershed survey, there was excessive sediment observed moving through the stream channel. In 2025, there were no obvious signs of erosion down to the stream crossing under the railroad. The stream is somewhat incised and has a sandy substrate, but it does not appear to be related to erosion. The slope from the railroad down to the stream is bare, sandy, and very steep.

*Sloped side of raised railroad leading down to a stream which travels under the railroad by a culvert (left and right).*

**Recommendations:** Check the outlet point of this tributary to the lake to see if there are patterns of sediment deposition. If the forest hillslope is eroding, a larger stabilization project may be needed. The site impact is currently considered moderate due to proximity to a lake tributary. If patterns of sediment deposition are not observed at the tributary mouth over repeated visits, the site could be changed to low impact.

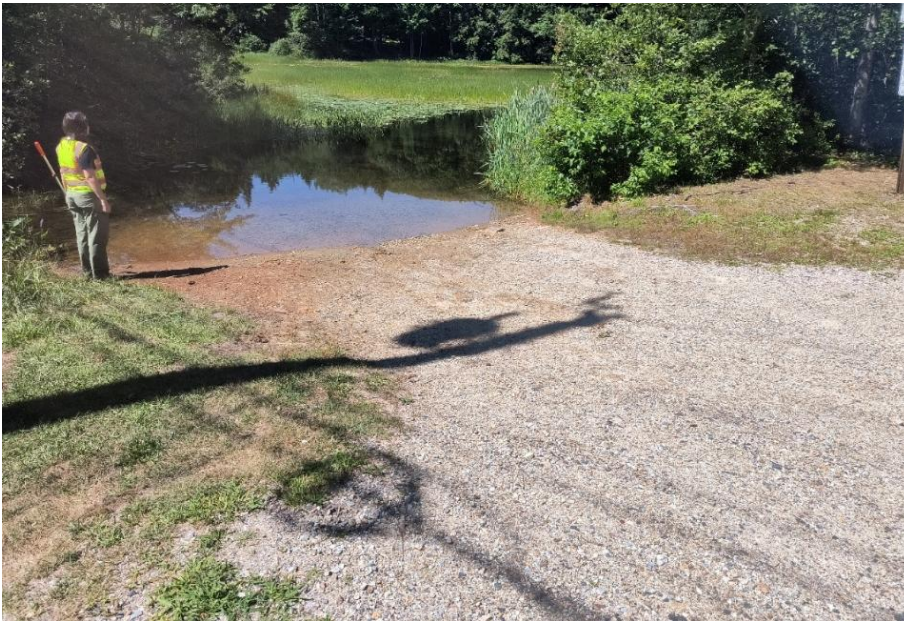
**Observations:** There were few changes at the site since 2014, in which sediment was observed to wash into the lake via the boat ramp with some small gullies directly down the ramp. The parking lot appears to be a loose material that could be easily mobilized. The culvert under the road was noted as an issue in the 2014 survey, but that issue appears to be resolved.

*Boat launch (left) with slight gullying from parking lot (right).*

**Recommendations:** Regrade the parking lot to divert water to small wetland at foot of parking area instead of boat ramp. If the size of the parking lot can be reduced at all, increase the width of the vegetated area by the wetland. If the launch area is only for small boats and kayaks, reduce the boat launch footprint and consider vegetating it or using interlocking pavers. Add more vegetation around the launch and/or cease mowing the grass. If mowing is necessary, keep to four inches minimum.

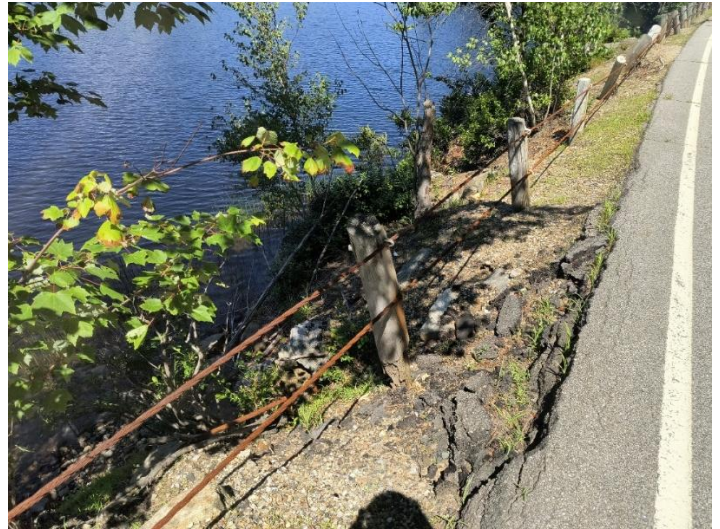
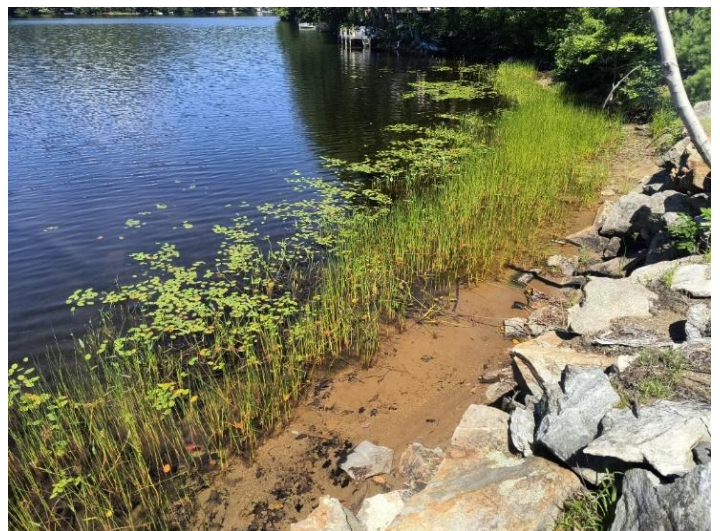
**Observations:** Winona Road is extremely close to Winona Lake and is constrained by a steep slope on the opposite side. There is severe shoreline/bank erosion and several large gullies leading down to the water. There is substantial sand built up along the lake shoreline (from erosion and/or stormwater runoff); this sand was observed to originate from watershed sources as there is a clear dividing line between the sand and the lake muck.

*Eroding roadside down a steep bank (top left, top right, bottom left) leading to sediment deposition into Lake Winona (right).*

**Recommendations:** A larger engineering study may need to be conducted at the site to determine the appropriate recommendations for the entire road. Potential recommendations may include live stake plantings or rip rap to stabilize the shoreline, super-elevating the road to direct all runoff to the upslope side and installing cross-culverts or, with significant engineering and permitting, building the land out into the lake to support the road.

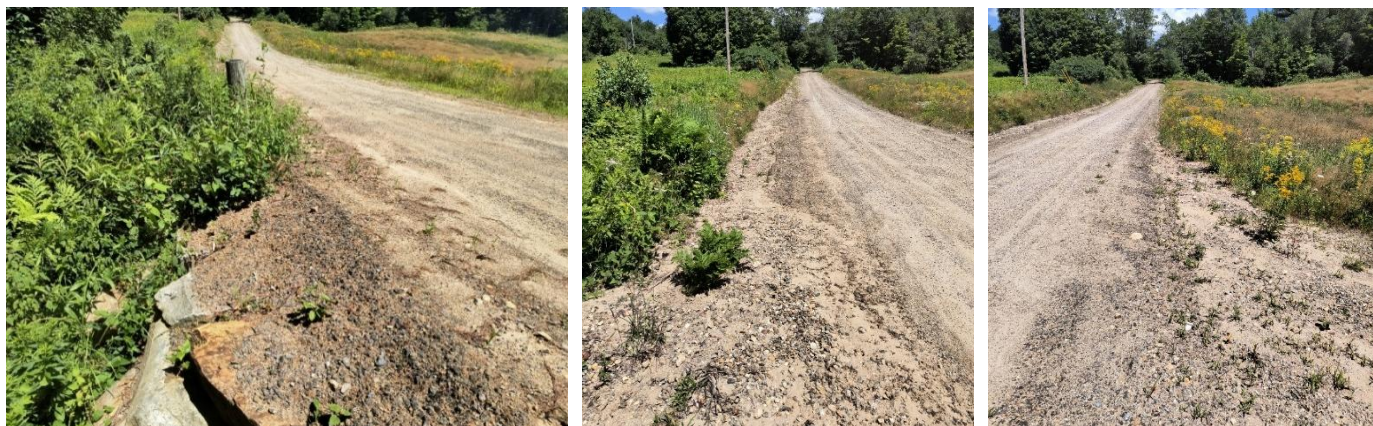
*Culvert at bottom of hills (left) and gullies along ditch (middle and right).*

**Recommendations:** Add check dams to the ditches on both sides of the road and turnouts into the meadow, which can be used to infiltrate stormwater before it reaches the stream.

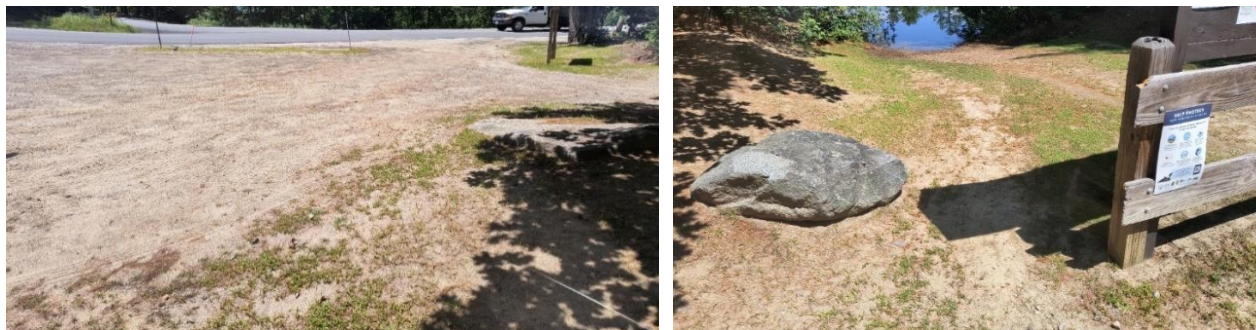
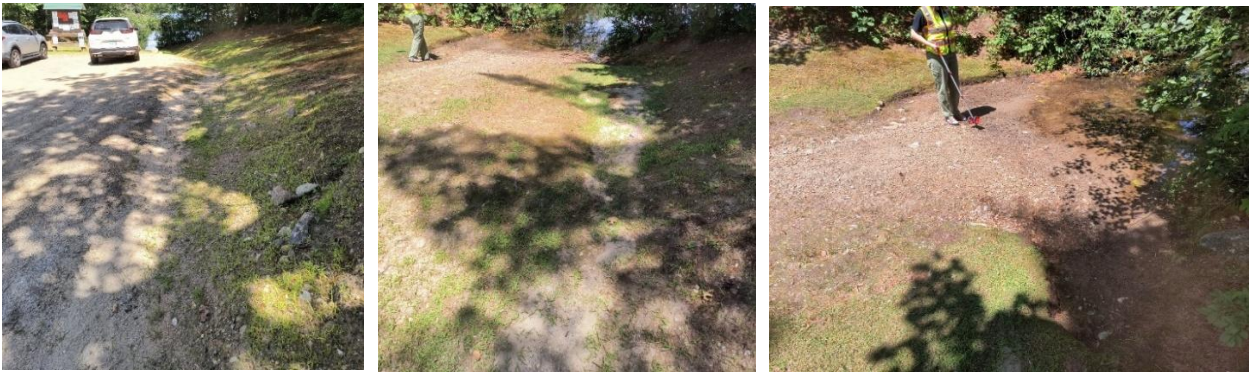
*Large sandy parking lot (top left) leading to boat ramp which has some erosion (top right and bottom right). A gully along parking lot (bottom left) leads to boat ramp (bottom middle).*

**Recommendations:** Vegetate the ditch along the parking lot edge. Install check dams in this ditch if necessary to slow flow. Re-grass the full boat launch area and make the access narrower and more defined. Remove sediment piles in the woods.

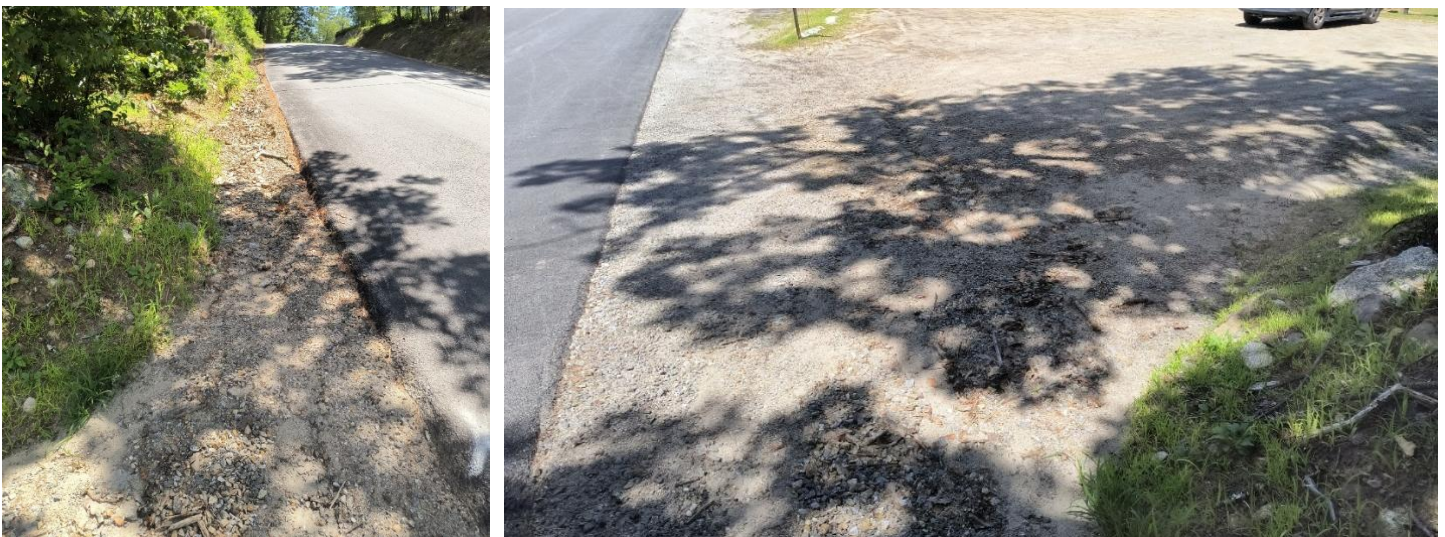
*Gully along edge of road (left) leading to more gullies in parking lot (right).*

**Recommendations:** Armor the road shoulder ditch with rip rap and add check dams to attenuate flow. Add turnouts into the woods, if possible.

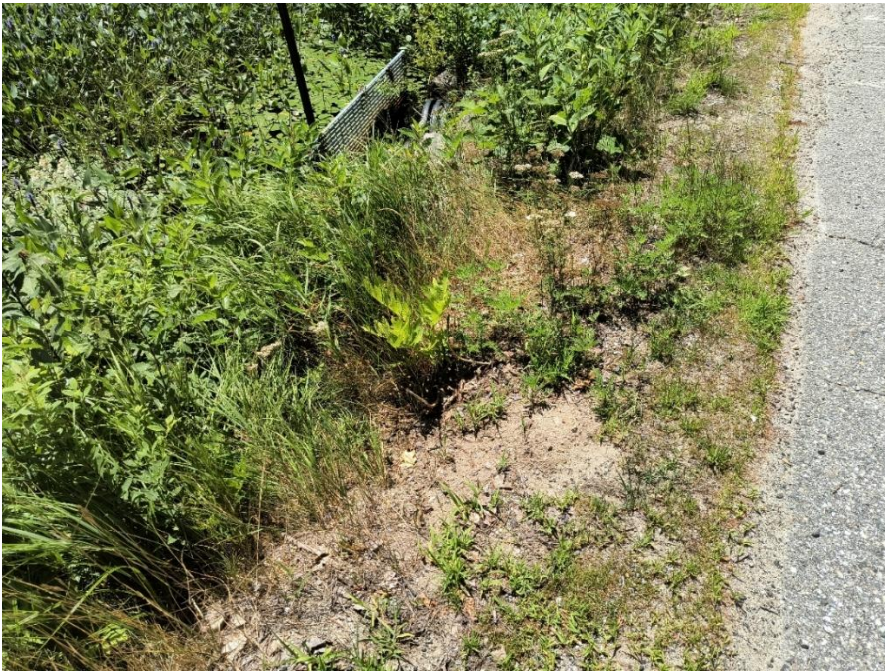
*Edge of road and wetland with lack of buffer (left). Eroding road shoulder with ample sediment buildup (right).*

**Recommendations:** Add curbing to the road to prevent stormwater from directly entering the water resource. Turnouts may also be installed to direct stormwater into the wooded area to infiltrate stormwater. Repave the eroding road surface. Remove excess sediment from the road and road shoulder.
