# Lake Waukewan | Watershed Survey Results

**TO:** Angela Labreque, Town of Meredith  
**FROM:** Evan Ma & Maggie Kosalek, FB Environmental Associates (FBE)  
**SUBJECT:** Lake Waukewan Watershed Survey Results  
**DATE:** January 14, 2026  
**CC:** Laura Diemer, FB Environmental Associates

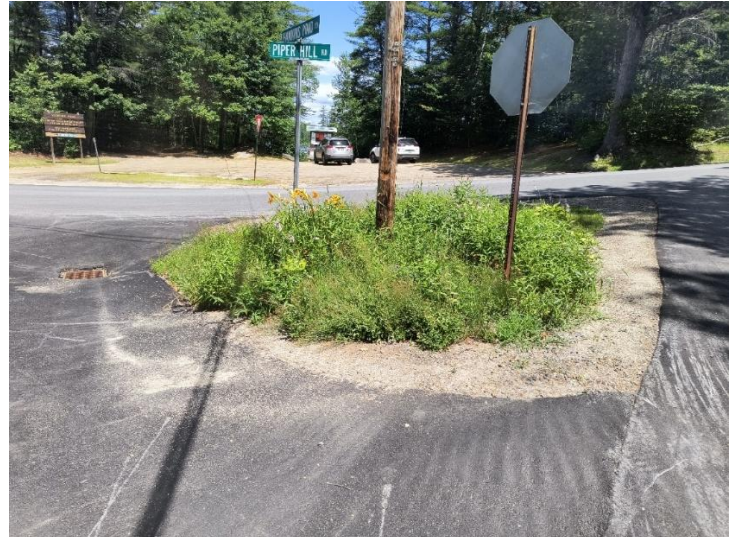
*A gully full of sediment (left) leads to catch basin (middle). Road intersection island with catch basin in roadway (right).*

**Recommendations:** Vegetate the road shoulder and stabilize the ditch. Add check dams and turnouts to the woods if necessary/possible. Add a filter bag to the catch basin in the roadway. Remove sediment from catch basins and shoulder. Increase vegetation in the road intersection island and remove the sandy gravel. Evaluate if the entire impervious area is needed for car travel and consider replacing with a smaller right-angle tee intersection without an island and with much less asphalt surface area; remove excess impervious cover and replace it with vegetation where possible.

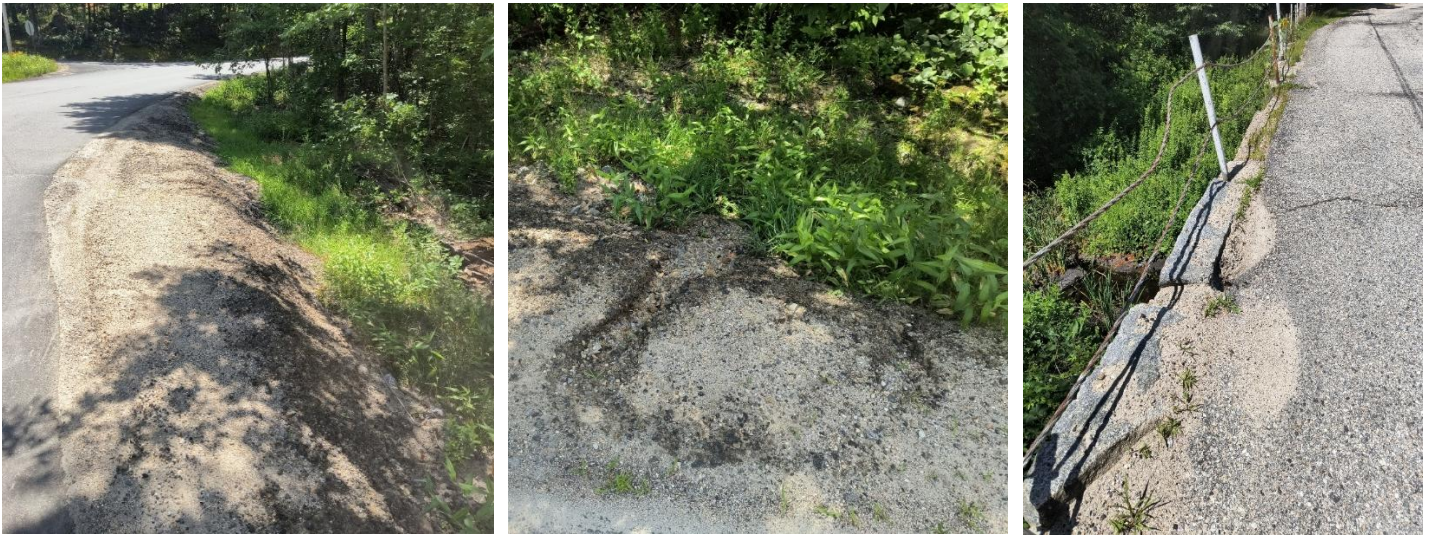
*Loose asphalt material on road shoulder with some small gullies (left and middle). Sediment buildup on bridge (right).*

**Recommendations:** Replace the road shoulder, which is composed of loose asphalt, with a more stable material and rip rap, if needed. Add curbing to the sides of the bridge to direct stormwater to vegetated areas on either side of the stream crossing.

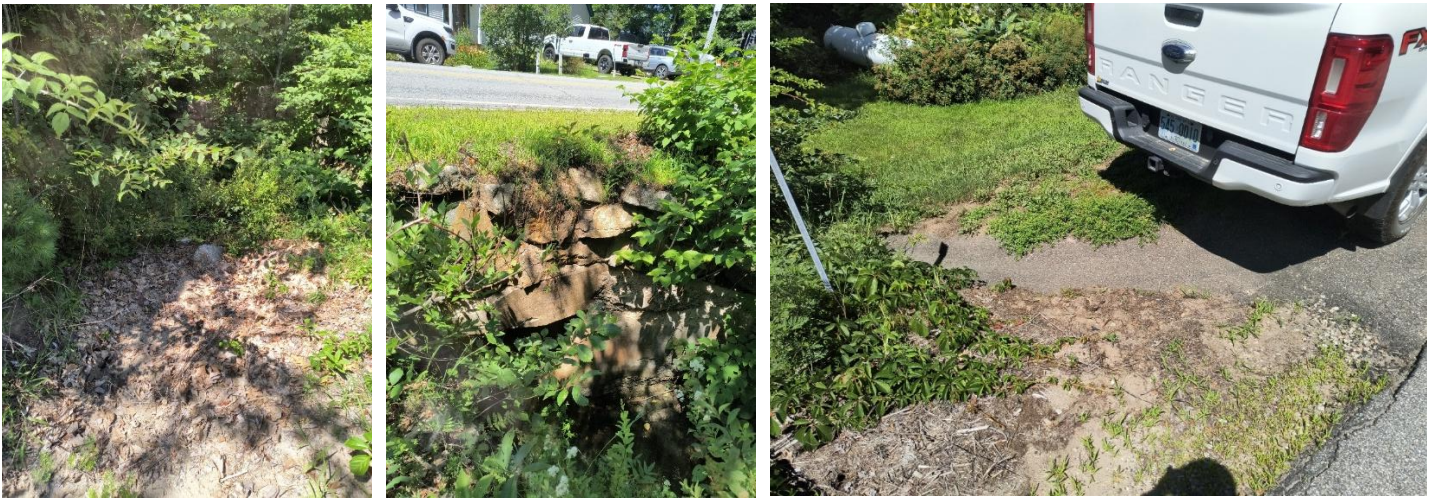
*Sediment buildup at end of gully that transports to stream (left). Lack of vegetation at culvert inlet (middle). Paved swale on downstream side that directs stormwater to stream (right).*

**Recommendations:** Remove sand from gully and inlet area. Implement a rain garden or at least more vegetation to this corner area as well as above the culvert inlet. Stabilize the stream bank at the outlet and investigate the use of the private pipe. Replace the paved swale with an infiltration structure.

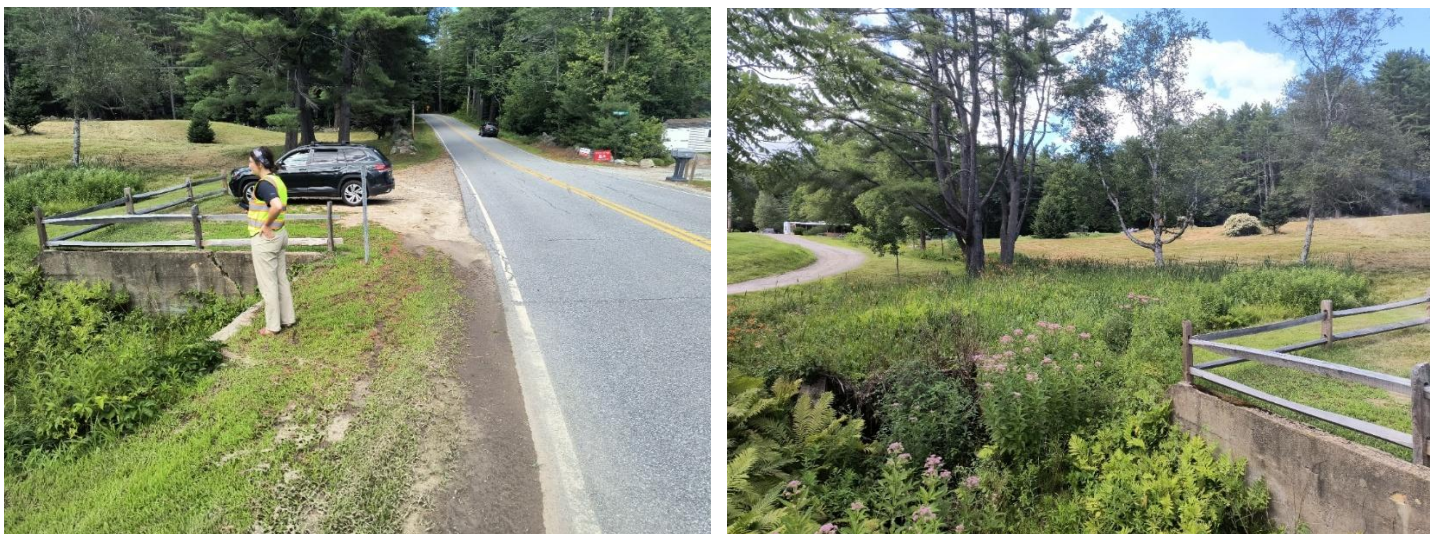
*Culvert inlet with lack of vegetation (left) and upstream with narrow buffer through campground (right).*

**Recommendations:** Engage with the landowner to increase the buffer along the stream as much as possible. Add vegetation around both the inlet and outlet of the culvert.

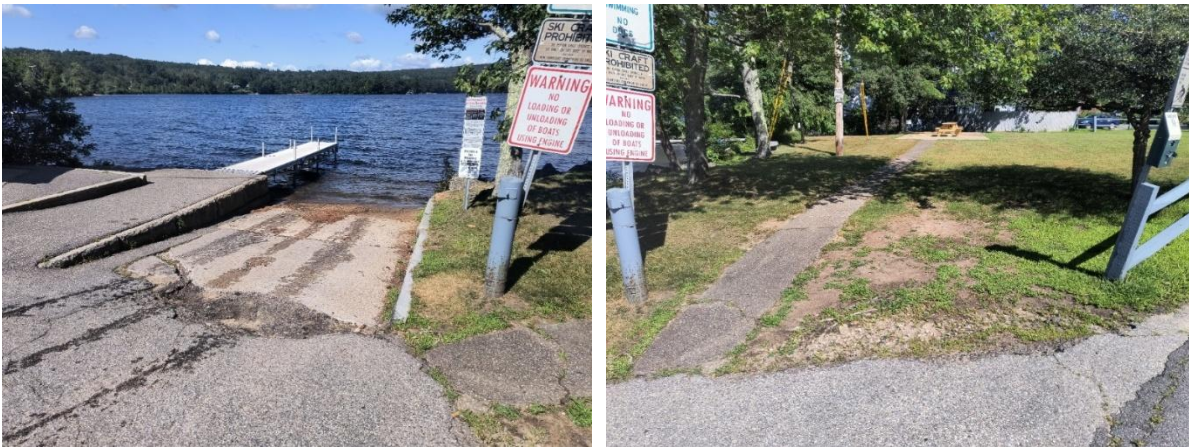
**Observations:** Polluted stormwater is entering the lake through the boat ramp; both the boat ramp and the adjacent park are eroding. Stormwater travels directly down the boat ramp from the north. There are signs in the park that a buffer was established as part of a past NHDES grant project, but the buffer has deteriorated and there is little vegetation in the park.

Boat ramp (left) and adjacent park (right).

**Recommendations:** Consult an engineer to redesign the boat ramp. Divert runoff from the street into the park with a broad-based dip. Add a rain garden to the park to direct the stormwater into. Re-grass all other areas of the park. Potentially add storm drains to the road north of the boat ramp; directing stormwater to the park area is preferred to infiltrate stormwater. Revegetate the buffer along the shoreline of the park. Collaborate with the Meredith gardening club to maintain buffer and rain gardens.

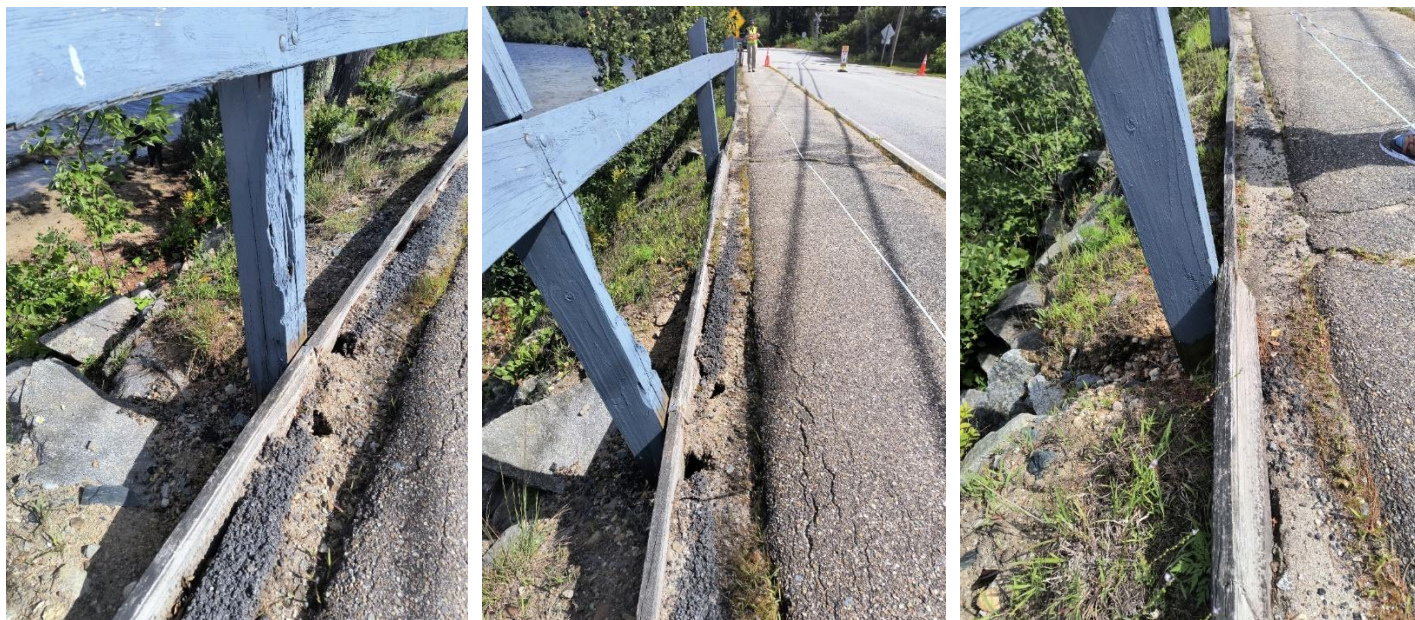
*Eroding edge of sidewalk with sand accumulation and bare soils (left, middle, and right).*

**Recommendations:** Repave the sidewalk and regularly remove sediment from this area.

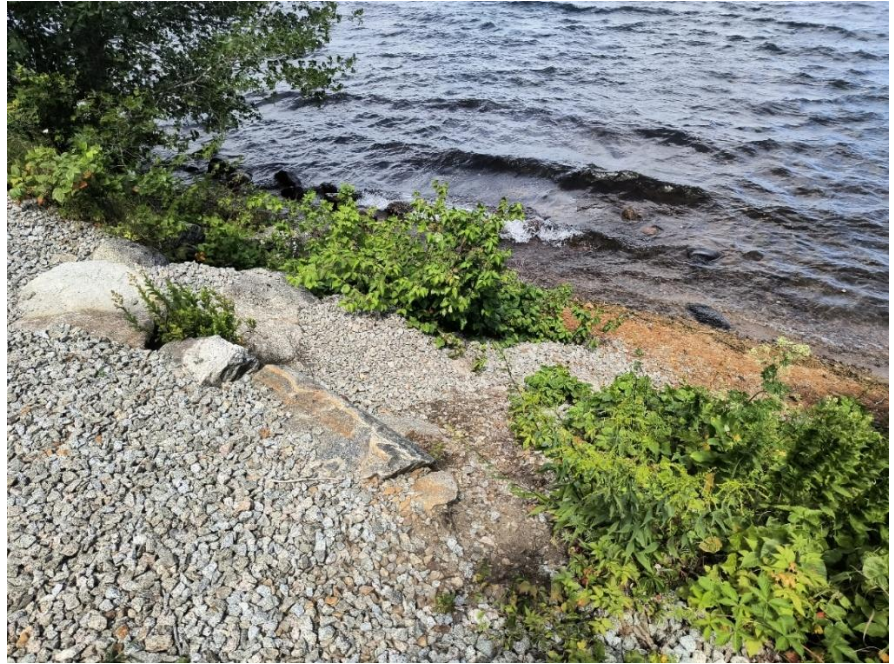
*Breaks in the shoreline buffer are either bare (left) or stabilized by rip rap (right).*

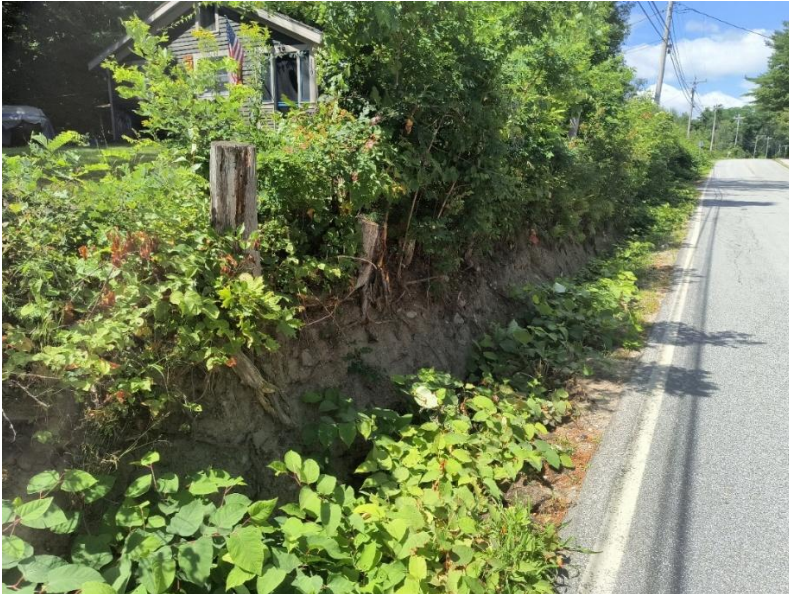
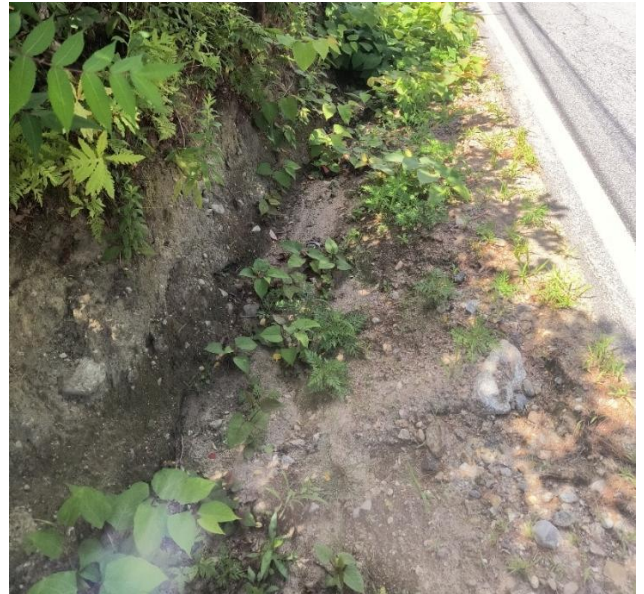
*The road ditches are scraped annually (left) causing erosion in the ditch and the backslope (right).*

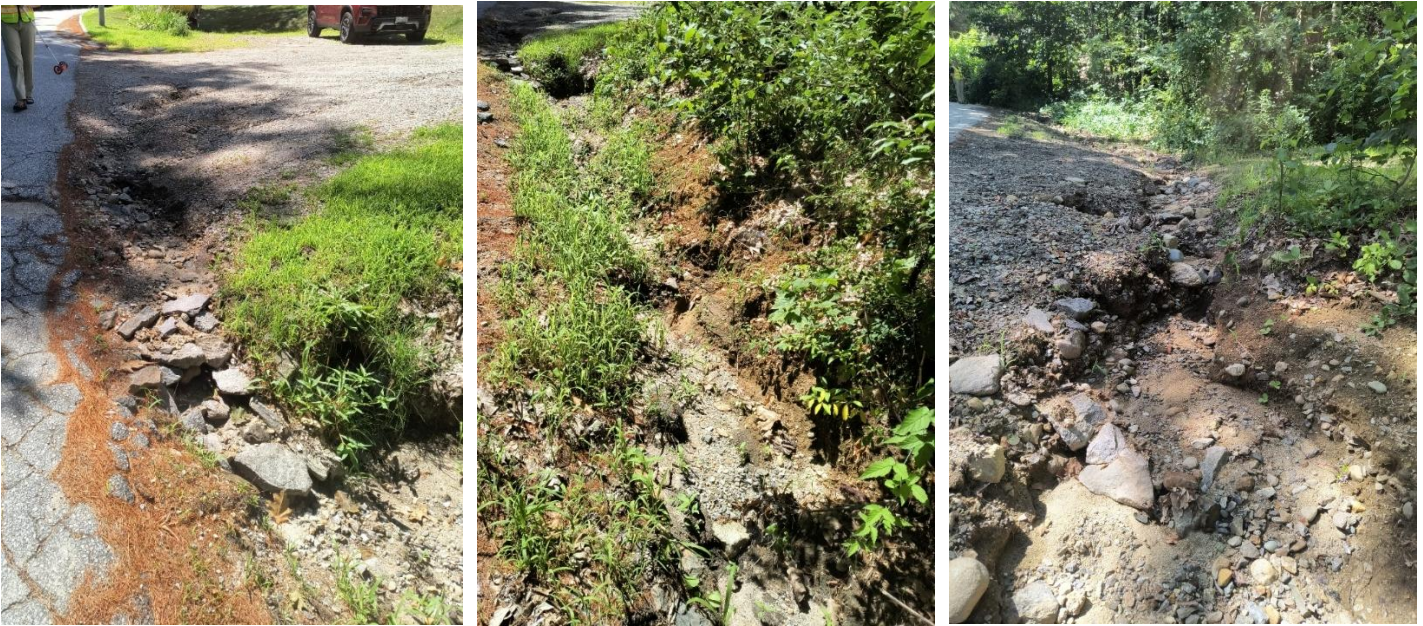
*Gully beginning on the driveway of 2 Pollard Shores Road (left) and continuing down the road (middle and right).*

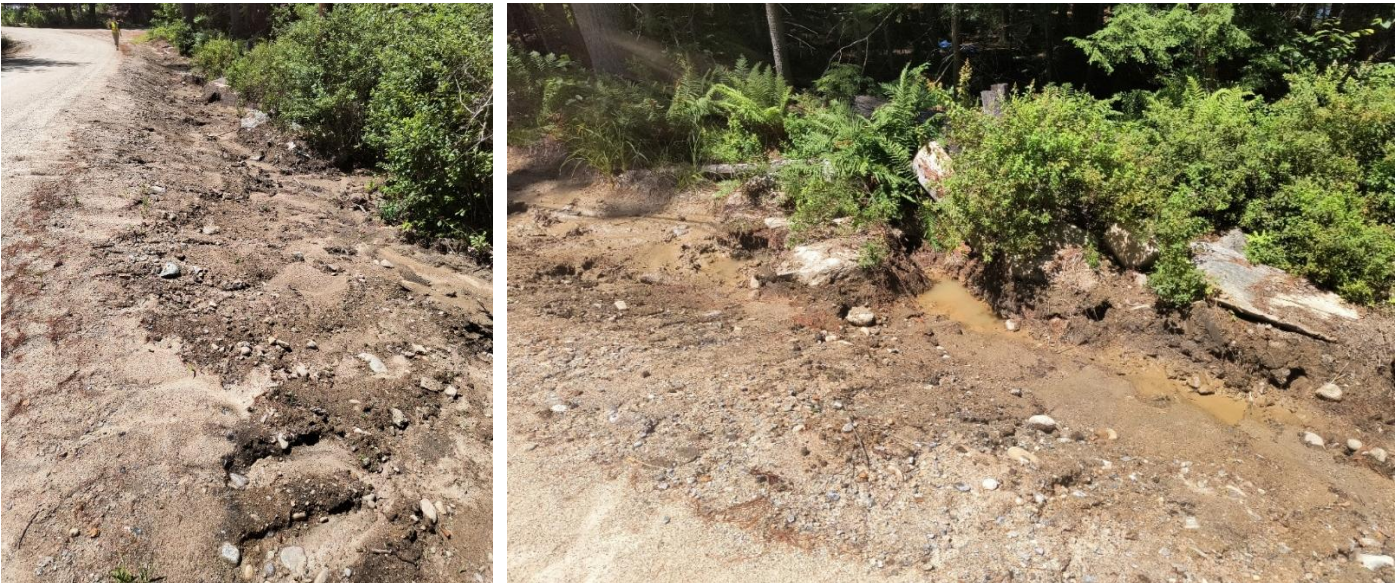
*Scouring on road shoulder (left) leads to a large, disturbed area with sediment built up (right).*

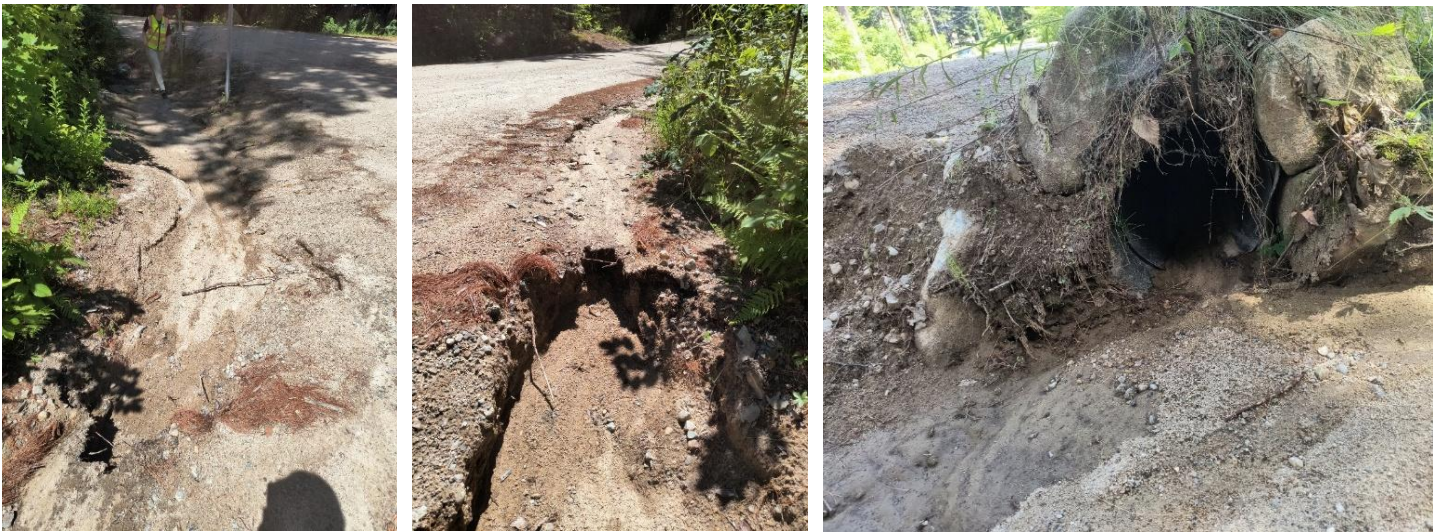
*Gully along ditch (left) leads to heavier erosion (middle) and transports sediment down through a culvert (right).*

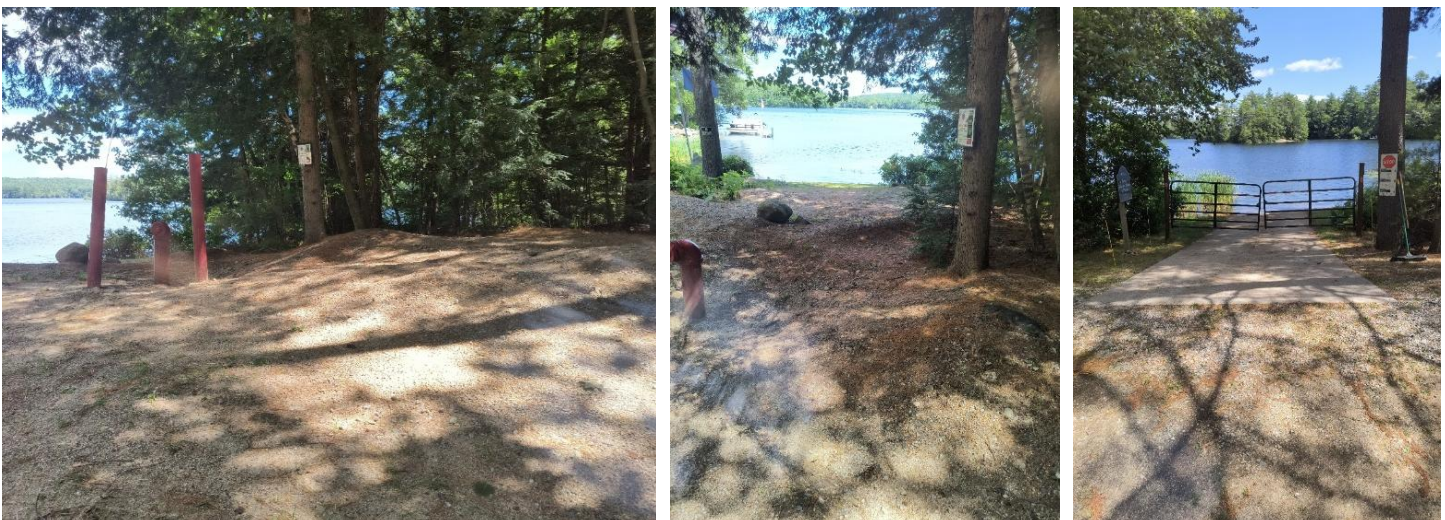
*Sediment piles apparently from plowing at the south end of the water access area (left) with direct transport to the water (middle). The boat ramp at north side of area appears to be stable (right).*

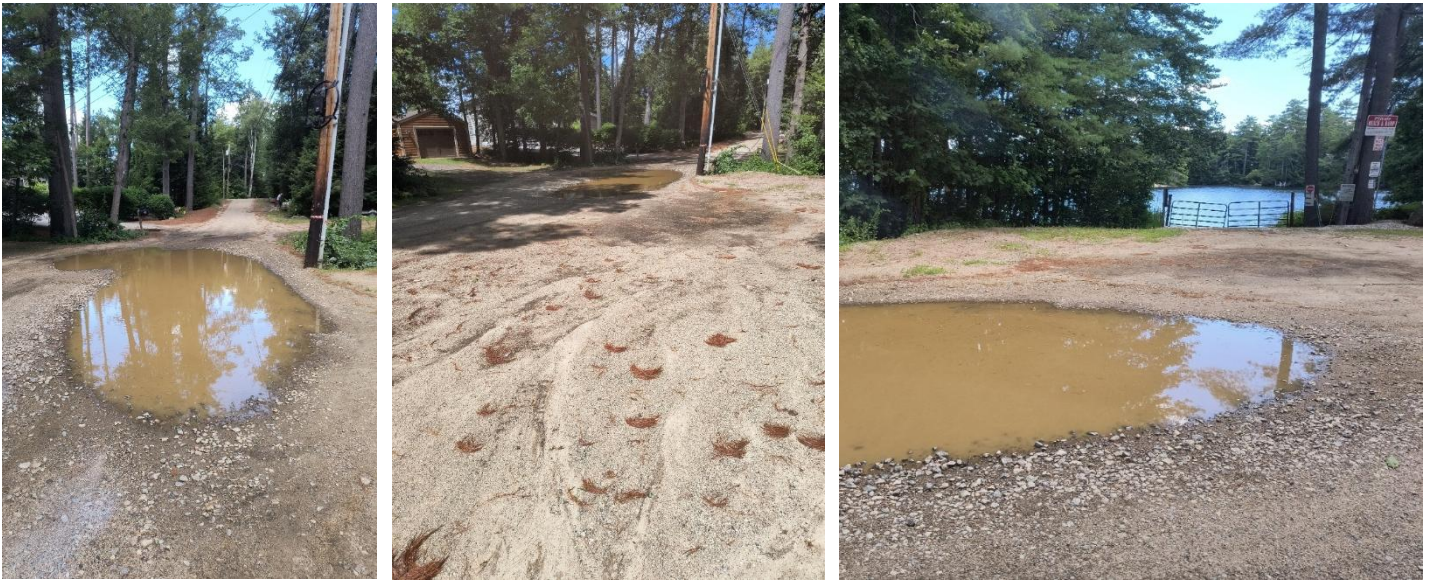
*A large pool in road (left) and rills in the road surface (middle) lead to the boat ramp (right).*

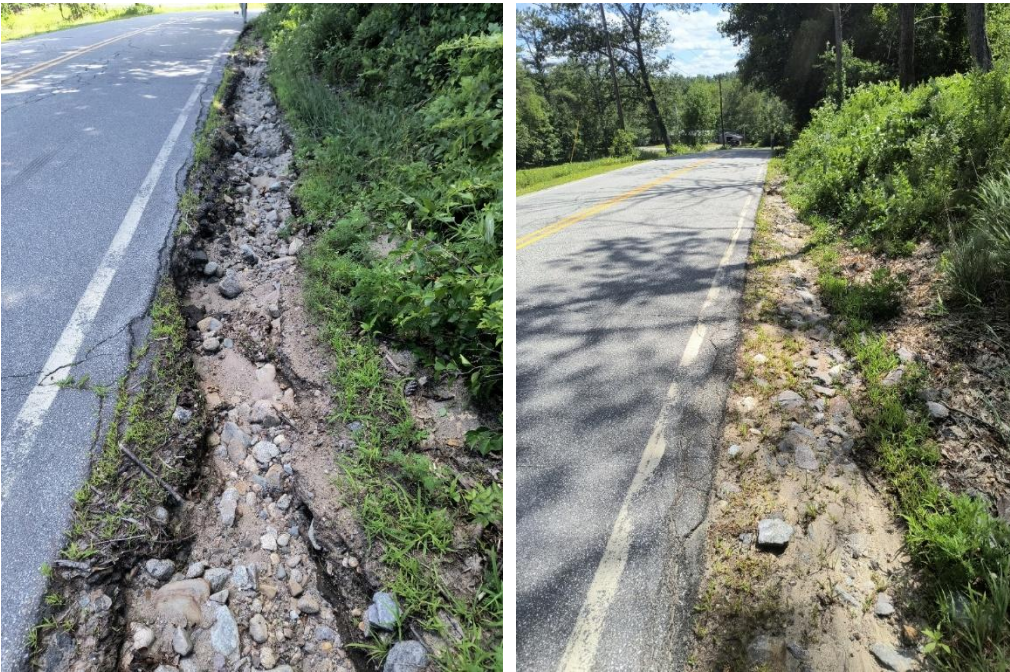
*A gully has formed in the road shoulder (left), which is filled with sediment (right).*

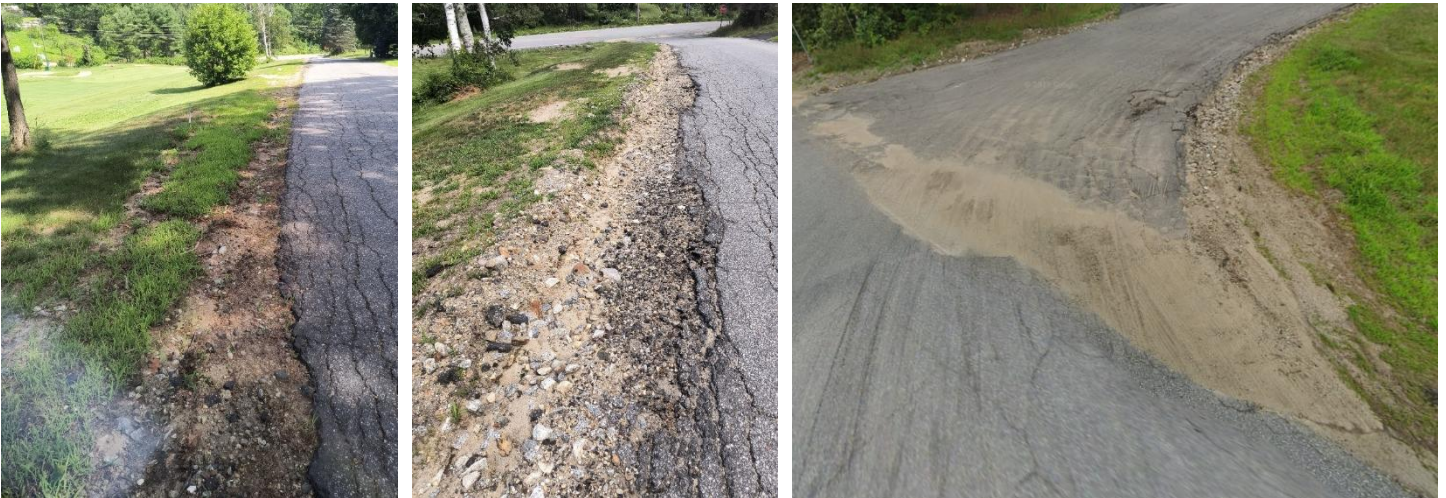
*Roadside erosion (left) that becomes wider further down the road (middle) and deposits sediment at the intersection (right).*

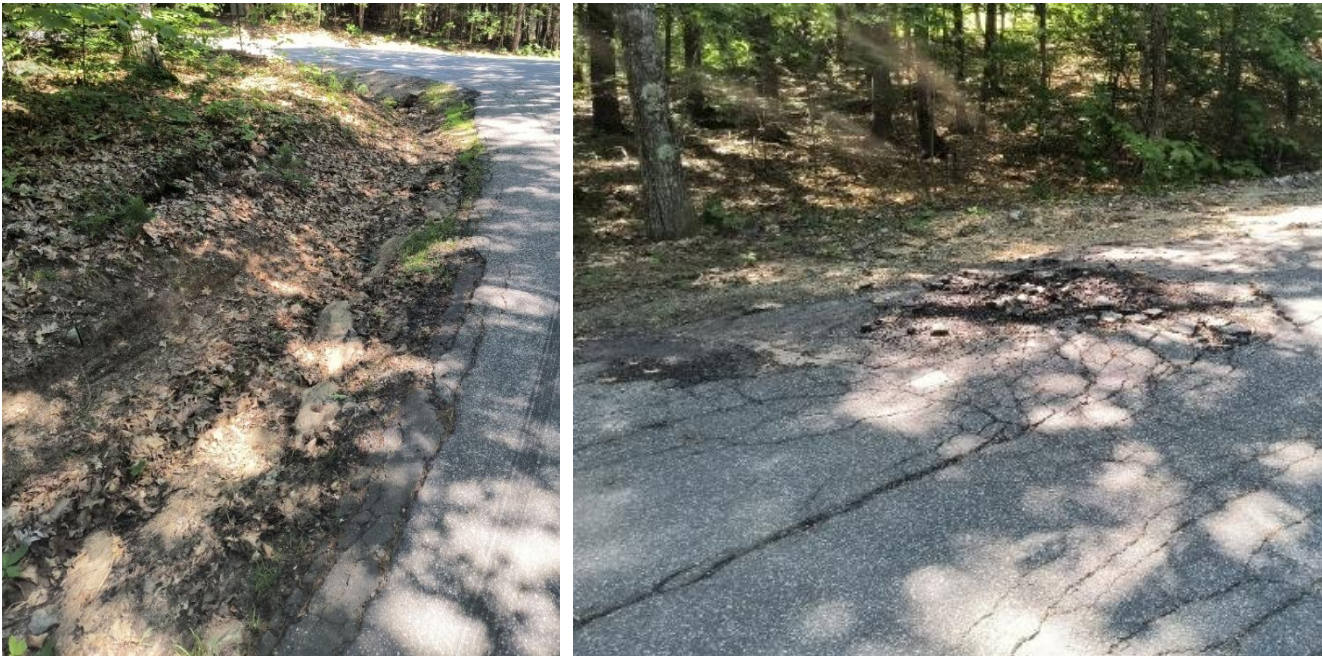
*Erosion in the road ditch of the island (left). Road surface erosion (right).*

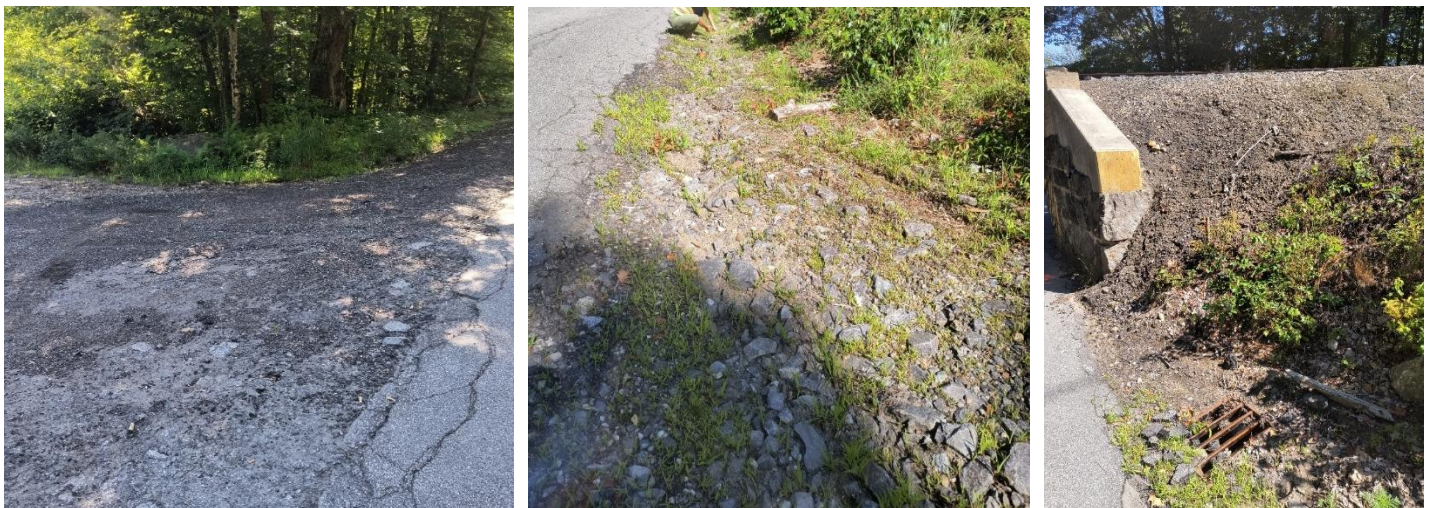
*Loose asphalt parking area (left) uphill of a gully (middle) that leads to a clogged catch basin by the railroad bank (right).*

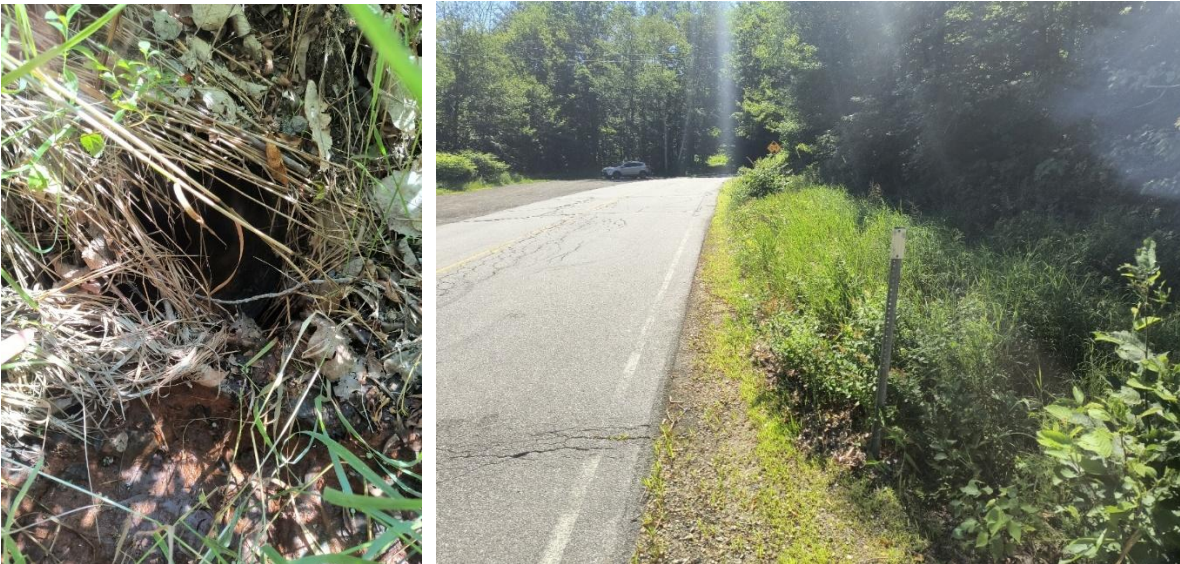
*Partially clogged culvert (left) that drains vegetated swale (right).*

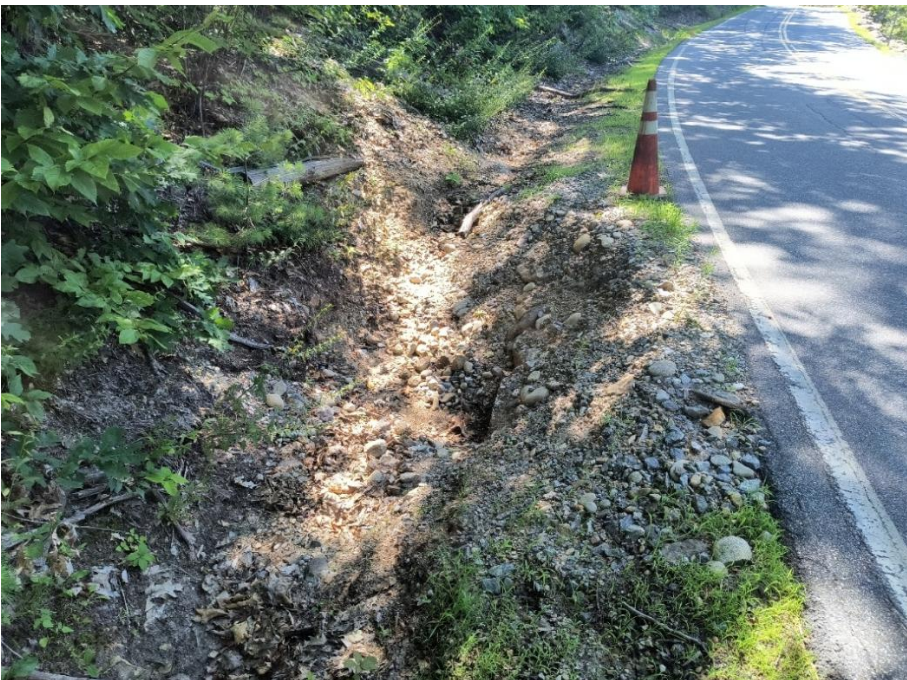
*Eroded culvert inlet and road shoulder (left) transporting sediment and organic material through to the outlet and lake (right).*

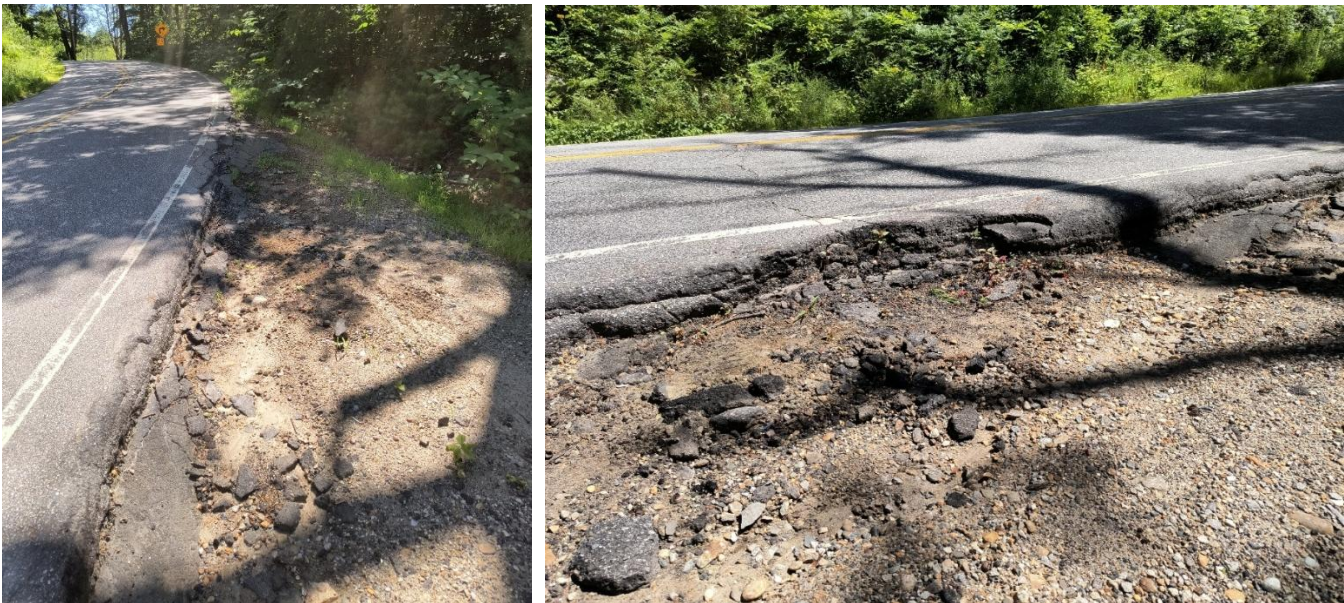
*Eroding road shoulder and parking area (left and right).*

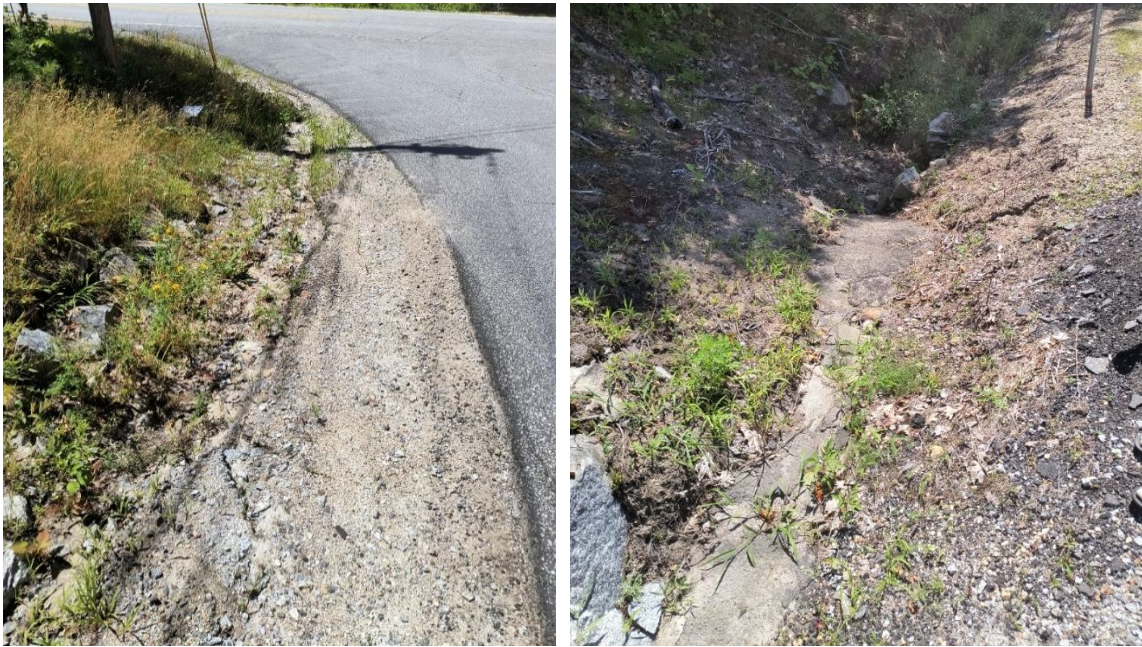
*Eroding road shoulder (left) which leads to a paved swale and culvert (right).*

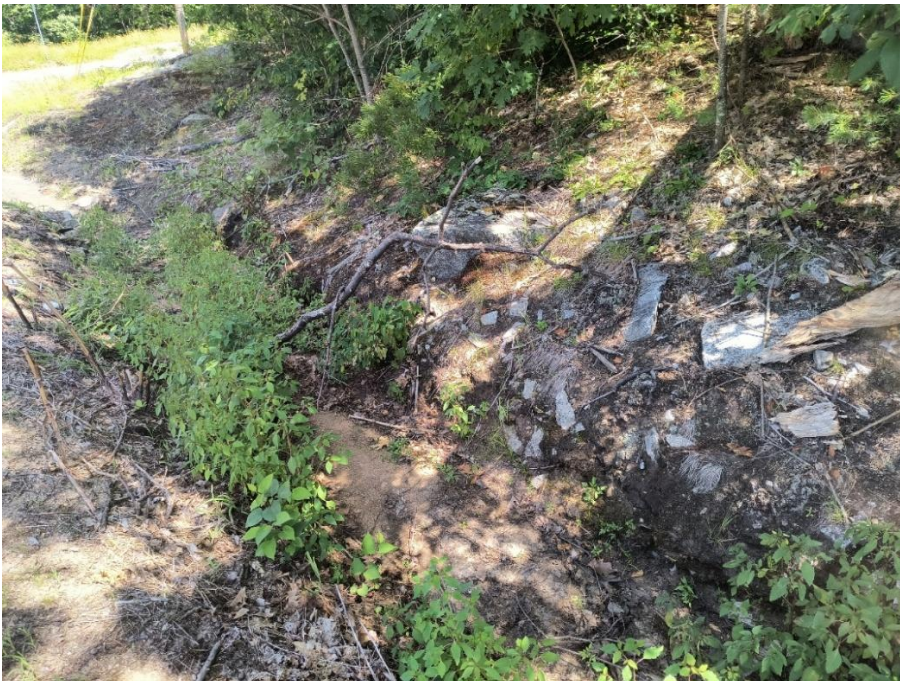
*Erosion of ditch and bank with evidence of sediment transport.*

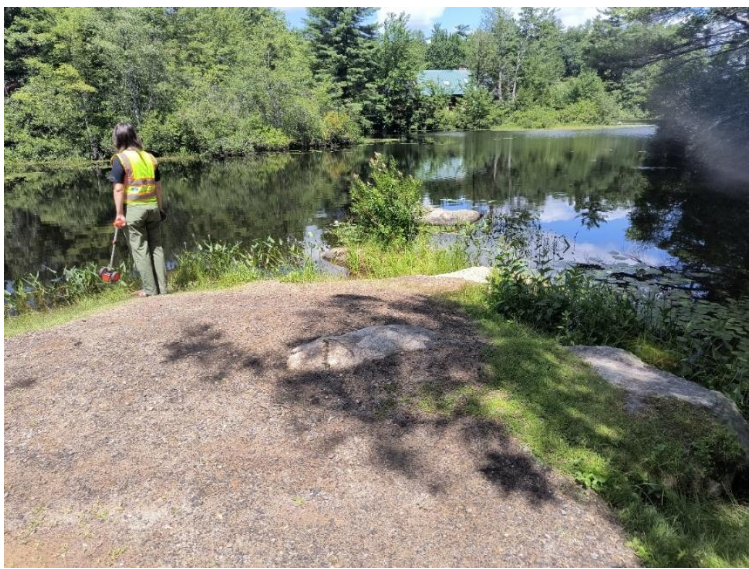
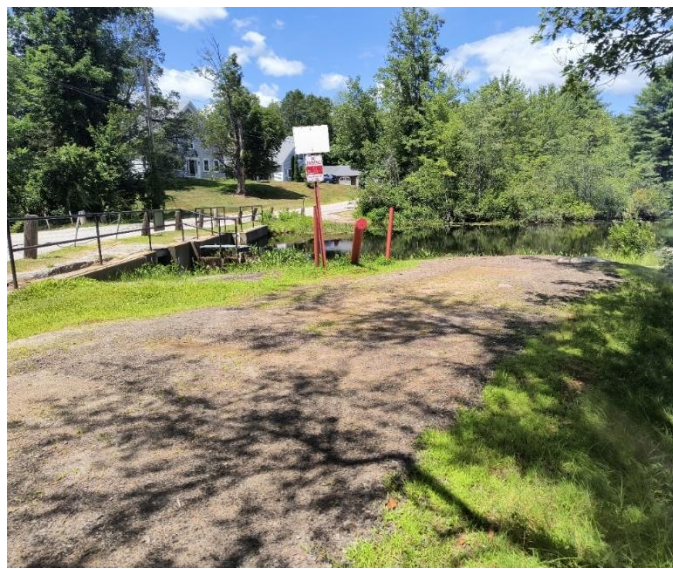
*Parking area with no buffer to pond (left and right).*

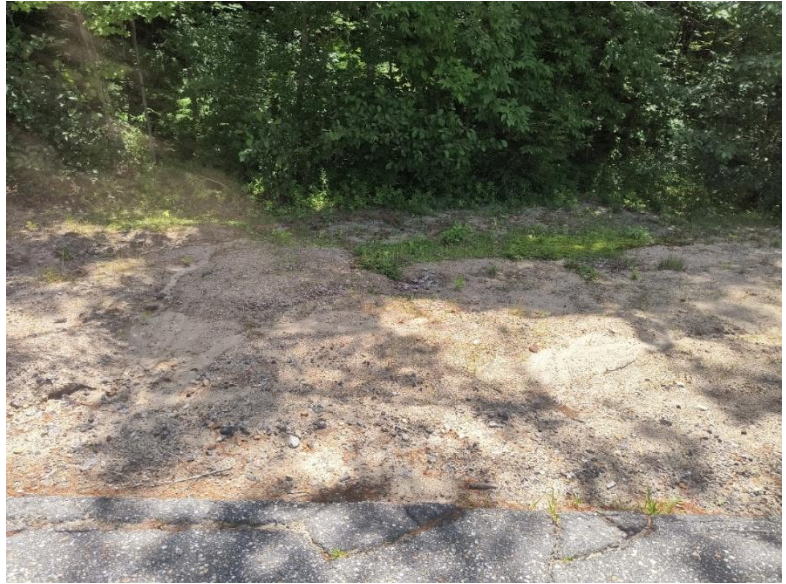
*Road shoulder erosion and sediment deposition on Piper Hill Road (left and right).*

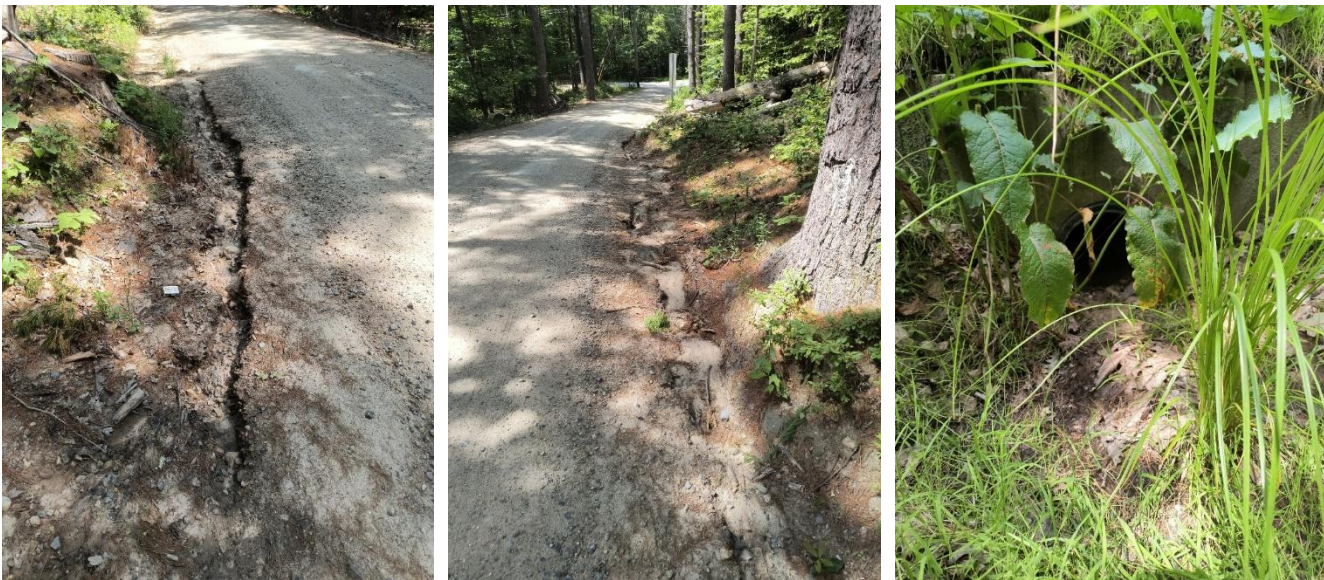
*Gully along roadside (left and middle) that drains to culvert (right).*

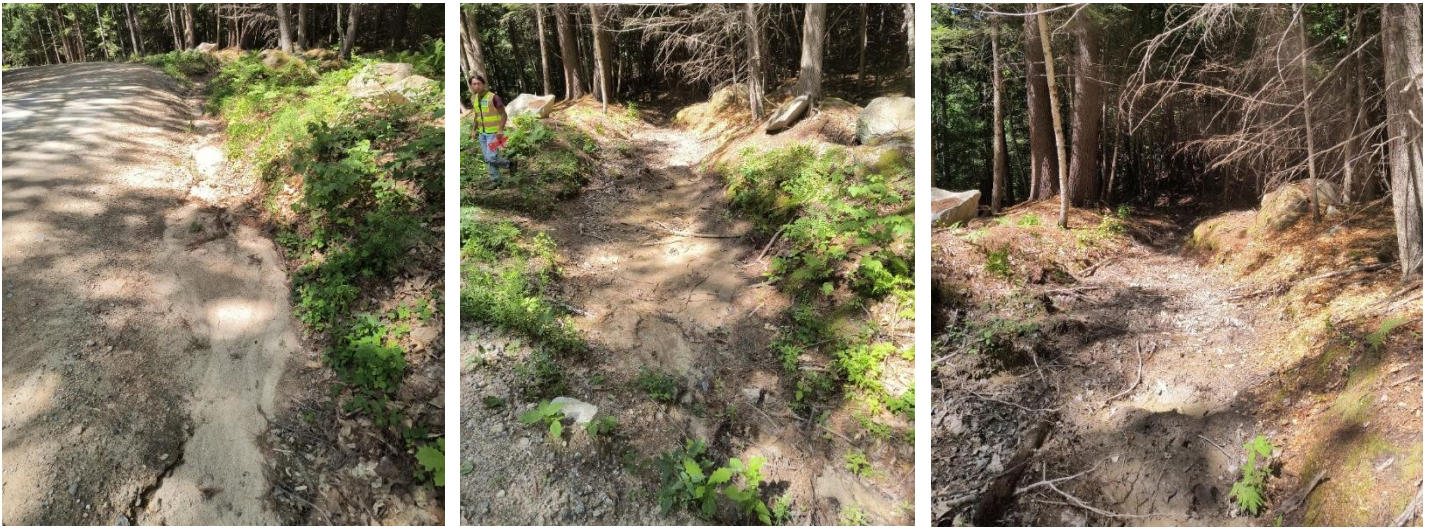
*Gully along roadside with sediment transport (left) that is turned out to a plunge pool (middle) and continues as concentrated flow into the woods (right).*

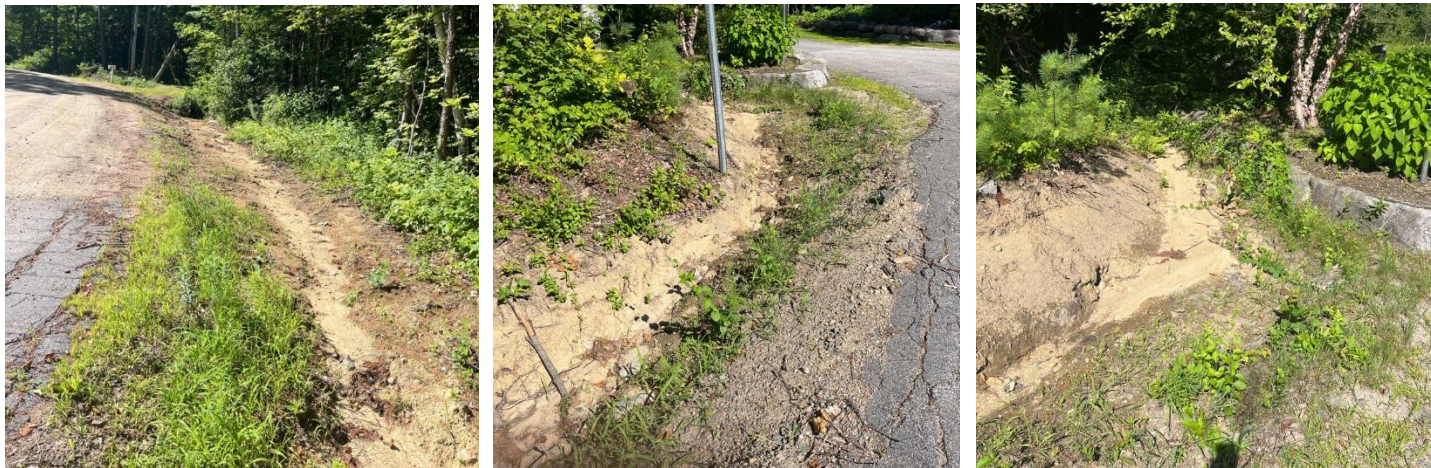
*A gully in the road ditch (left) leads to an intersection (middle) and outlets into the woods (right).*

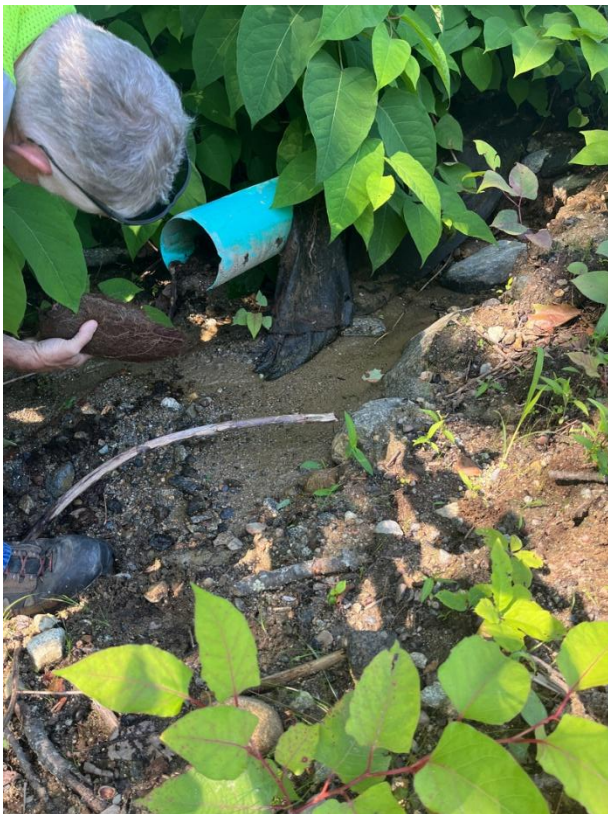
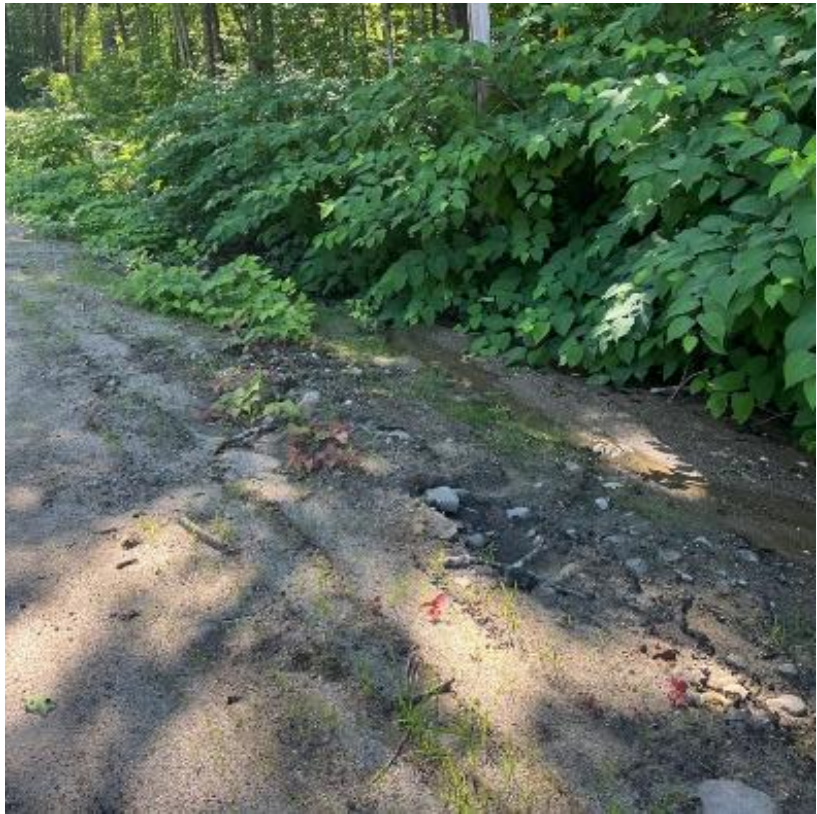
*Pipe draining from unknown source (left). Erosion on road shoulder in ditch (right).*

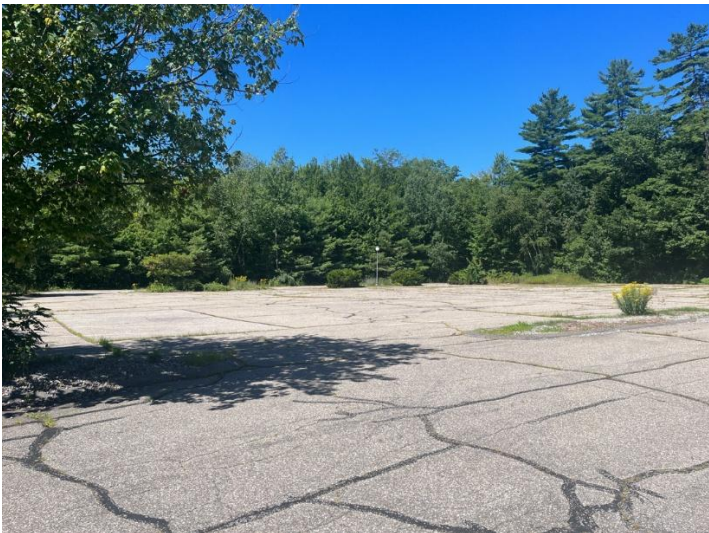
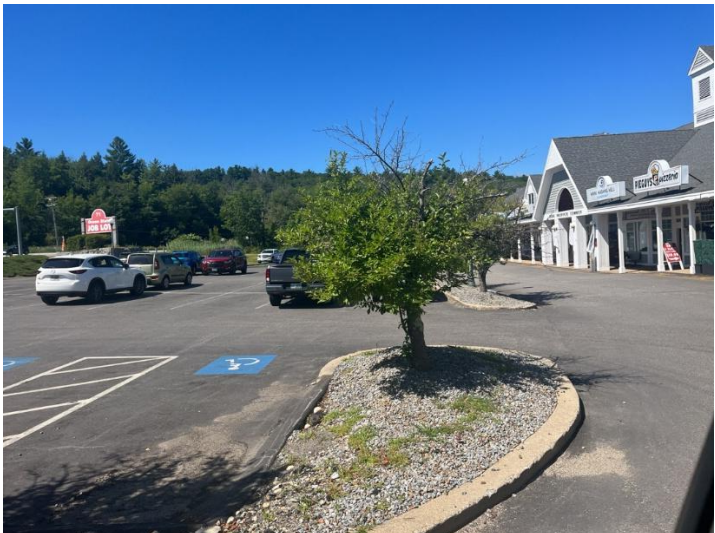
*Large, unused parking lot (left). Used portion of parking lot with lack of green stormwater infrastructure (right).*
