# Lake Waukewan | Watershed Survey Results

**TO:** Angela Labreque, Town of Meredith  
**FROM:** Evan Ma & Maggie Kosalek, FB Environmental Associates (FBE)  
**SUBJECT:** Lake Waukewan Watershed Survey Results  
**DATE:** January 14, 2026  
**CC:** Laura Diemer, FB Environmental Associates

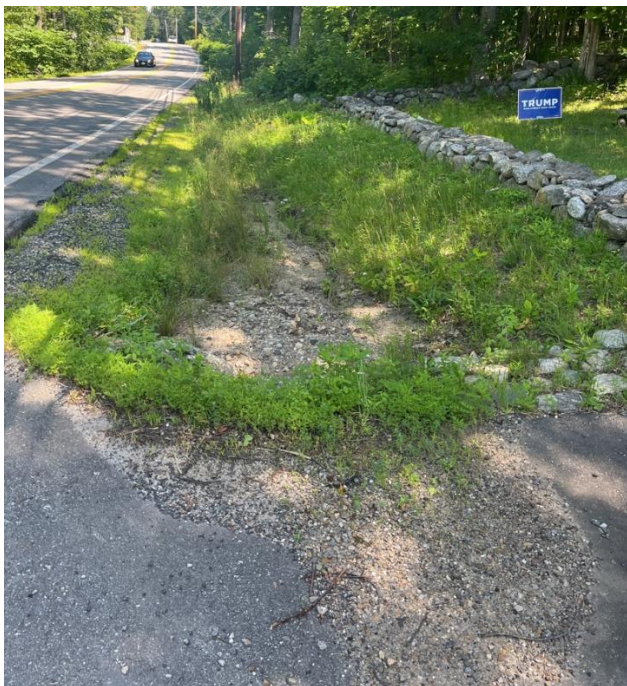
*Sediment deposition in the road ditch and on a driveway (left) clogs the culvert under the driveway, along with trash (right).*

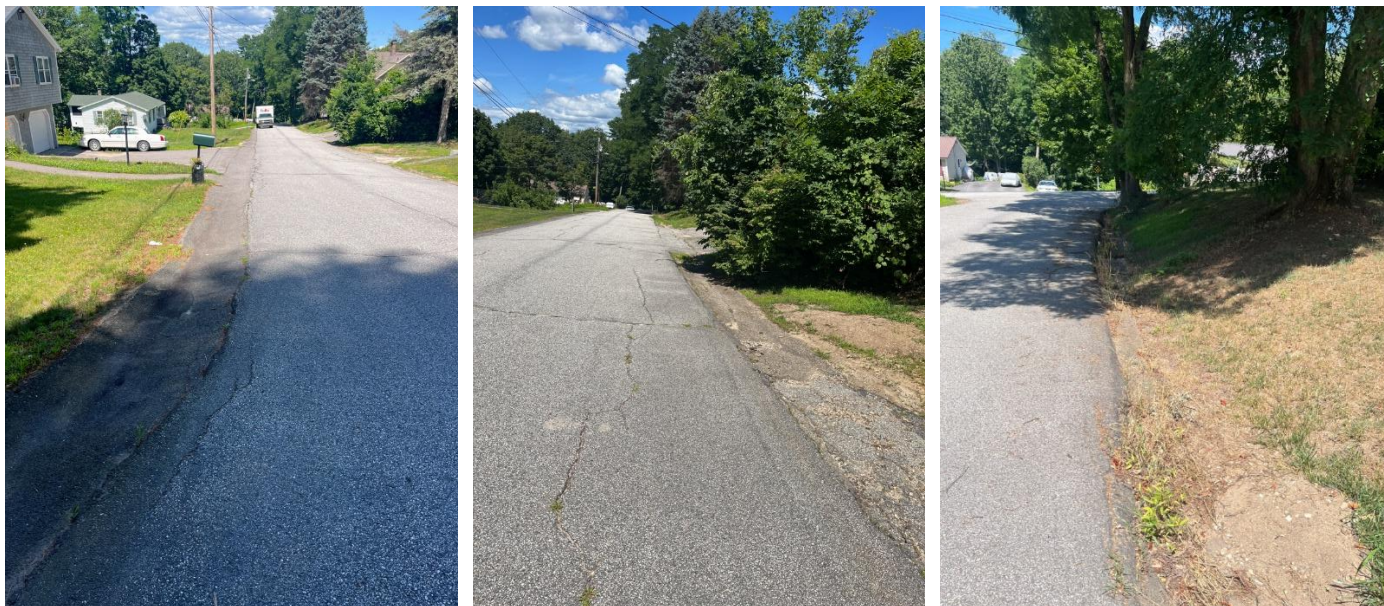
*Paved swales lining the road (left and middle) and sediment has accumulated on the road shoulder (right).*

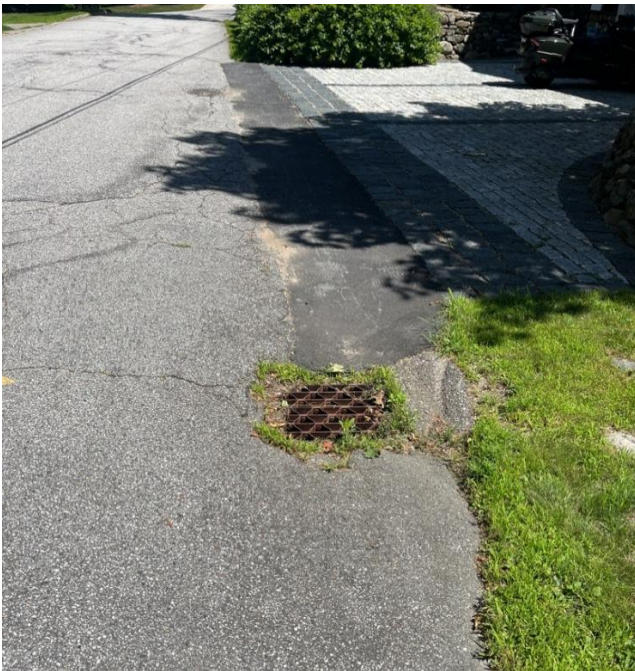
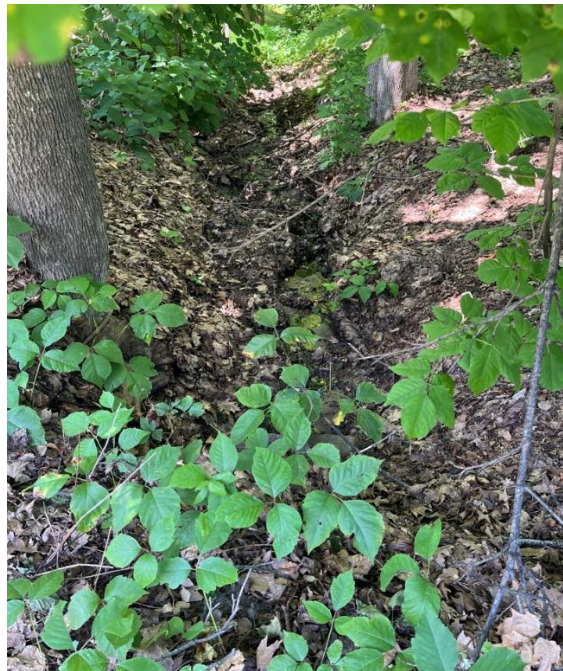
*Catch basin in the middle of pavement (left) and the stream to which it discharges (right).*

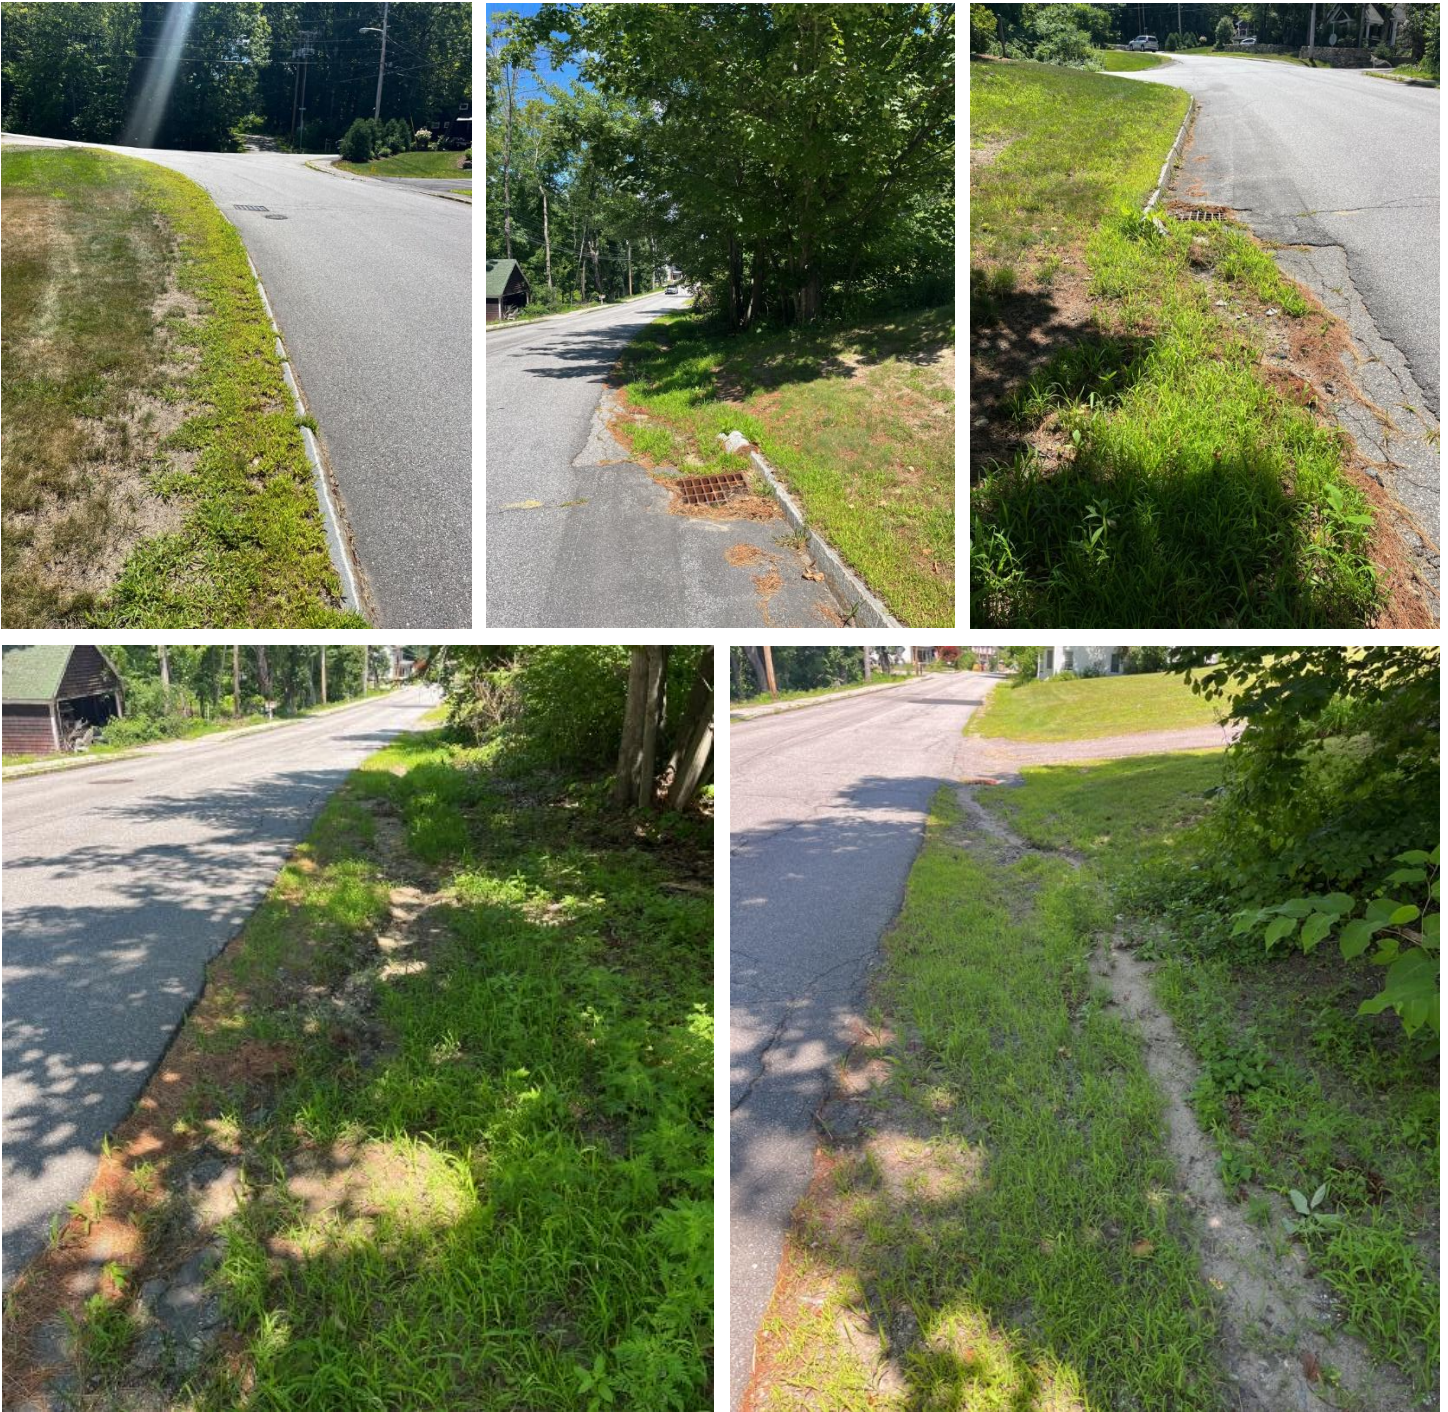
*Catch basins on the street (top left, middle, and right) and erosion gullies on road shoulder (bottom left and right).*
