# Lake Waukewan | Watershed Survey Results

**TO:** Angela Labreque, Town of Meredith  
**FROM:** Evan Ma & Maggie Kosalek, FB Environmental Associates (FBE)  
**SUBJECT:** Lake Waukewan Watershed Survey Results  
**DATE:** January 14, 2026  
**CC:** Laura Diemer, FB Environmental Associates

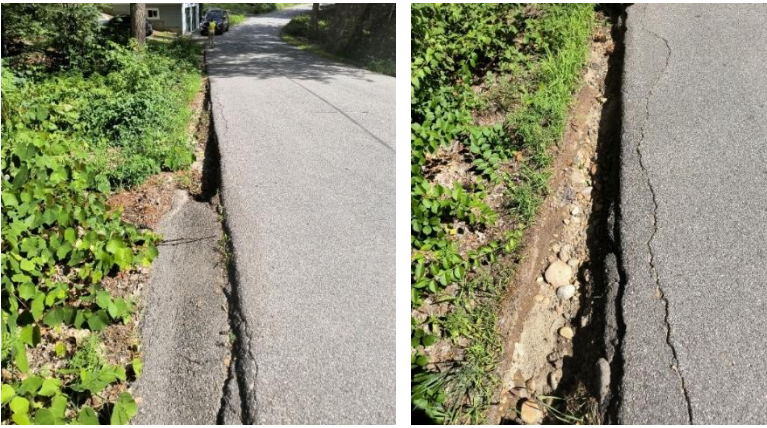
### Site 1-02A and 1-02B: Water Street Stream Crossing (Meredith)

**Observations:** A paved swale on the east side of Water Street carries untreated stormwater down the roadside before forming a deep gully. Paved swales do not allow for any stormwater infiltration, producing large volumes of high temperature, high velocity stormwater that can worsen erosion downhill. This site is located near the stream crossing on Water Street when entering the road from the north.

*Paved swale on road shoulder (left) that creates a gully downstream (right).*

**Recommendations:** Stabilize the gully with rip rap and vegetation on the upstream side of the road. Remove the asphalt from the swale if possible and replace it with a vegetated or rip rap-lined ditch.

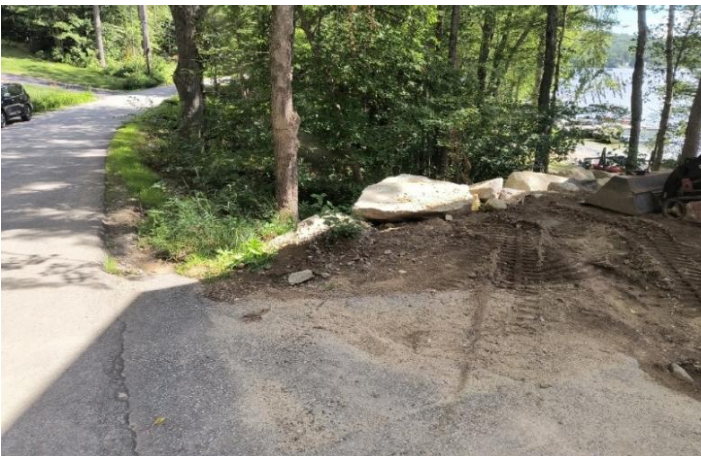
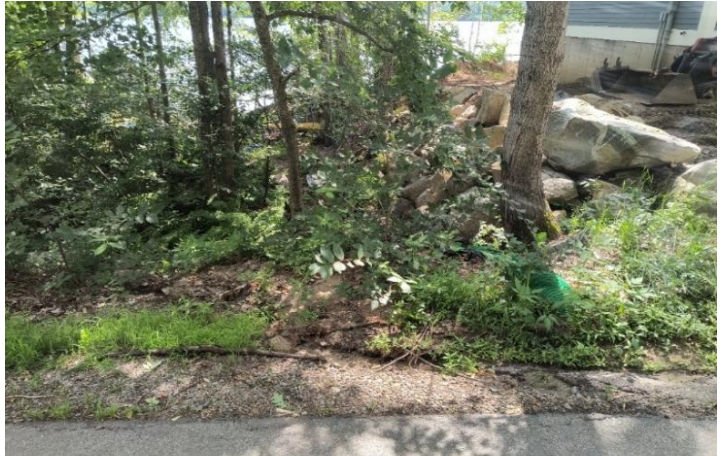
### Site 1-02C: Unknown Stream (Meredith)

**Observations:** There is some recent land clearing at the site next to stream crossing that has exposed bare, loose soil. A small silt sock is in place to prevent sediment transport to the stream. Few gullies were observed on site, which is evidence of sediment transport to the stream. The 2014 watershed survey found a plethora of issues at the site including undercut banks and lack of shoreline buffer near the stream.

*New construction (left) with stream on other side of rock wall and small silt sock. Some visible gully on side of road (right).*

**Recommendations:** Extend the sediment silt sock to the road. Revegetate the shoreline and road shoulder and implement rip rap where needed to stabilize the road shoulder.

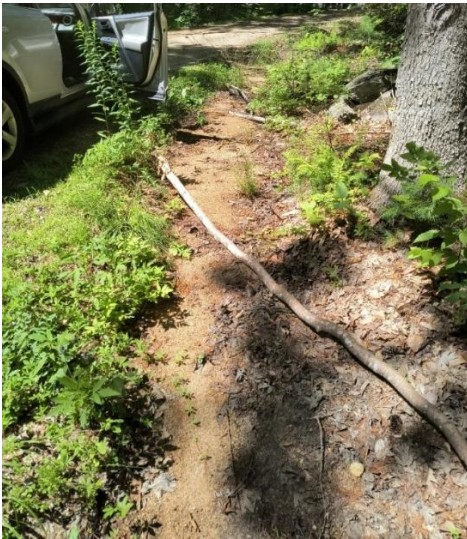
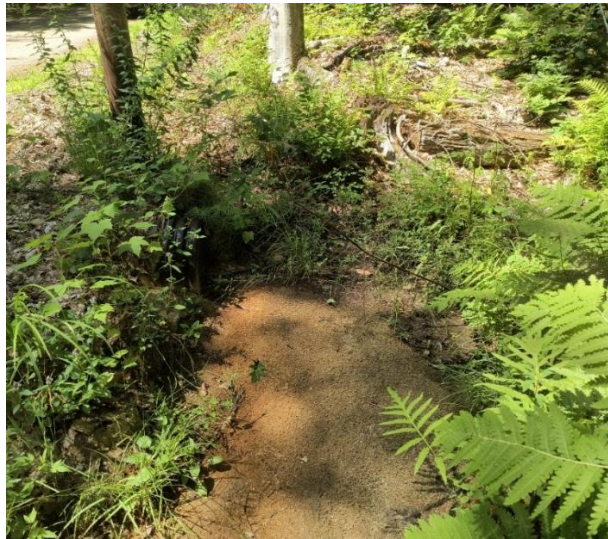
**Observations:** The road ditch on Red Gate Lane is full of sand, though evidence of erosion is sparse. The sediment built up around the culvert inlet washes into a wetland rather than Lake Waukegan, which likely provides some pollutant and storm flow attenuation; sedimentation can degrade the functions/values of wetlands despite this benefit to the lake. There appears to be a plunge pool (whether or not intentionally constructed) at the site that has filled with sand. Severe erosion was found at the site during the 2014 watershed survey; the same levels of erosion were not observed here.

*Ditch filled with sediment (left) that leads to a pool of water filled with sediment (right).*

**Recommendations:** Regularly remove sediment to maintain culvert and add an intentional plunge pool.

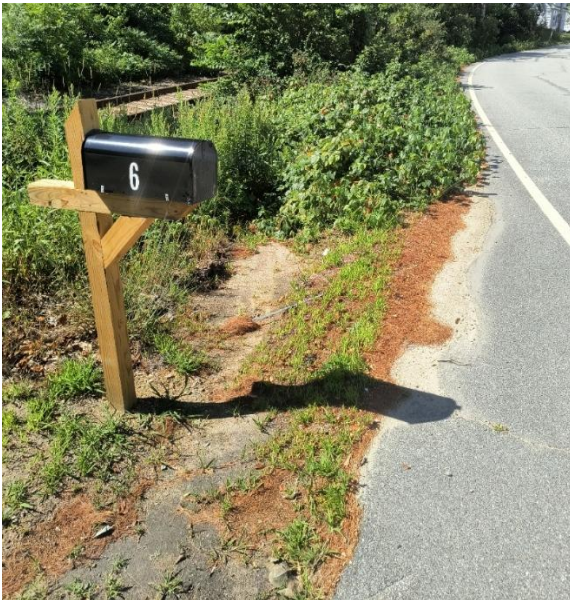
**Observations:** There currently appears to be less road shoulder erosion and more vegetation at the site compared to the 2014 watershed survey (though the vegetated buffer is mostly poison ivy). There is still some sediment build-up and transport along the railroad crossing, which is evidence of stormwater pooling at this area.

*Slight sediment transport to ditch (left) and sediment build-up on road surface (right).*

**Recommendations:** Include this site in regular street sweeping.

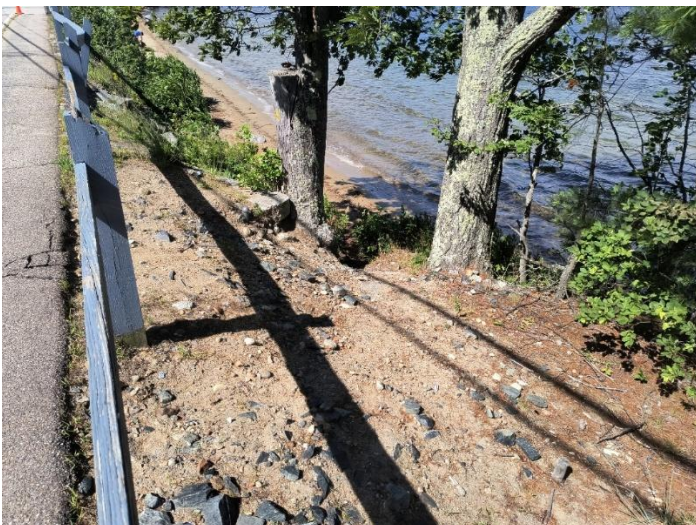
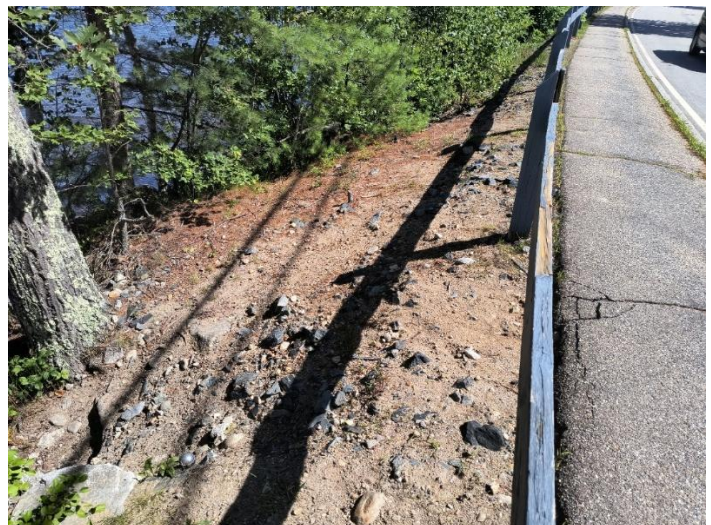
## Site 1-07: Beach South End

**Observations:** The erosion noted in the 2014 survey is still present. It appears that this area is used to access the lake, preventing vegetation from re-establishing and leads to continued erosion when combined with foot traffic.

*Bare soil area on side of road (left and right) with foot path down to water (left).*

**Recommendations:** Recommendations for the site are similar to those from 2014. Install a runoff diverter, establish a shoreline buffer, and discourage people from using the steep slope as an access point. If access cannot be re-directed to a better location, consider establishing a proper access point by building infiltration steps and stabilizing soils as needed, some of which may require permitting given the shoreline location.

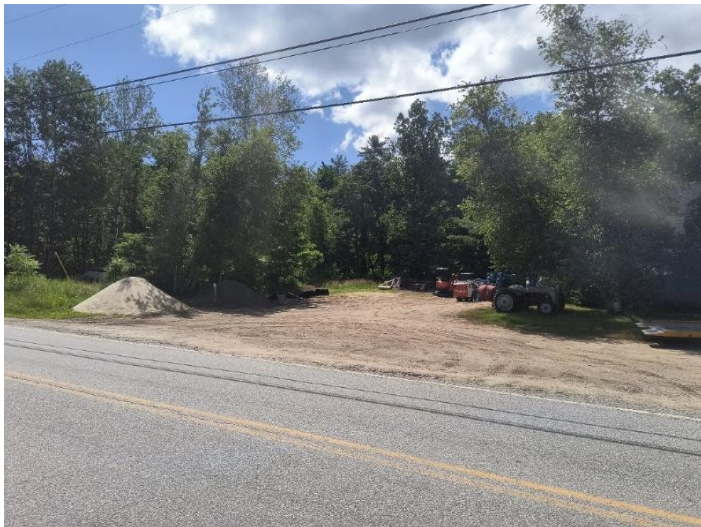
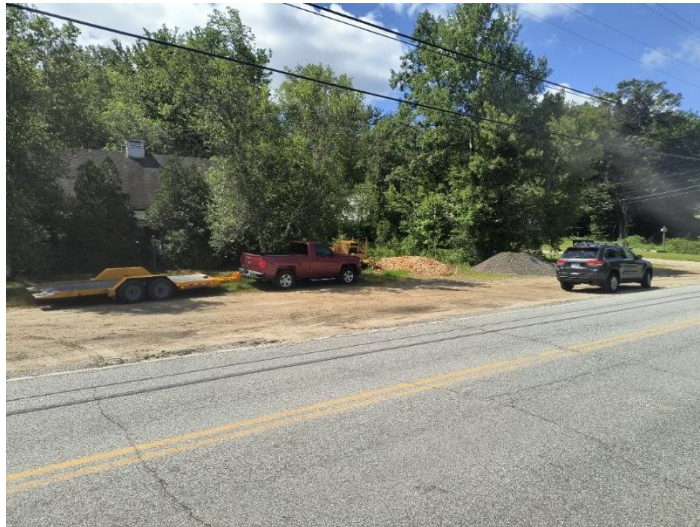
**Observations:** This site is still a bare lot with piles of wood chips, fine sand, and gravel. Sediment appears to have migrated from the lot into the road.

*Bare soil lot with piles of sediment (left and right).*

**Recommendations:** Ensure sediment piles are properly managed and retained. Regularly remove sand at this site.

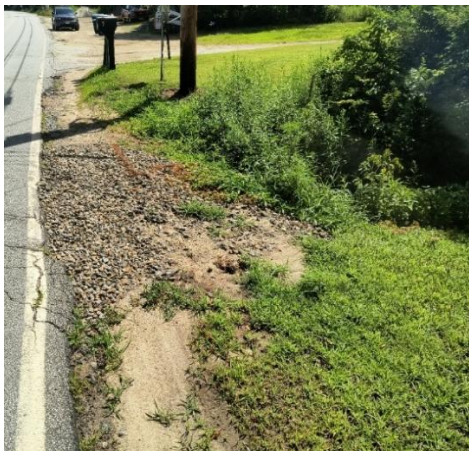
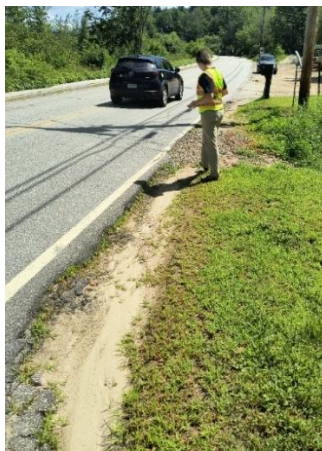
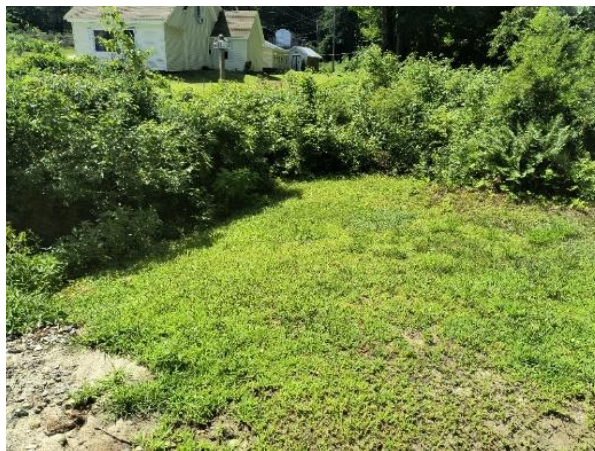
### Site 1-10B: House next to Carder Lane on Waukegan Street (Meredith)

**Observations:** The stream bank appears to be more vegetated now than in 2014; however, erosion and sediment transport to the culvert inlet on the road shoulder are still present. Erosion and deposited sediment were observed along the driveway of house #96 and up to the next driveway.

*Road shoulder erosion and sediment transport straight to culvert (left and middle). Area where a rain garden could be planted to divert stormwater to (right).*

**Recommendations:** Repave surrounding driveways. Revegetate / stabilize the road shoulders. Plant native vegetation / a rain garden in the grassy area next to the stream to capture and infiltrate stormwater.

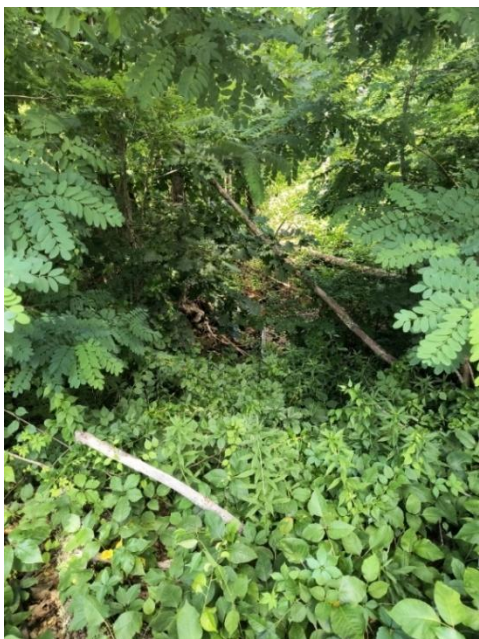
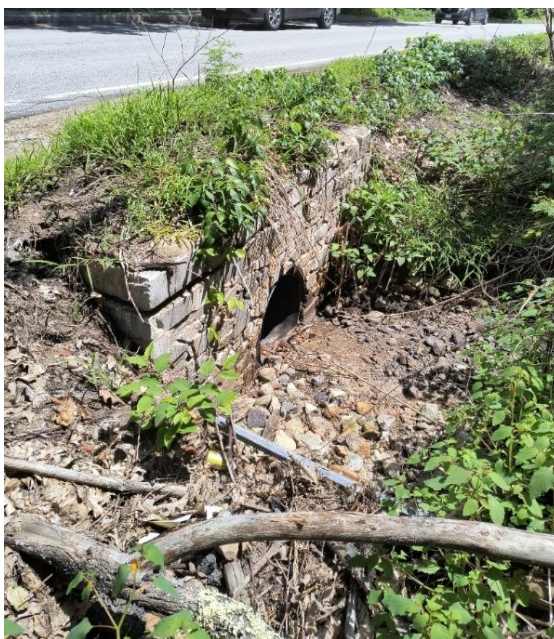
## Site 1-11: Waukegan Street Stream Crossing (Meredith)

**Observations:** The culvert outlet is adequately vegetated, although mostly with poison ivy, making it inaccessible for closer inspection during the survey. There is moderate erosion at the culvert inlet; sediment was observed to be building up in the culvert. Trees in the upstream riparian buffer appear to have been cut down.

*Adequate vegetation (although poison ivy) at downstream side of culvert (left). Moderate erosion and sediment build-up at upstream side of culvert (right).*

**Recommendations:** Stabilize the road shoulder and inlet with rip rap and revegetate bare areas. The culvert inlet appears to be in good condition but should be checked more closely to confirm. Consider focused outreach to inform and discourage cutting vegetation in riparian corridors.

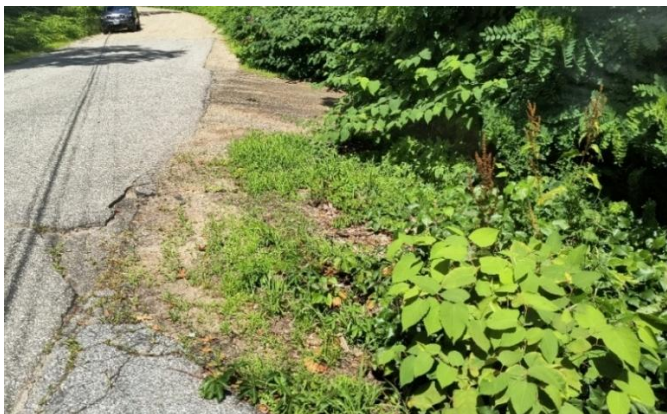
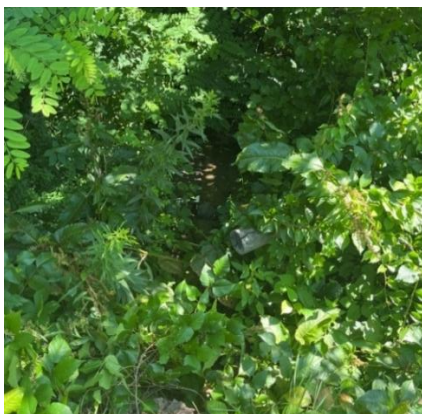
## Site 1-12: Wall Street and Waukegan Street Intersection (Meredith)

**Observations:** In the 2014 watershed survey, road shoulder erosion was observed at the site, and the stream bed was composed of sand that had washed in from the road. In 2025, there is still some sediment in the stream and some erosion on the road shoulder. Poison ivy and knotweed obscure the view of the culvert.

*Erosion on road shoulder (left) and sediment visible in stream (right).*

**Recommendations:** Revegetate the small section that is bare. This is not a priority site as it is well-vegetated.

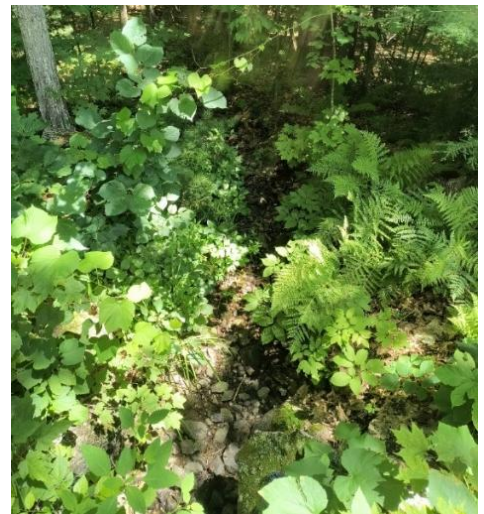
## Site 1-14 and 1-15: Wall Street #1 (Meredith)

**Observations:** A Wall Street resident provided an anecdote about how increased development on the upstream side of the road (between Wall Street and Winona Road) has caused a large increase in runoff volume over the past years. Before, the runoff would infiltrate on the upstream side of the road, causing the area between Wall Street and the lake to be a marsh. With the increased impervious surface, culverts have been added under the road, thus channelizing stormwater flow instead of dispersing runoff and allowing it to infiltrate. The resident also noted sediment entering the lake from the watershed near their home has caused a beach to form on their property. They also noted biological changes to the lake, such as the absence of freshwater mussels that were previously found in the lake. Site observations appeared consistent with this description.

*New construction on the upstream side of road (left). A culvert under the road to drain water from the upstream side (right; there are several of these along the road).*

**Recommendations:** Add level spreaders at the culvert outlets to disperse flow throughout the forest. Add check dams near the banks of the stream as needed to slow and disperse flow. Investigate options on the uphill side of Wall Street to slow and infiltrate runoff before it reaches Wall Street. Stabilize bare soil areas with vegetation.

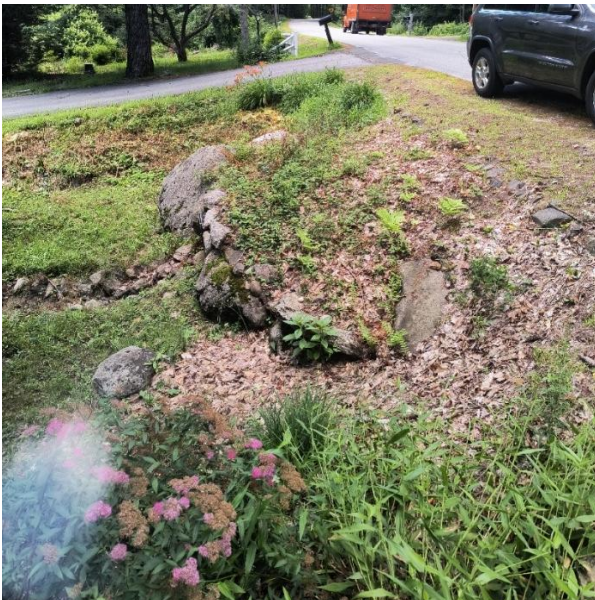
**Observations:** An intermittent stream cuts through a residential yard, entering through a cross-road culvert. There appears to be less erosion at the site than mentioned in the 2014 survey, though there is still a lack of a buffer.

*Culvert inlet with minimal vegetation.*

**Recommendations:** Increase the amount of vegetation on the road shoulder and engage with the homeowner to add more vegetation around the culvert and stream bank.

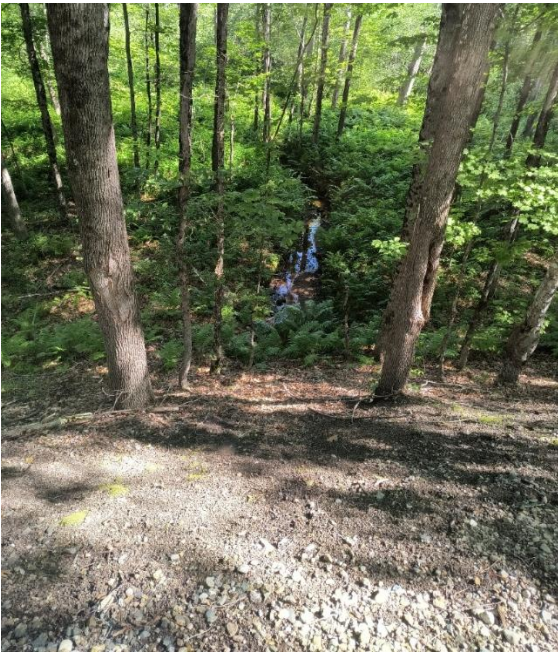
**Observations:** In the original 2014 watershed survey, there was excessive sediment observed moving through the stream channel. In 2025, there were no obvious signs of erosion down to the stream crossing under the railroad. The stream is somewhat incised and has a sandy substrate, but it does not appear to be related to erosion. The slope from the railroad down to the stream is bare, sandy, and very steep.

*Sloped side of raised railroad leading down to a stream which travels under the railroad by a culvert (left and right).*

**Recommendations:** Check the outlet point of this tributary to the lake to see if there are patterns of sediment deposition. If the forest hillslope is eroding, a larger stabilization project may be needed. The site impact is currently considered moderate due to proximity to a lake tributary. If patterns of sediment deposition are not observed at the tributary mouth over repeated visits, the site could be changed to low impact.

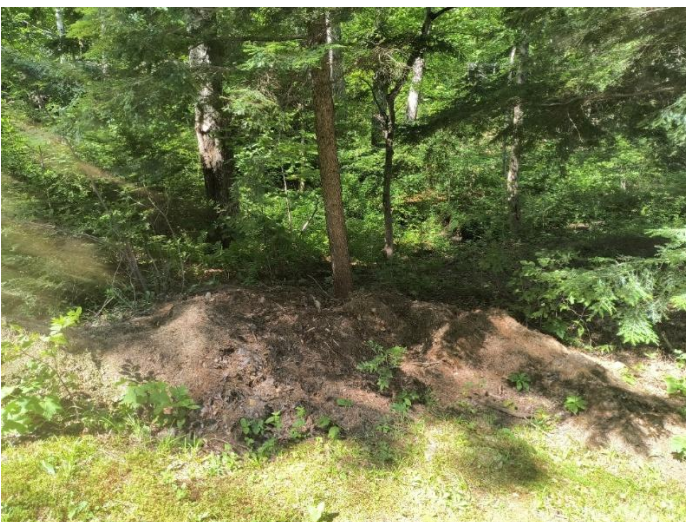
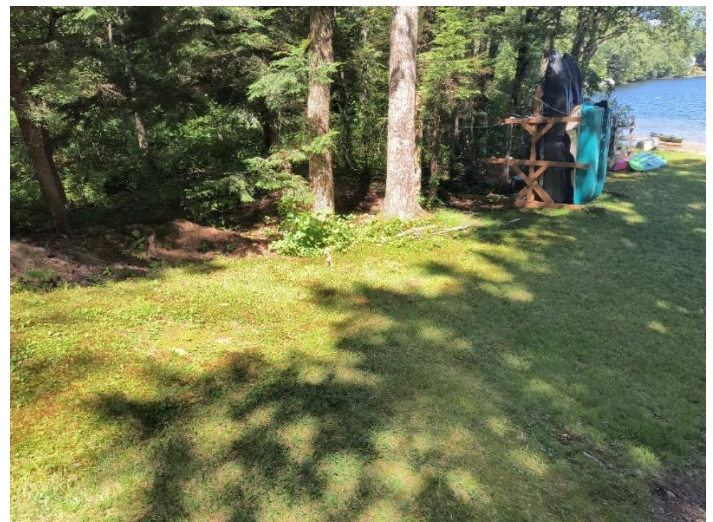
## Site 2-11: Bay View Beach (New Hampton)

**Observations:** The site appears to have changed since the original 2014 survey. Photos from the 2014 survey show that a stream cut through the property, leading down to the beach. In 2025, the stream channel did not appear to be in the same place and instead cuts through the forest. The area presumed to be the former stream channel is now a residential lawn. It is uncertain to what extent the site has changed over the past ten years. There are small piles of debris (soil) near the new stream channel. This site is private property within the Lake Winona watershed.

*Yard waste piles (left) alongside of mowed lawn that leads down to beach (right).*

**Recommendations:** Engage homeowners to remove sediment piles from the site. Encourage homeowners to implement property-level stormwater management in the town of New Hampton. Engage with homeowners to determine whether the site has changed in the past ten years, especially regarding the stream channel.

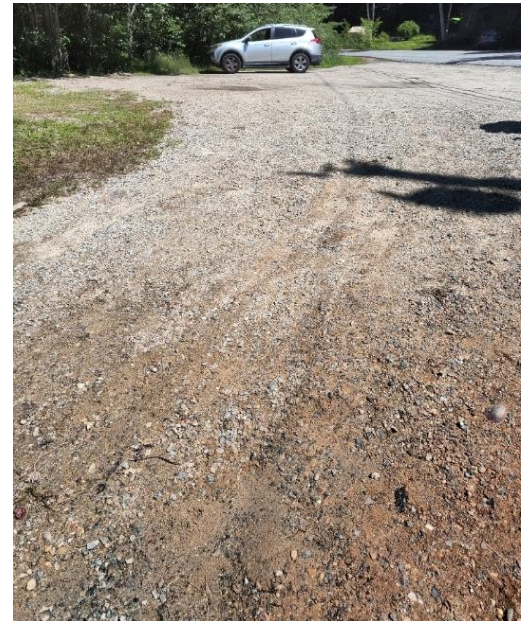
## Site 2-12A and 2-12B: Winona Lake Outlet Canoe Launch (Center Harbor)

**Observations:** There were few changes at the site since 2014, in which sediment was observed to wash into the lake via the boat ramp with some small gullies directly down the ramp. The parking lot appears to be a loose material that could be easily mobilized. The culvert under the road was noted as an issue in the 2014 survey, but that issue appears to be resolved.

*Boat launch (left) with slight gullying from parking lot (right).*

**Recommendations:** Regrade the parking lot to divert water to small wetland at foot of parking area instead of boat ramp. If the size of the parking lot can be reduced at all, increase the width of the vegetated area by the wetland. If the launch area is only for small boats and kayaks, reduce the boat launch footprint and consider vegetating it or using interlocking pavers. Add more vegetation around the launch and/or cease mowing the grass. If mowing is necessary, keep to four inches minimum.

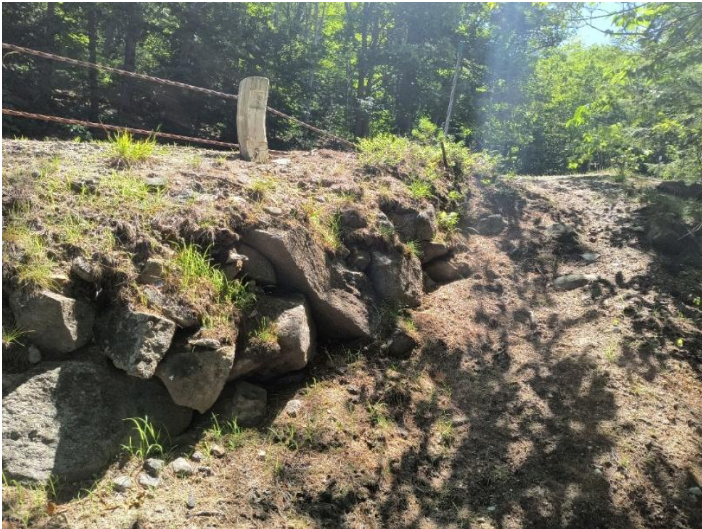
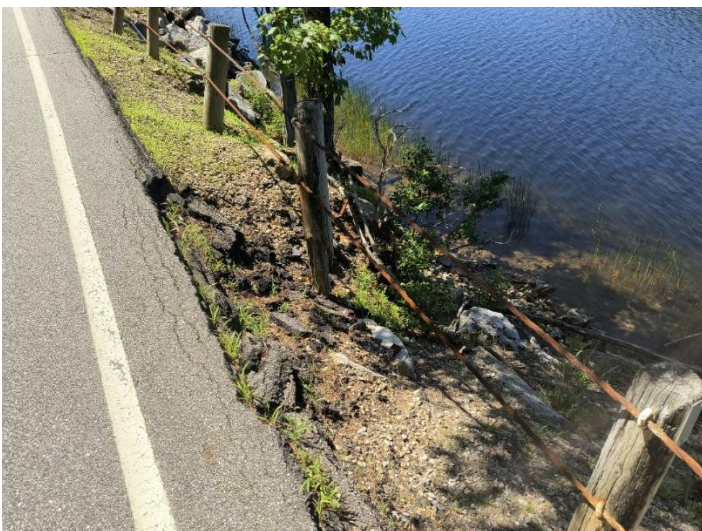
## Site 2-13A and 2-13B: Winona Road Bordering Winona Lake (Center Harbor)

**Observations:** Winona Road is extremely close to Winona Lake and is constrained by a steep slope on the opposite side. There is severe shoreline/bank erosion and several large gullies leading down to the water. There is substantial sand built up along the lake shoreline (from erosion and/or stormwater runoff); this sand was observed to originate from watershed sources as there is a clear dividing line between the sand and the lake muck.

*Eroding roadside down a steep bank (top left, top right, bottom left) leading to sediment deposition into Lake Winona (right).*

**Recommendations:** A larger engineering study may need to be conducted at the site to determine the appropriate recommendations for the entire road. Potential recommendations may include live stake plantings or rip rap to stabilize the shoreline, super-elevating the road to direct all runoff to the upslope side and installing cross-culverts or, with significant engineering and permitting, building the land out into the lake to support the road.

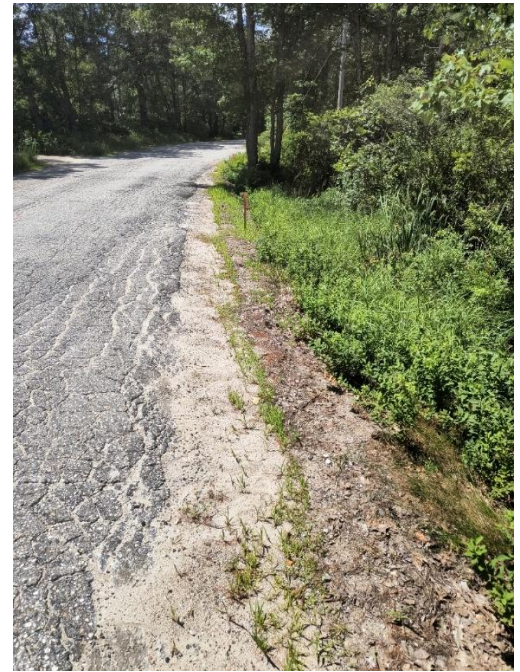
**Observations:** An undersized culvert connects a roadside ditch to a wetland on Piper Road. Road shoulder erosion transports sediment to the wetland in concentrated flow paths. Road work may be planned as there was pink flagging tape and paint on the road.

*Edge of road and wetland with lack of buffer (left). Eroding road shoulder with ample sediment buildup (right).*

**Recommendations:** Add curbing to the road to prevent stormwater from directly entering the water resource. Turnouts may also be installed to direct stormwater into the wooded area to infiltrate stormwater. Repave the eroding road surface. Remove excess sediment from the road and road shoulder.

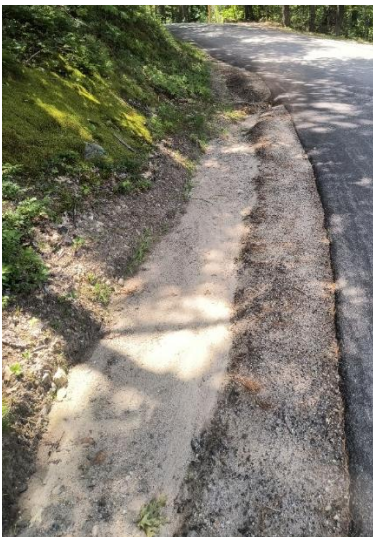
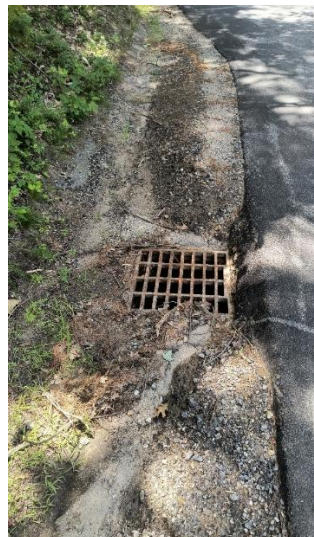
**Observations:** A gully has formed in the road ditch at the site, and sediment has built-up within each gully signaling that sediment is traveling down the road and into one of the catch basins. Sediment from the road intersection island transports to another catch basin. Winter sand likely also accumulates in this catch basin.

*A gully full of sediment (left) leads to catch basin (middle). Road intersection island with catch basin in roadway (right).*

**Recommendations:** Vegetate the road shoulder and stabilize the ditch. Add check dams and turnouts to the woods if necessary/possible. Add a filter bag to the catch basin in the roadway. Remove sediment from catch basins and shoulder. Increase vegetation in the road intersection island and remove the sandy gravel. Evaluate if the entire impervious area is needed for car travel and consider replacing with a smaller right-angle tee intersection without an island and with much less asphalt surface area; remove excess impervious cover and replace it with vegetation where possible.

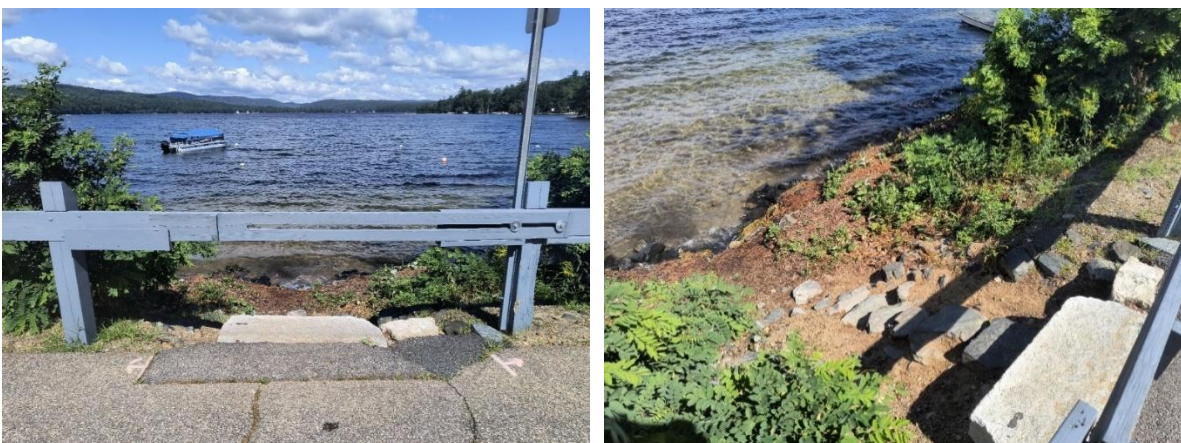
**Observations:** This site appears to be used as a canoe/kayak launch. The bank surrounding the steps and bare soil is eroding.

Launch gate from road (left) and steps for launch to water (right).

**Recommendations:** Formalize the launch by adding wide, stable steps to discourage people from stepping on the bare ground; revegetate the bare areas. Add a slight curb to road to prevent stormwater from entering the lake from the road. Consider establishing a formal canoe launch at the site to prevent shoreline erosion.

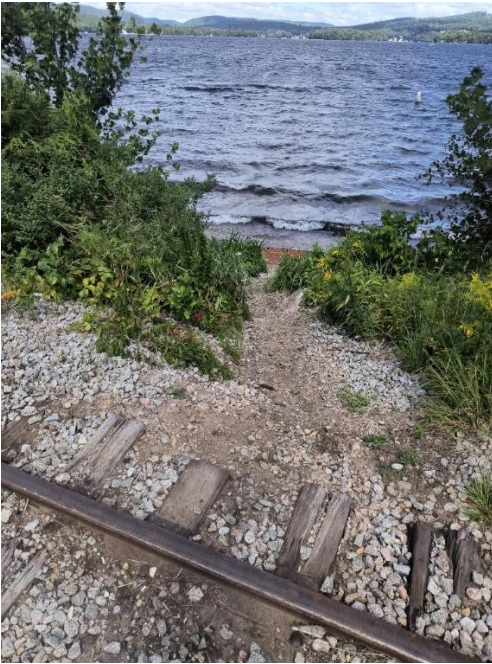
**Observations:** Along this section of the railroad, there were four areas observed to have gaps in shoreline buffer. Some areas seem to be adequately stabilized with rip rap, but some are bare and potentially transporting sediment through them.

*Breaks in the shoreline buffer are either bare (left) or stabilized by rip rap (right).*

**Recommendations:** Restore the vegetated buffer in these gaps, if possible. Otherwise, maintain current conditions (prevent deterioration) or add additional rip rap to stabilize the shoreline. Live stake plantings may be used if establishing vegetation is difficult.

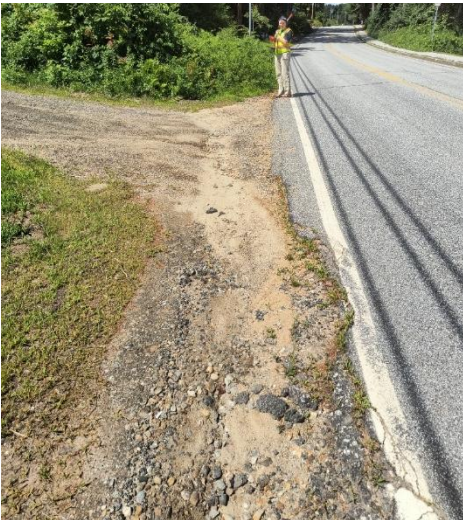
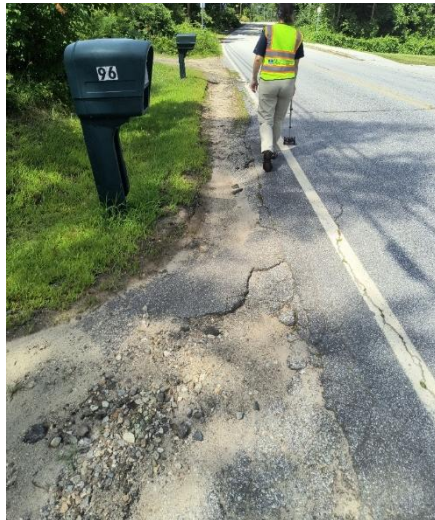
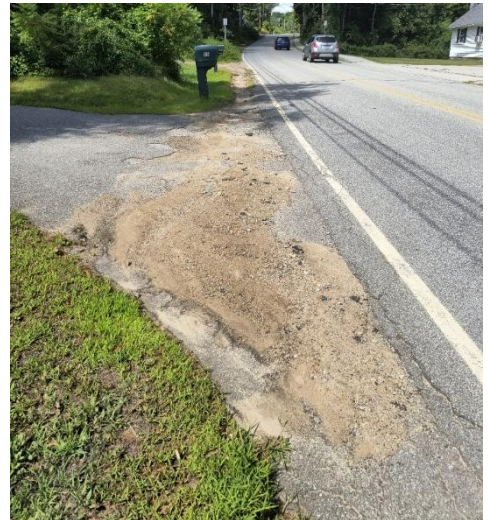
### **Site 3-05: Driveway of 98 Waukewan Street (Meredith)**

**Observations:** House #98 has an unpaved driveway that is actively eroding. Sediment is transported through a gully forming in the road ditch. Eroded sediment from the driveway builds up on the driveway of house #96. Stormwater from the site, which carries sediment and other pollutants, ultimately leads to a stream crossing.

*Erosion of house #98 driveway (left) that travels down the road, gullying the ditch (middle) and erodes and deposits sediment on the driveway of house #96 (right).*

**Recommendations:** Engage with the landowner to pave their driveway, add crushed stone to stabilize the surface, or use water bars to direct stormwater into the nearby wooded area. Armor the road ditch with crushed stone to repair the gully and add a turnout to the vegetated area near the stream down the road. Remove eroded sediment from the area.

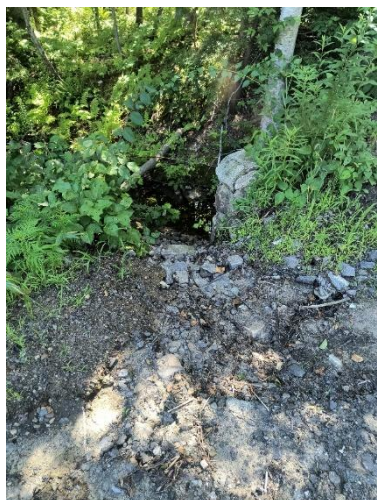
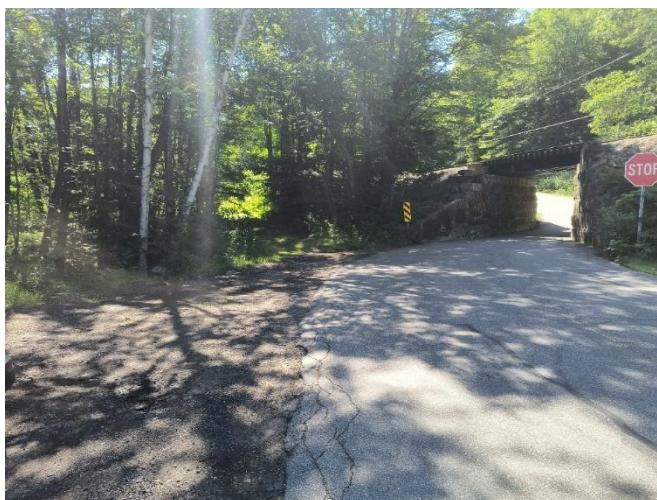
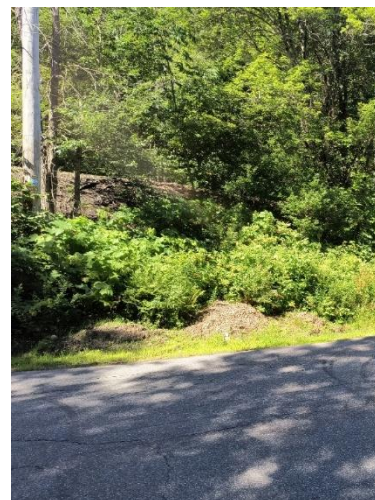
**Observations:** There is a gully in the parking area that leads down to the stream. The gully is filled with gravel displaced from the parking area, which has loose surface material. There are sediment piles, potentially from plowing, at the edge of the parking area and across the road in the ditch. Some yard waste is dumped near the stream as well. This stream flows to the Snake River.

*Gully to stream (left) from parking area and railroad crossing (middle). Sediment pile in vegetated swale across street (right).*

**Recommendations:** Divert stormwater from under the railroad bridge to the side of the road opposite the stream using a rubber razor or broad-based dip. Utilize the vegetated swale on the opposite side of the road for stormwater storage and infiltration. Fill in the gully with vegetation to deter stormwater from concentrating here. If water access is required, consider creating a formal water access point with stable infiltration steps. Remove sediment piles on both sides of road and ensure plow piles are removed each spring. Ensure yard waste, which is a source of nutrients to the lake, is not placed near the stream.

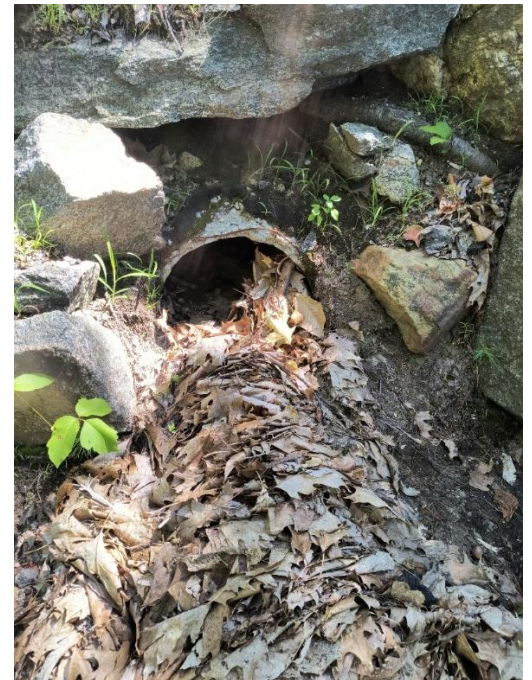
**Observations:** This site is next to site 2-13A. There is road ditch erosion; the ditch transports sediment through a culvert with an unstable inlet and outlet. There is a silt fence below the outlet of the culvert which is full of sediment and appears to be ineffective.

*Eroded culvert inlet and road shoulder (left) transporting sediment and organic material through to the outlet and lake (right).*

**Recommendations:** Stabilize the culvert and potentially replace it, if needed. Clean out the silt fence and ensure it is regularly maintained to keep sediment from entering the lake. Stabilize the surrounding ditches with vegetation or rip rap if needed.

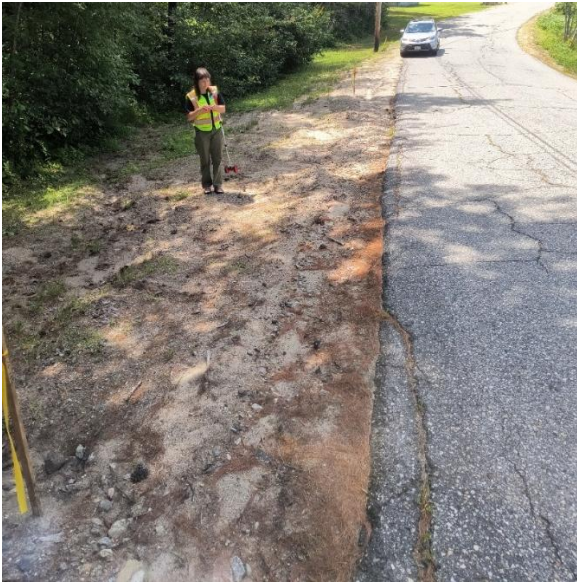
**Observations:** There are multiple gullies along the wide, sandy road shoulder on Piper Hill Road. Stormwater at the site carries pollutants to a wooded area, opposite the wetland that abuts Hawkins Pond. The road condition is poor and likely needs to be repaved; flagging along the road indicates that this work may already be planned.

*Road shoulder erosion and sediment deposition on Piper Hill Road (left and right).*

**Recommendations:** Repave the road and super-elevate it so drainage is directed toward the forested area instead of the wetland. Stabilize the road shoulder with vegetation.

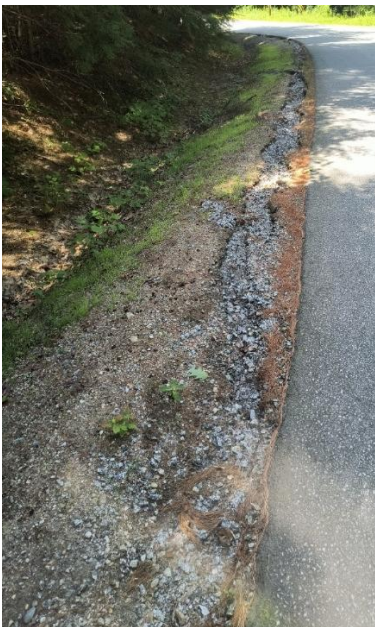
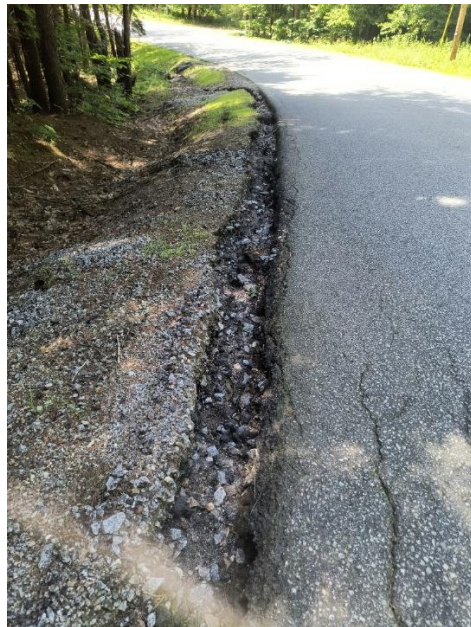
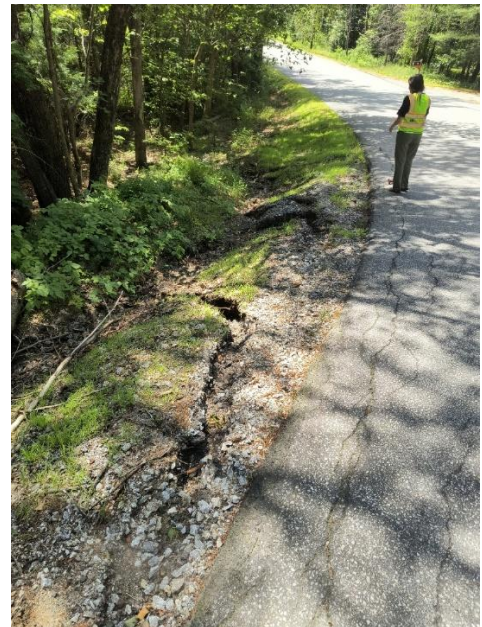
### **Site 3-28: Piper Hill Road by MacDonald Excavation (Center Harbor)**

**Observations:** A nearly 300-foot gully runs through the road shoulder of Piper Hill Road. Stormwater from the road drains through several individual gullies before forming a formal ditch. The bottom of the ditch is very deeply incised. The road shoulder material is too soft and erodible, which allows the gullies to form.

*Stormwater forms a gully along the road shoulder that deepens (left and middle) until it travels into the road ditch through several gullies (right).*

**Recommendations:** Stabilize the shoulder and ditch with more suitable roadside material that is less loose. Consider digging a wider road ditch that is armored with vegetation and check dams.

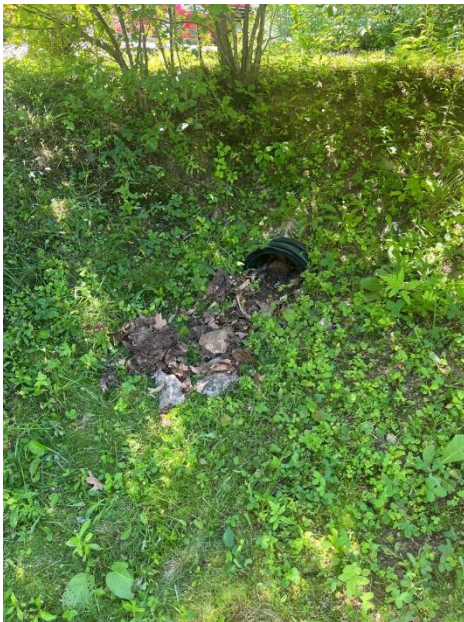
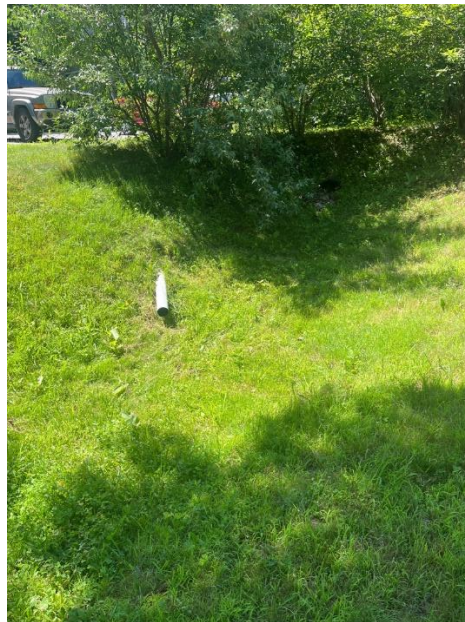
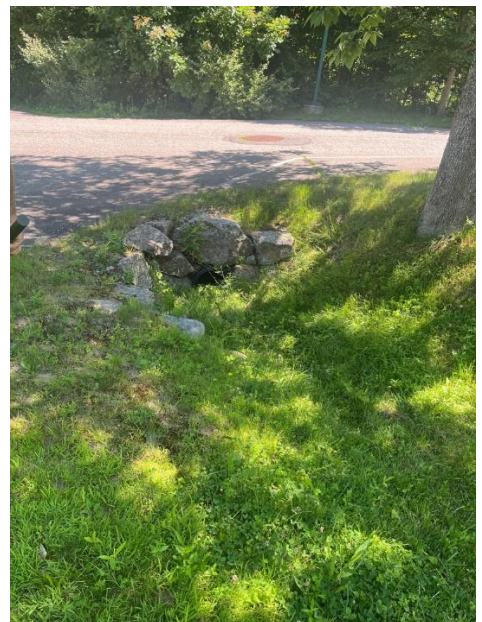
**Observations:** Stormwater from the parking lot drains to a vegetated ditch which enters a culvert and forms a headwater stream. A second pipe also appears to connect to the ditch, though the origin of the pipe is unknown,

*Stormwater from uphill enters the vegetated area (left). Another pipe of unknown origin leads to the ditch.*

**Recommendations:** Create a bio retention area/rain garden and plant wetland species. A check dam may also be installed uphill of the culvert to detain stormwater in the vegetated area and allow it to infiltrate.

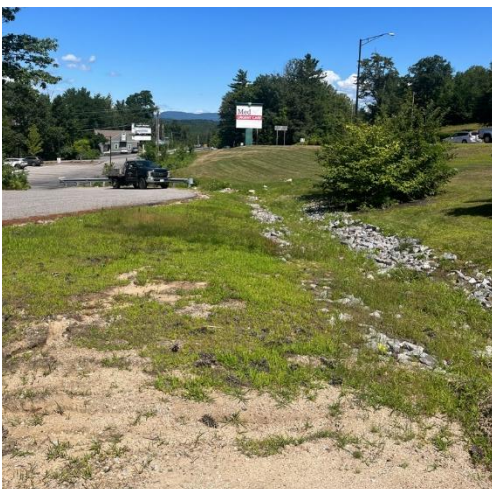
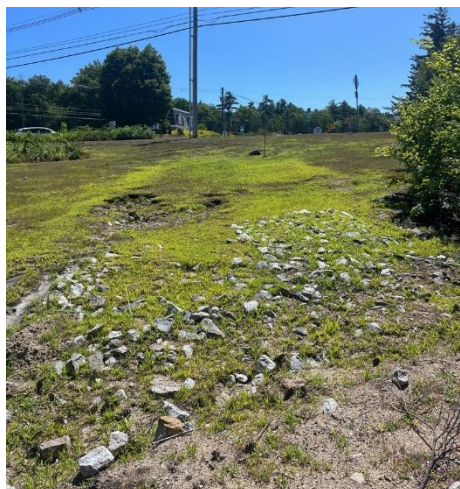
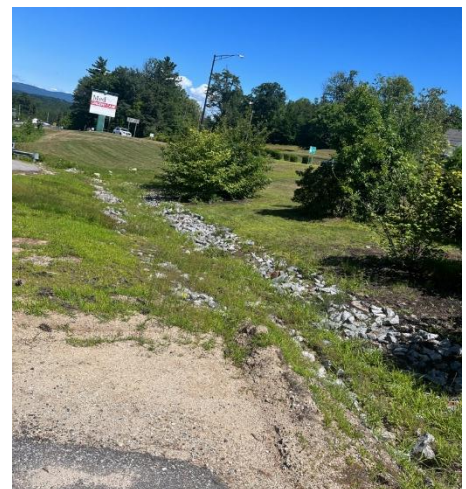
#### Site 4-09: Med Urgent Care at Traffic Circle (Meredith)

**Observations:** Stormwater enters the site through a concrete culvert and travels down the hillside, eroding the hill slope until it reaches a rip rapped area. From this area, stormwater enters catch basins at the hospital and travels down Reservoir Road, which leads to the lake. The town maintains this lawn.

*Large lawn area with erosion and sparsely placed rip rap (left, middle, and right).*

**Recommendations:** Implement green stormwater infrastructure in this area, such as a rain garden or a detention swale. Stabilize eroded areas and vegetate all mowed areas, assuming they are not used for recreational or other purposes.

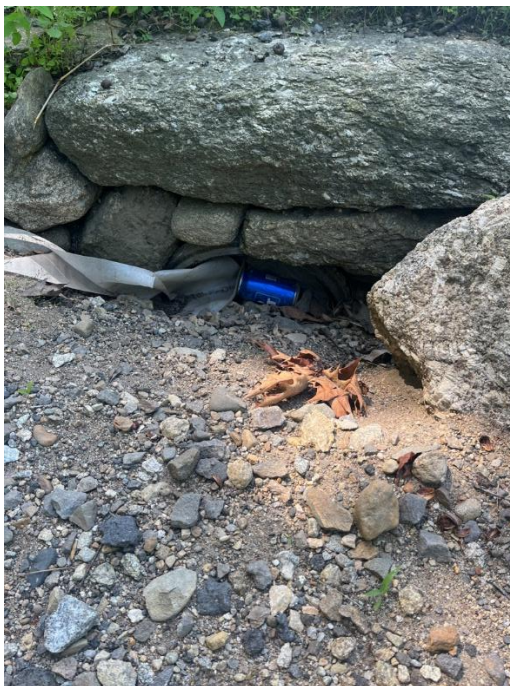
#### Site 4-10: Parade Road Near Tracy Way (Meredith)

**Observations:** The culvert under a driveway on Parade Road is clogged with sediment and trash. Sediment has accumulated downstream of the culvert, but the road shoulder there is extremely vegetated which likely filters pollutants.

*Sediment deposition in the road ditch and on a driveway (left) clogs the culvert under the driveway, along with trash (right).*

**Recommendations:** Remove sediment and trash from the culvert. Reshape the ditch and repair the roadside erosion by adding vegetation.

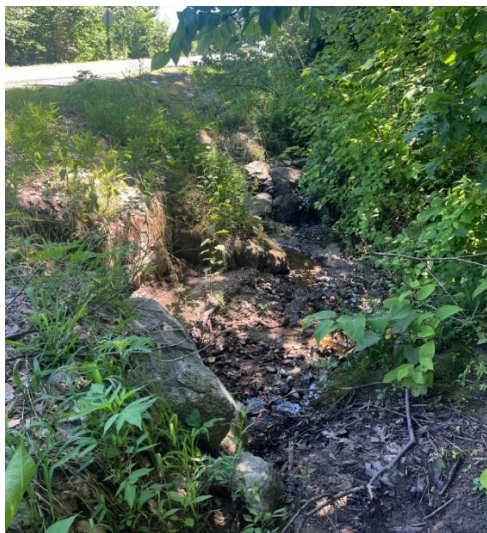
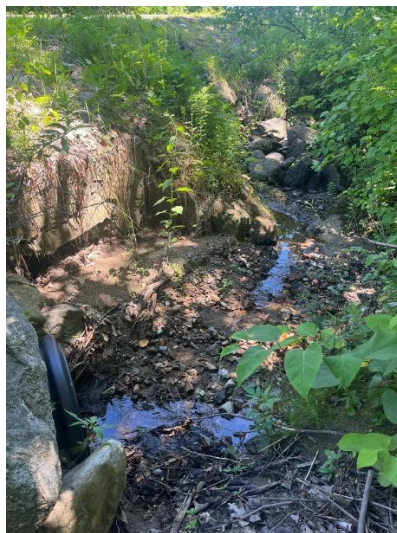
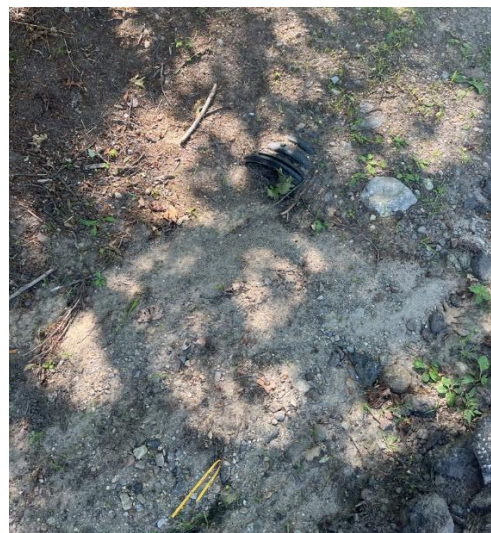
#### Site 4-12: Lower Ladd Hill Road Near Daniel Webster Highway (Meredith)

**Observations:** Stormwater from the Hillrise Lane road ditch leads to a stream at the corner of Lower Ladd Hill Road and Daniel Webster Highway. A culvert under a nearby driveway is completely clogged with sediment.

*Bank cutting of ditch (left) leads to sediment buildup in stream (middle) and clogged culverts (right).*

**Recommendations:** Vegetate the ditch to attenuate flow and install check dams or rip rap if needed. Unclog the culvert.

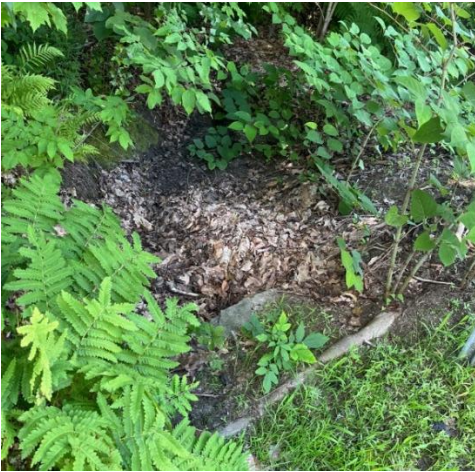
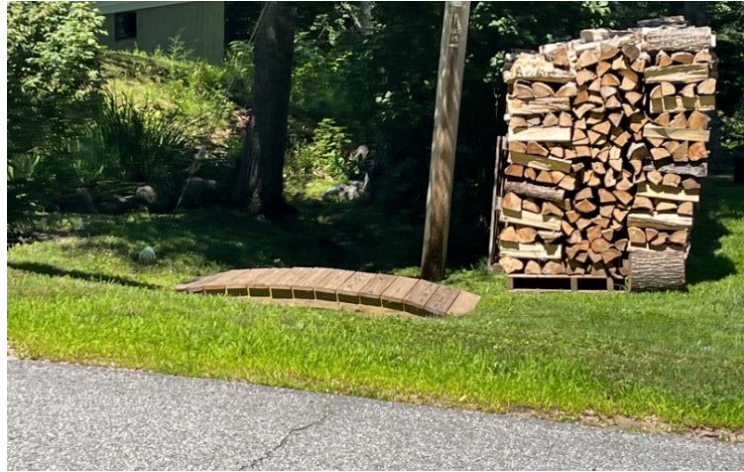
**Observations:** A culvert is completely blocked with leaves. Water comes from a stream that cuts through the woods from Hillrise Lane down to the culvert. The stream crosses the road and leads to Lake Waukegan. There is not a very well-defined stream channel, and only minor erosion around the culvert inlet and outlet. The outlet is mostly vegetated.

*Blocked culvert (left and right).*

**Recommendations:** Unblock the culvert.
